## HERITAGE IMPACT ASSESSMENT

## Hammond Reef Gold Project 23 km Northeast of the Town of Atikokan Thunder Bay Mining District Northwest Ontario

Submitted to: Canadian Malartic Corporation 145 King Street East, Toronto, ON

Report Number: 1408383\_DOC005\_Rev 1 Distribution:

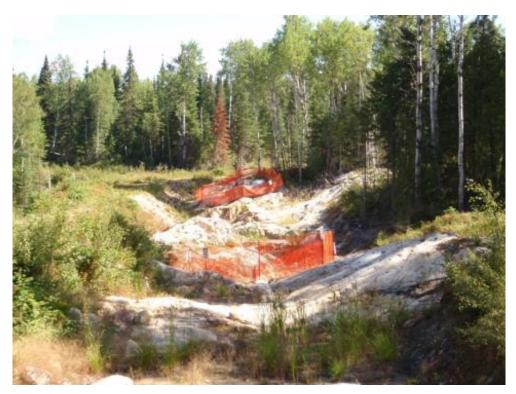
Three water filled shafts were identified during the fieldwork which matches the locations indicated on the geological map in Figure 9. The shaft entrances were all fenced using temporary snow fencing as a health and safety measure for the new mine operation (Figure 12). The main mine shaft contained a number of wooden beams which may date to the original mine operations (Figure 13).

Figure 12: Main Shaft and Air Shaft from First Operation of the Mine (View Northeast)

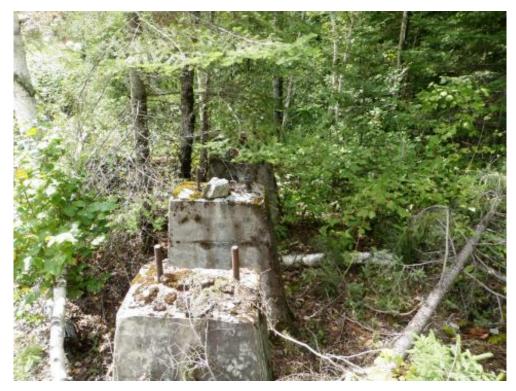
A concrete foundation approximately 20m by 30m with a 5m by 15m addition on the west side of the structure was located 20m to the east of the main mine shaft (Figures 14-15). The structure contains four concrete platforms stepped one below the other on the downslope from the main shaft. Several concrete pedestals and low walls with rebar projecting from the top were scattered throughout the structure (Figures 16-17). The concrete pedestals indicate that the building housed large mechanical equipment which required significant structural reinforcement to operate. One large rectangular pit was located in the northeast portion of the structure (Figure 18).

Figure 17: View of Concrete Pedestals in the Central Area of the Stamp Mill (View West)

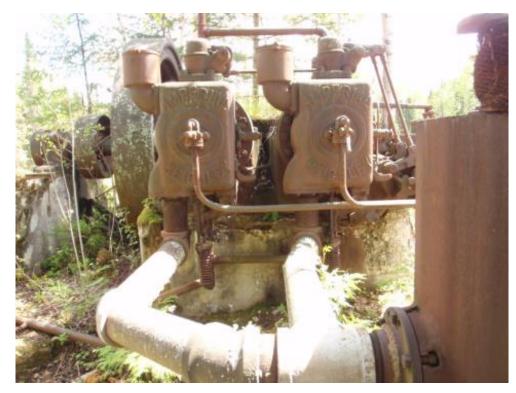
A large two-cylinder gasoline (or diesel) engine was located approximately 10m east of the main shaft (Figure 19). The engine was still located on its original concrete bed. The engine appears to be in relatively good condition and most of its components are still in place (Figures 20-21). A builder's plate identified it as "Imperial Keighley." This company manufactured oil and gas engines in the early 20<sup>th</sup> century in Keighley, England. The placement of the engine adjacent to the main shaft indicates that it was likely the hoist engine. When in operation, the engine would have been enclosed in a hoist house. No evidence of the structure remained at the time of the site visit. The engine is assumed to have been installed in the 1930s.

Figure 20: South End of the Engine with Imperial Keighley Marking Visible (View North)

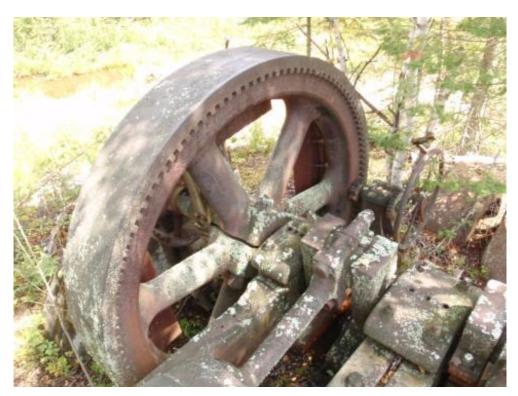
Figure 21: Flywheel of Engine on West Side of the Engine (View Northwest)

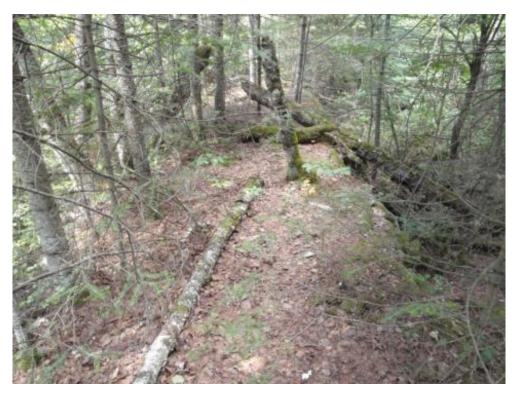
A tramway originally connected the stamp mill with Sawbill Bay. The approximate location of the tramway is labelled as a trail on the geological map of the mine (Figure 9). The extant remains of the tramway consist of a thick rubble platform over the majority of the path of the tramway (Figure 22-25). Closer to Sawbill bay the base of the platform thins considerably until it is mostly visible as a pair of parallel ditches (Figure 26). The width of the tramway stays consistent at approximately 2 m along the entire length.

Figure 22: View on Top of the Tramway near the Stamp Mill (View Northwest)

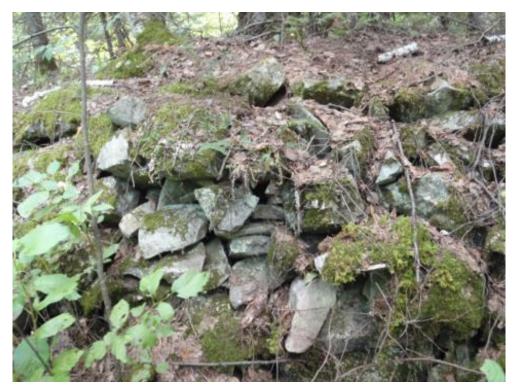
Figure 23: Close-up of the Base of the Tramway (View South)

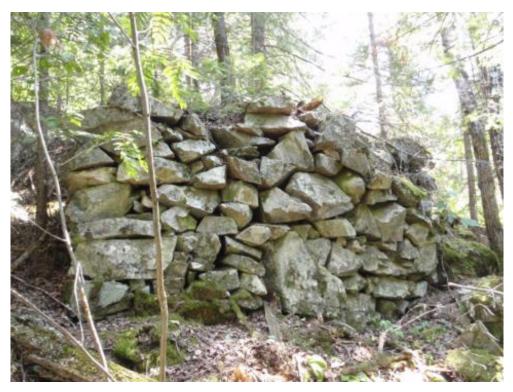
Figure 24: Tramway Abutment for Crossing of a Creek (View Southeast)

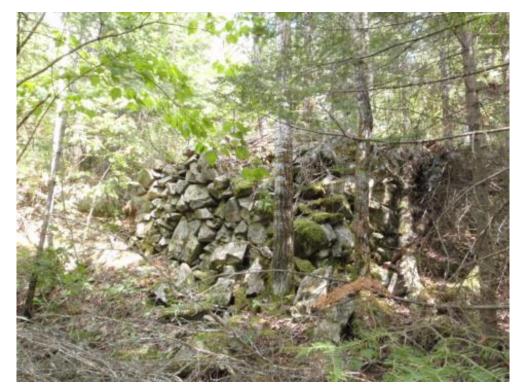
A concrete pad, approximately 20 x 30 m, was located on the west side of the tramway approximately 20 m north of the creek crossing seen on the geological map (Figure 9). This platform contained no distinctive features. However, considering it was located approximately 3 m lower in elevation than the platform of the tramway, it is probable that the pad served as support for a wooden structure which was level with the tramway platform.

Figure 25: View of the Side of the Tramway from Concrete Slab West of the Tramway (View North)

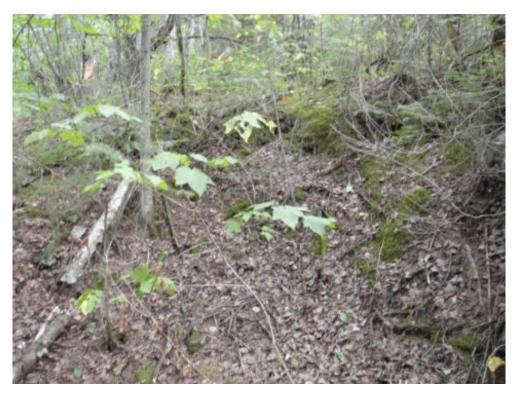
Figure 26: Tramway with Thin Base Mostly Seen as a Ditch in the Centre of the Photograph (View Northwest)

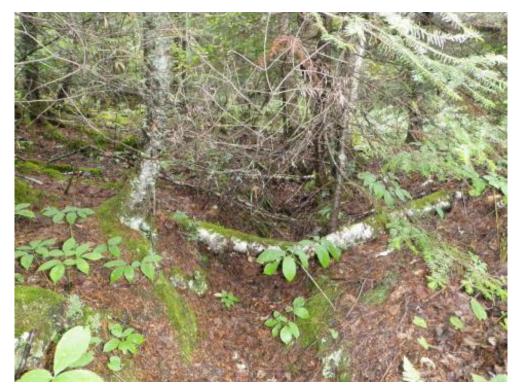
The geological map of the area, seen in Figure 9, identifies numerous trenches which were observed in the field work. The greatest concentration was observed along the crest of the hill (Figures 27-28). The trenches are now primarily overgrown.

Figure 28: Surface Trench near Sawbill mine (View Southwest)

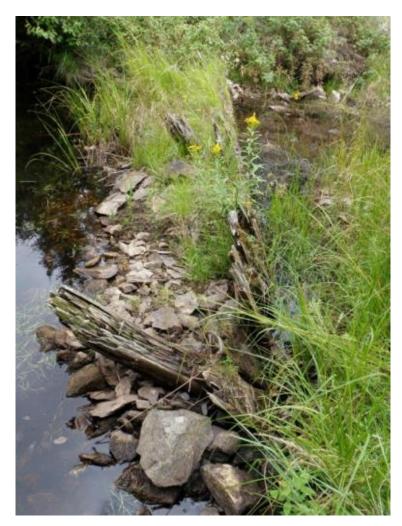
Figure 32: Close up of Timber Crib Dam Structure (View North)

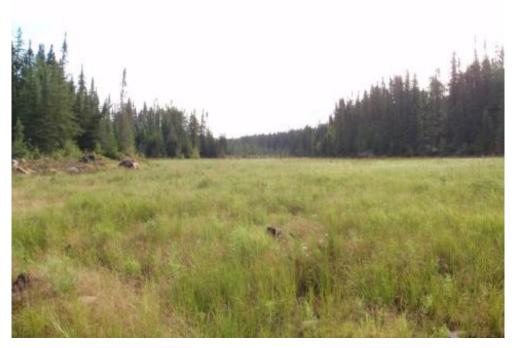
Figure 33: Former Head Pond above the Timber Crib and Waste Rock Dams; now Silted In. (View East)

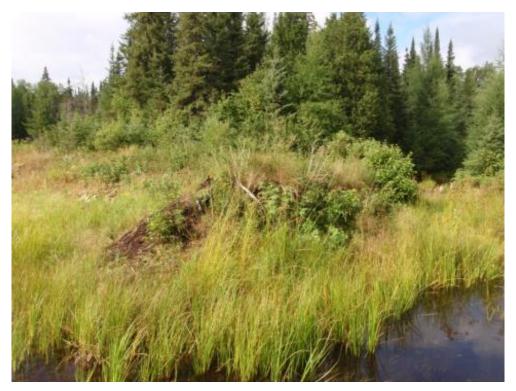
At the base of the south side of the hill on which the Sawbill mine sits, runs a stream valley visible in the geological map of the Sawbill mine as a gap between the Trondhjemite gneiss bedrock (Figure 9). This drainage continues southwest for approximately a kilometre before turning north to drain into Sawbill bay. Along the stream valley, three dams were noted, two timber cribs dams and one earthen dam constructed of waste rock. A pair of these dams were located approximately 200 m to the south Sawbill mine and could have created a large pond from their construction (Figures 31-33). This valley had two channels, one which was blocked by an earthen dam which would have redirected most or all of the water into the smaller eastern channel (Figures 34-35).

Figure 34: Two Channels from Head Pond, Smaller Channel with Timber Dam to the Right (View East)

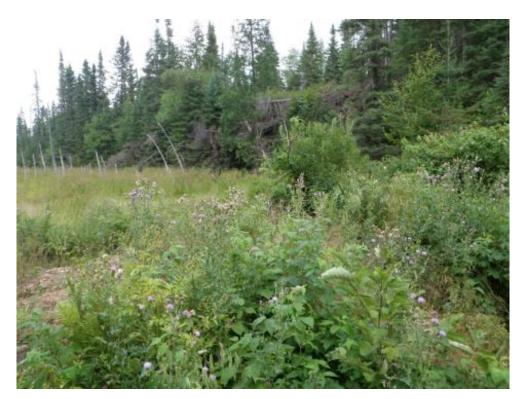
Figure 35: Waste Rock Dam Blocking Main Channel of the Head Pond (View southeast)

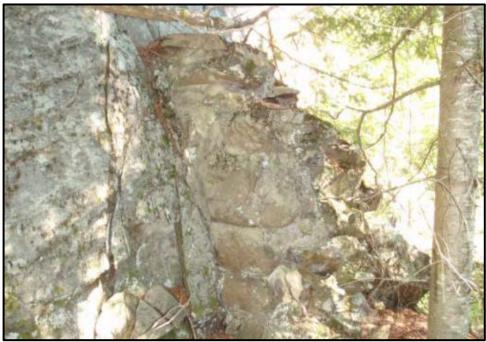
*Figure 2:* Stone dam remains of former power plant. October 2011. Source Golder Stage 1 Baseline Study and Stage 2 Archaeological Assessment 2013.

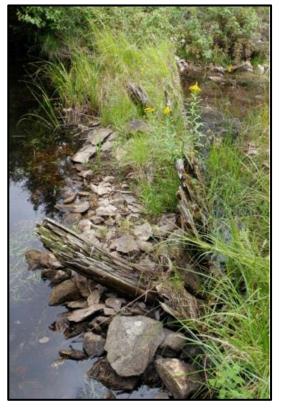
In 1897 the company built a dam above the mill to create a pond to provide boiler water. However, the water proved unsuitable for this use and the pond was abandoned. Water was instead pumped from Sawbill Lake.<sup>10</sup> The design was typical of small, 19<sup>th</sup>-century mill dams (Figure 12). The steeply sloped vertical boards on the upstream side provided a water proof barrier (Plate H-13). The rock on the downstream side provided ballast to stabilize the dam (Figure 11). By 2014 the former pond above the dam had silted in as a beaver meadow

*Figure 11: Close Up of Timber Crib Dam Structure, October 2011 (Source Golder* Stage 1 Baseline Study and Stage 2 Archaeological Assessment 2013.

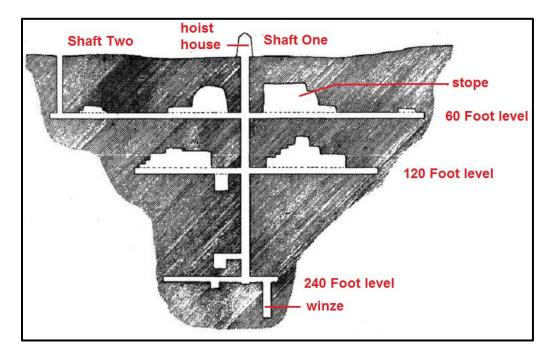
Mining commenced in April, 1895 and by the end of 1896 'the main shaft had been sunk to 44 metres (145 feet) and the "60 foot" and "120 foot" levels were excavated.<sup>21</sup> Shaft One, with the headframe, is located in the centre of Figure 16 and Shaft 2 is to the left. The outline of the hoist house is similar to that depicted at the Elizabeth Mine in Figure 13.

Figure 15: Sawbill mine c 1900. (Ontario Department of Mines Annual Report 1921, Part 2 Ontario Gold Deposits Their Character, Distribution and Productiveness; mine section was originally published in 1900 Annual Report)

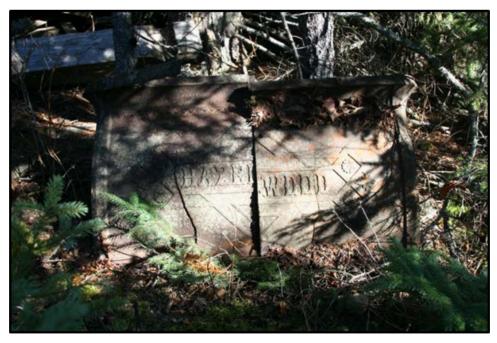
The archaeological and built-heritage assessments of the property identified wood stove castings (Figure 2) and other small artifacts; as well as a large "equipment dump" of fragments of gold-milling equipment. The Atikokan Museum curator indicated that she might be interested in obtaining some of these artifacts for the museum collection.

Figure 2: "Hazelwood" Stove iron castings at Hammond Mine
