*Ajax Project Open Pit – Review of Open Pit Design Parameters
for Updated Hydrogeological Conditions*

AJAX PROJECT

**Environmental Assessment Certificate Application / Environmental Impact Statement
for a Comprehensive Study**

KGHM Ajax Mining Inc.

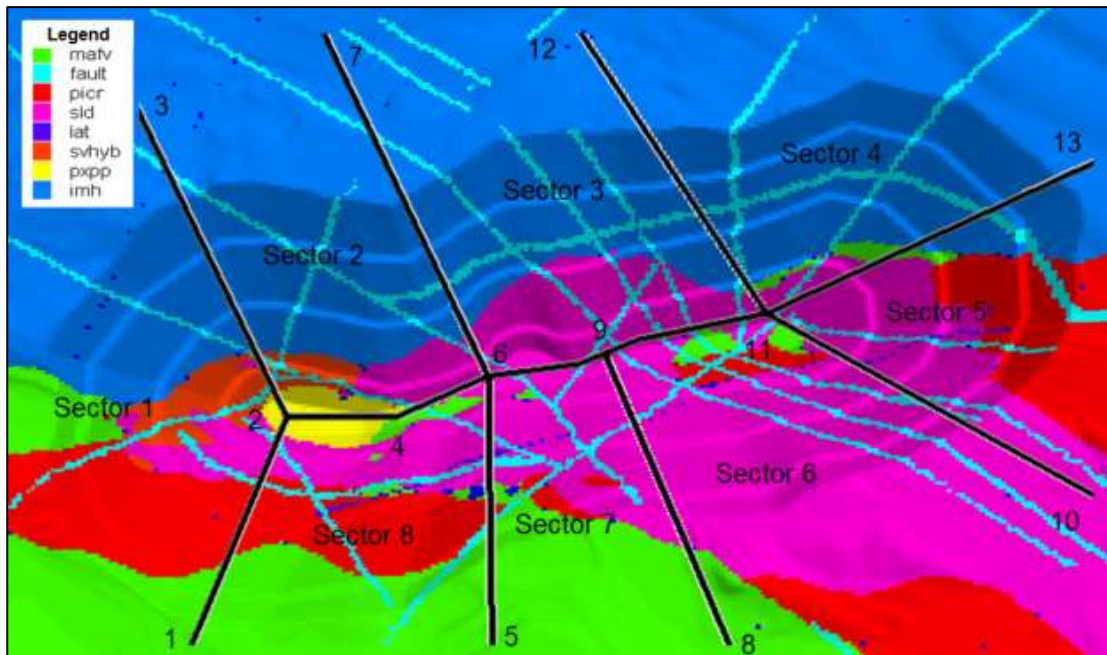
Figure ES-1: Location of Design Sectors 1 to 8

For completeness, the location of the sectors is shown in Figure ES-1 and the recommended slope parameters in Table ES-2. This table includes the same information shown in the SRK report of June 2014, although the OSAs for sectors 1, 2 and 6 have been updated.

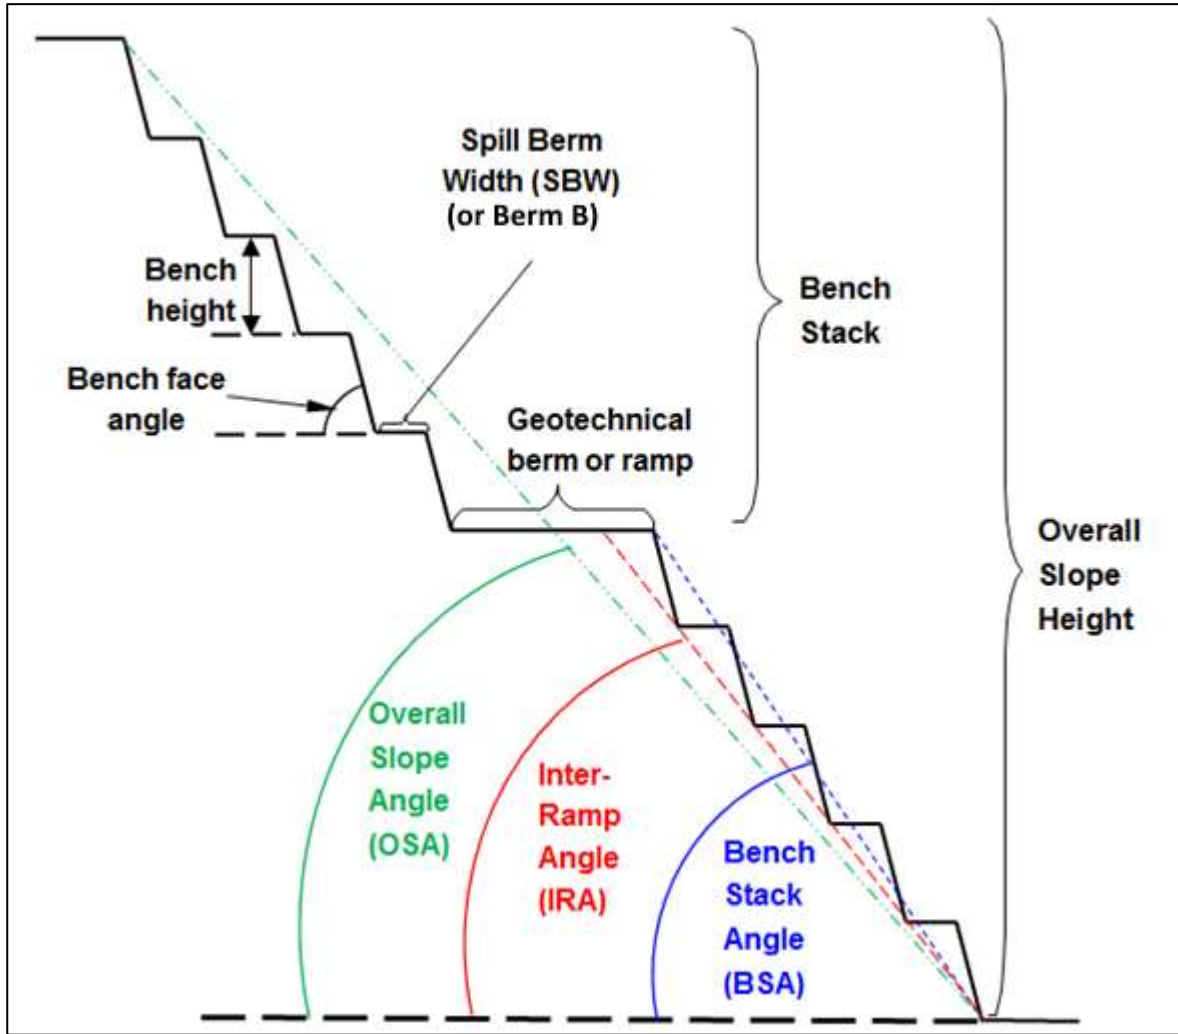
Figure ES-2: Naming convention for pit slope geometrical elements

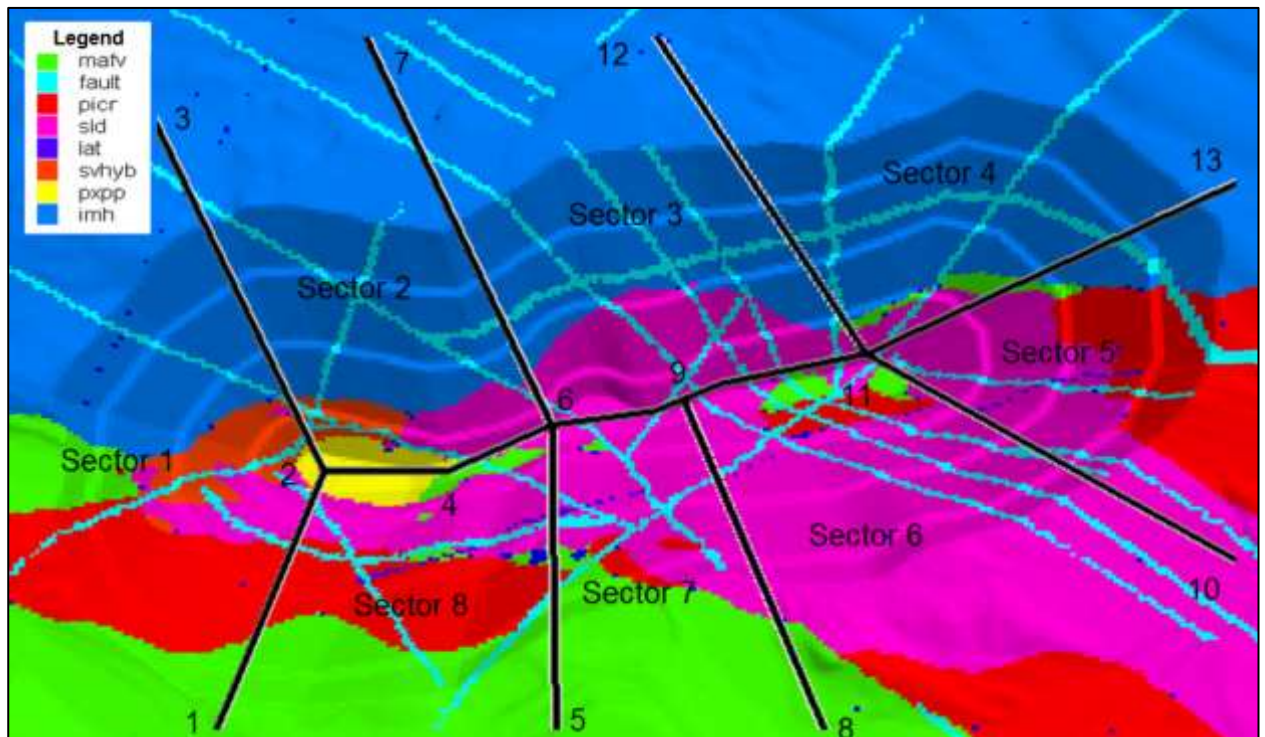
Figure 1-1: Pit design sectors (1 through 8) shown relative to approximate final pit shape, and lithology model

Based on this information, KGHM requested SRK to review the slope parameters recommended for sectors 1 and 2 and consider alternative drainage conditions for Sector 6 (Figure 1-1). The requested analyses are described in Table 2-1.

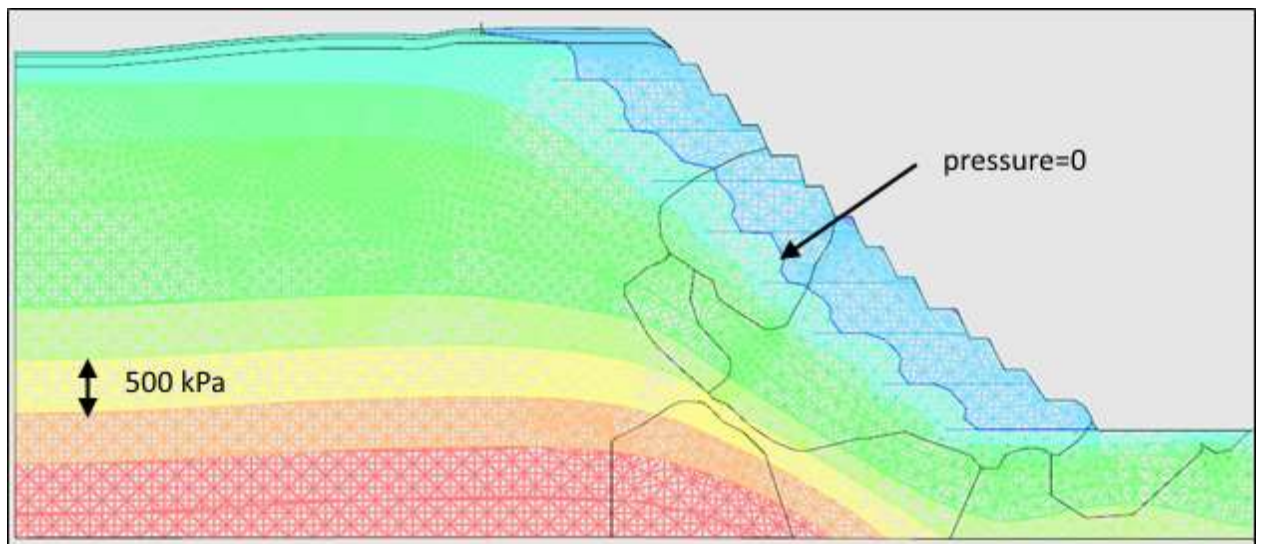
Figure 2-3: Pore water pressure distribution for mitigated case sensitivity 4 (transient) (KCB July 2014)

The pore water pressure distributions adopted in the stability analysis are therefore mitigated base case (shown in Figure 2-2) and mitigated sensitivity 4 (shown in Figure 2-3).

The water table defined in the present scope of work was stated as metres behind the wall (125 m and 150 m); this will be used for Sector 6 only. For sectors 1 and 2, the results provided by KCB will be used to model an improvement in water drainage conditions. SRK understands the idea of these analyses is a normal case (most probable) and an improved dewatering case. In order to do this, the normal case is considered the base case with drainage (Figure 2-2), while the improved case is presented as sensitivity 4 (Figure 2-3).

The analysis of Sector 1 using two different levels of drainage (125 m and 150m) was replaced with the analysis considering two water tables provided by KCB, shown in Figure 2-2 and Figure 2-3. The results of the analyses are discussed in detail in Section 3.6.

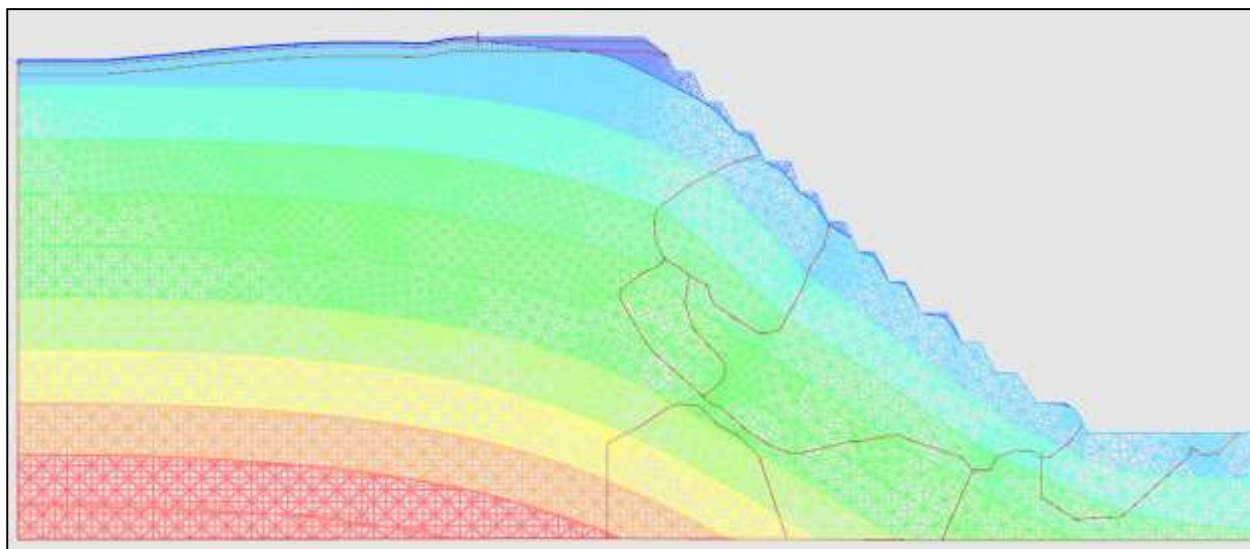
The pore water distribution used for this analysis corresponds to the base case with no mitigation or drainage of any kind; the pore water pressure is shown in Figure 2-4. It is important to note the proximity of the water table to the surface of the design pit wall.

Figure 2-4: Pore water pressure distribution for base case no mitigation or drainage installed (KCB July 2014)

The analysis considers no drainage on the pit wall on Sector 1. KCB results indicated that minimum drainage occurs if no mitigation system is put in place (Figure 2-4) and the water table remains relatively close to the pit wall surface.

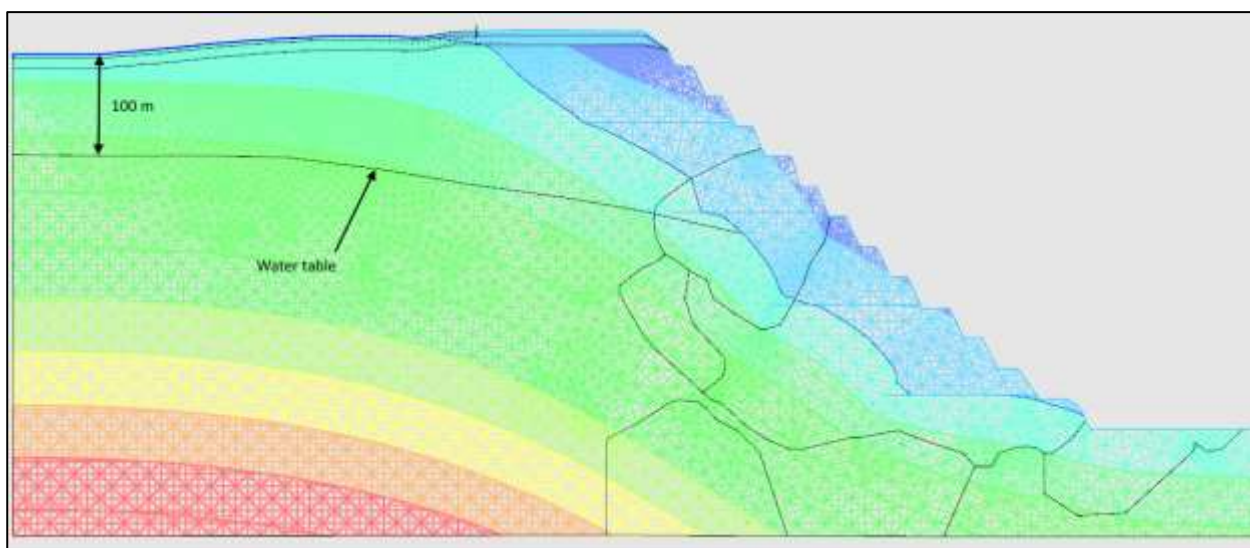
For this analysis, the pore water pressure calculated for sensitivity 9 (Table 2-2) was modified to assume water table located 100 m below Jacko Lake. Figure 2-5 shows the pore water pressure distribution and the location of the assumed water table.

Figure 2-5: Pore water pressure distribution for sensitivity 9 (KCB July 2014)

In this analysis, an optimistic water table was assumed located 100 m below Jacko Lake (Figure 2-5). The pit geometry used in the analysis corresponds to the pit design provided by KGHM which includes increasing the OSA to 48°, to make this analysis comparable to the analysis D described in the next paragraph.

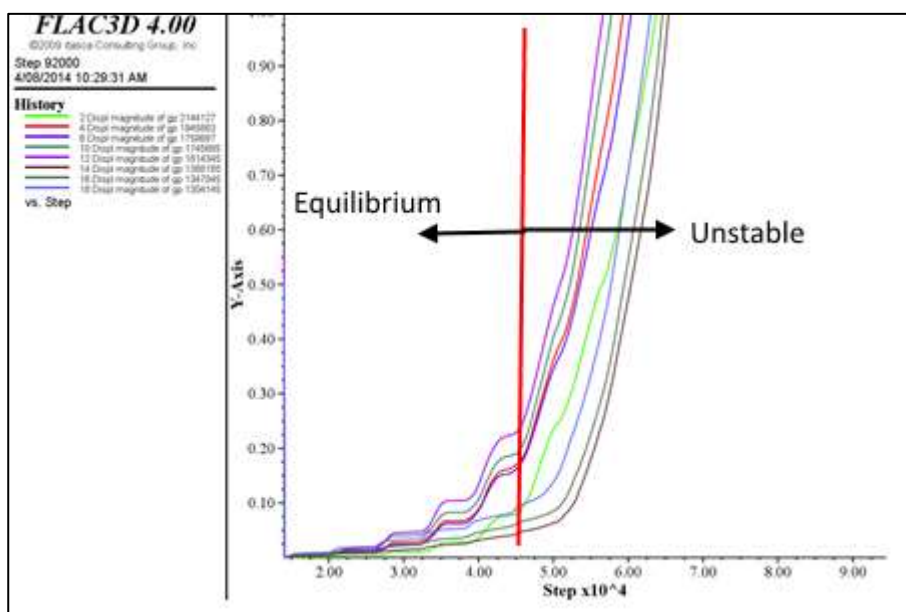
Figure 3-1 shows a typical displacements history point; after each reduction, the displacement increases; however, if the slope is in equilibrium, the displacements do not continue increasing. When an unstable condition is reached, the displacements continue increasing without reaching a plateau.

Figure 3-1: Example of typical displacement history points during an SRF calculation

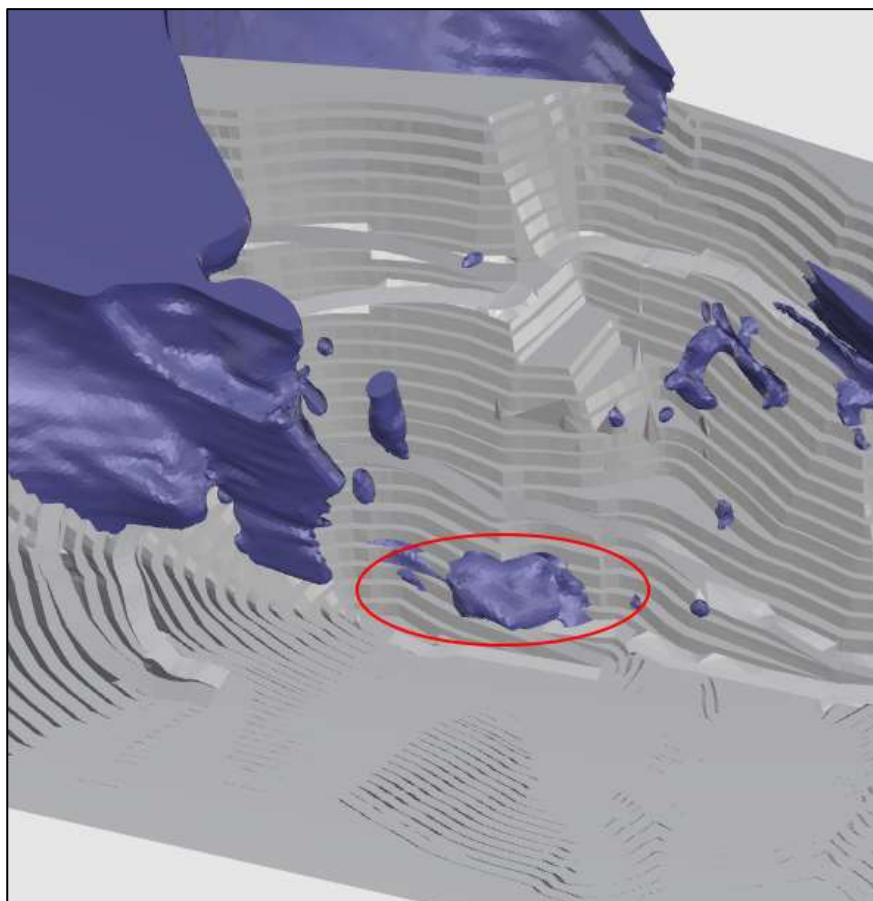
Figure 3-3: Sector 6 - Previous design showing exposure of PICR at the toe of the slope

The latest design received from KGHM has some differences when compared with the pit design used in the previous work of June 2014 – the pit is between 40 m and 60 m shallower, and the Picrite (PICR) (weak rock) has less exposure in the new design, as shown in Figure 3-3 and Figure 3-4.

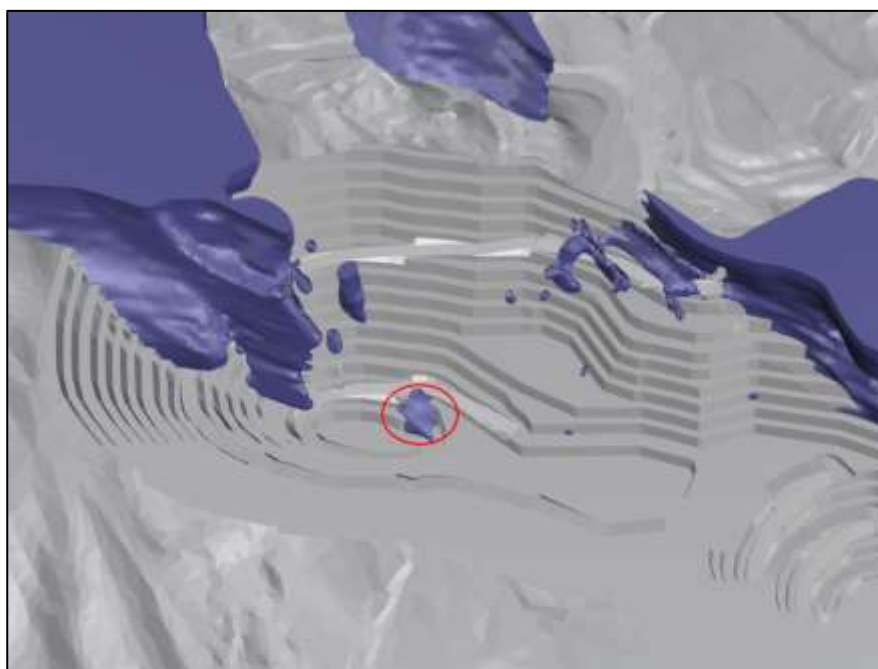
Figure 3-4: Sector 6 - Current design showing exposure of PICR at the toe of the slope

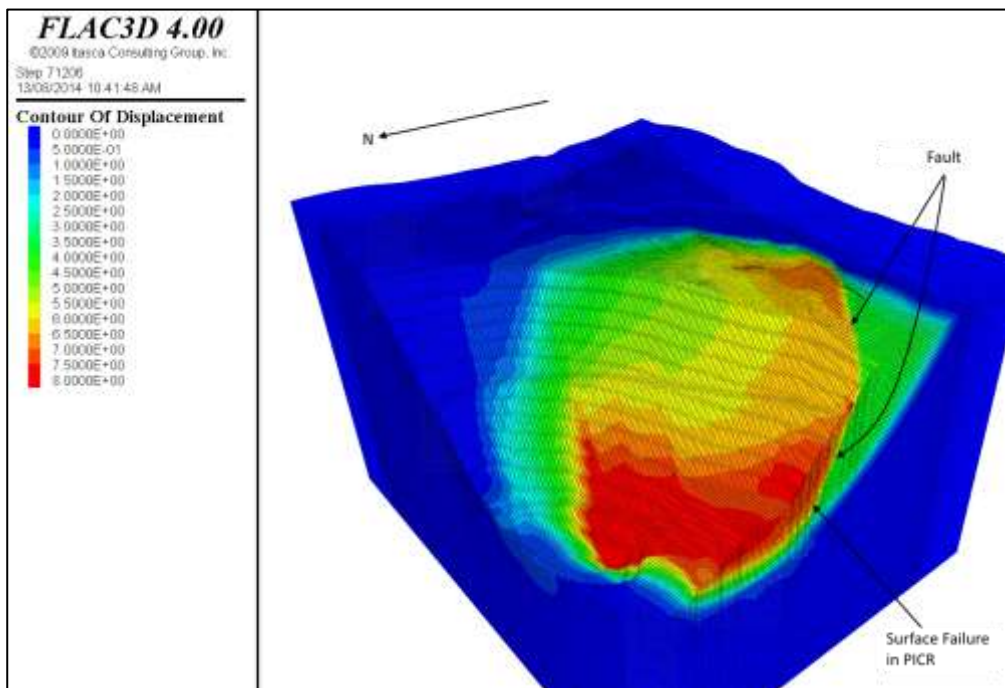
A similar same situation occurs again based on the revised pit slope design; the fault indicated in the Figure does not trigger the mode of instability, but becomes part of it when the FoS is calculated (Figure 3-6).

Figure 3-6: Sector 6 - Displacements at failure for Sector 6

The overall angle was increased 5° (increase of 3° from the 42° recommended by SRK, 2014) to an OSA=45° for Sector 6 and the analysis was repeated for the new geometry. The FoS obtained were 1.47 and 1.61 for 125 m and 150 m of drainage. Figure 3-6 shows the displacements at failure, and indicates that PICR behind the wall and a fault controls the surface instability.

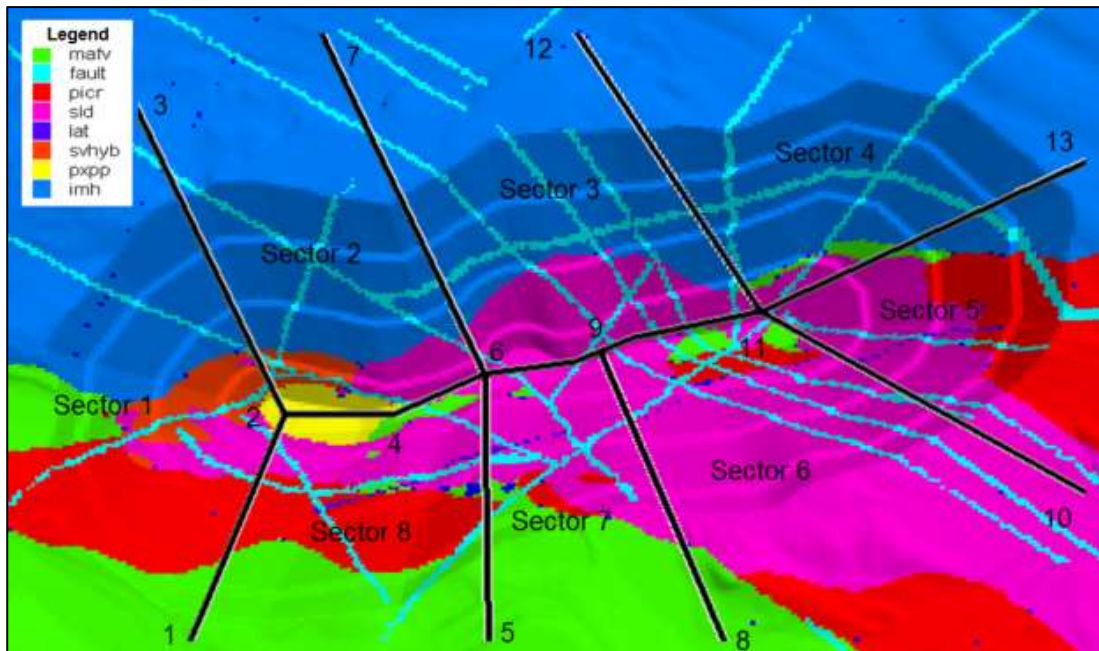
Figure 4-1: Location of design sectors

For completeness, the locations of the sectors are shown in Figure 4-1 and the recommended slope parameters are given in Table 4-3. This table includes the same information shown in the SRK Report of June 2014; however the OSAs for sectors 1, 2 and 6 have been updated.

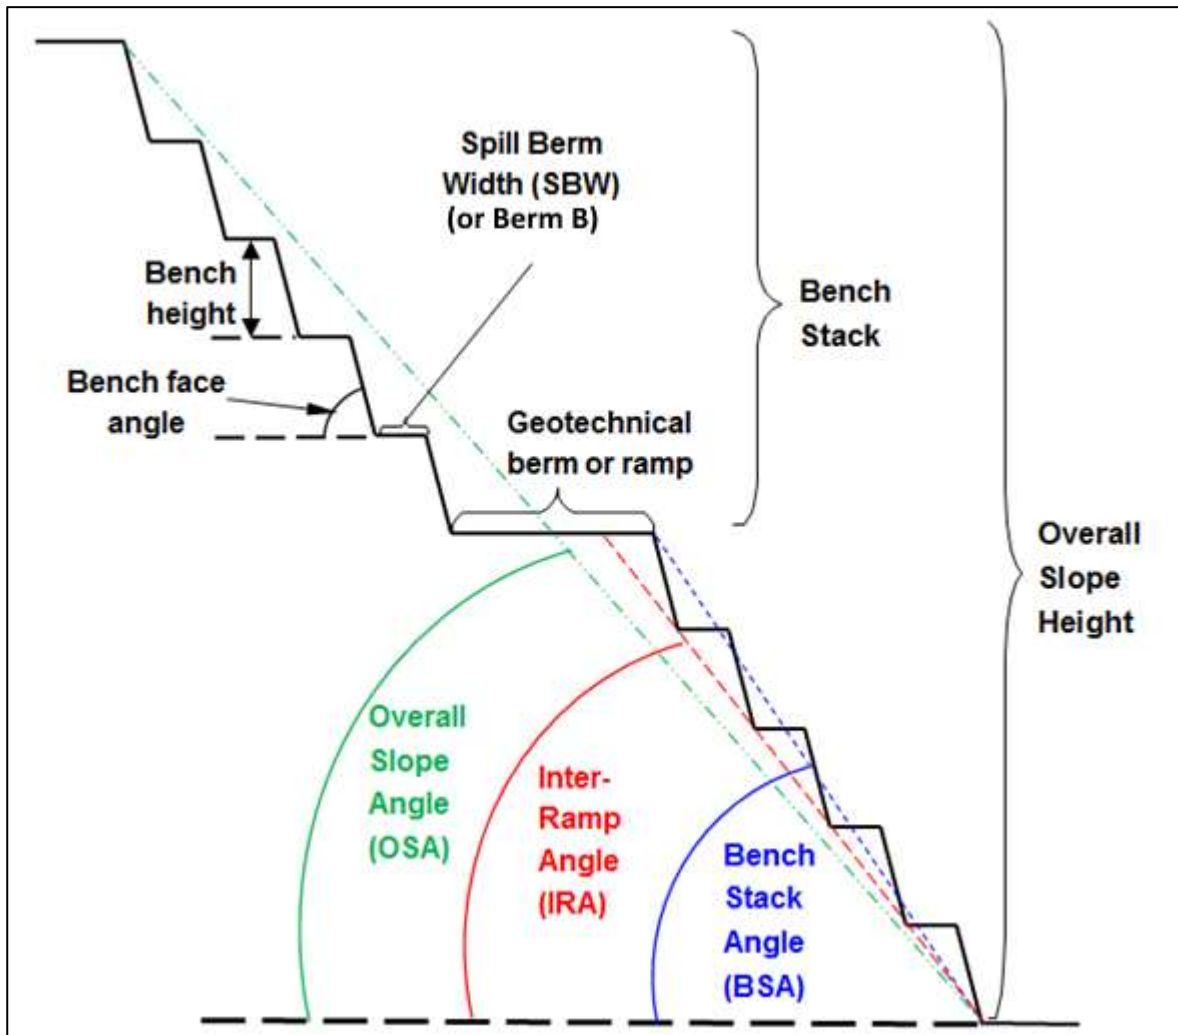
Figure 4-2: Naming convention for slope geometrical elements
