Ajax Mine: Tailings Dam Failure Modes Assessment and Dam Breach Inundation Evaluation

AJAX PROJECT

**Ajax Mine: Tailings Dam Failure
Modes Assessment and Dam Breach
Inundation Evaluation**

KGHM Document Number:
C180-KA39-RPT-00-005

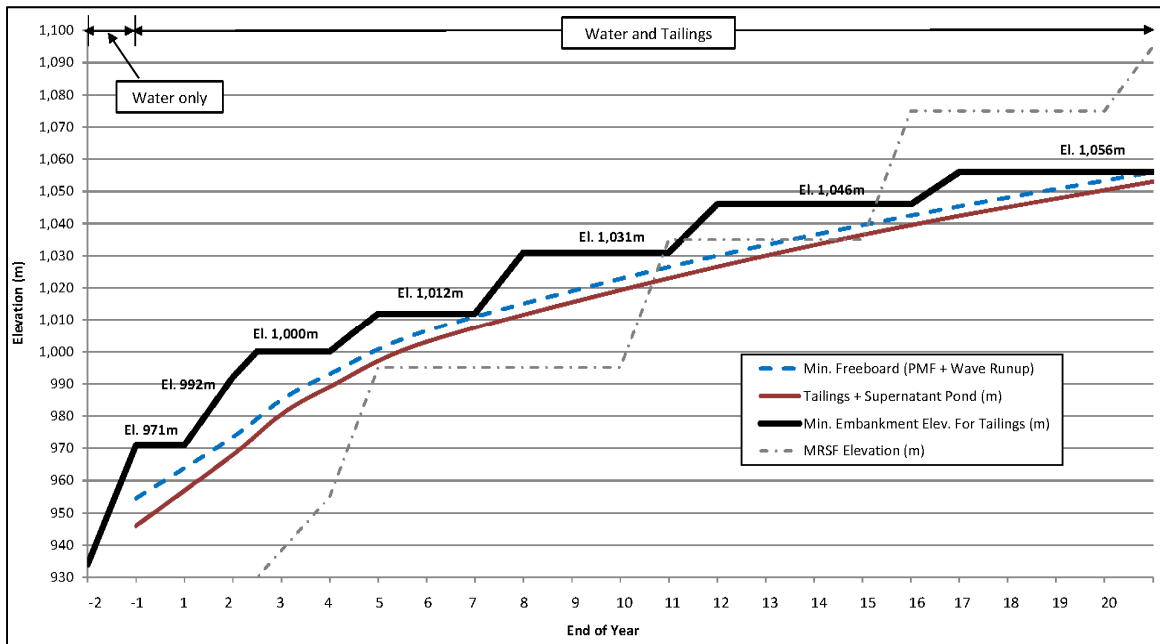
Figure 2-2
TSF Filling Schedule

Figure 2-2 shows the TSF filling schedule that shows the cumulative tailings volumes, freeboard for PMF and wave run-up and respective dam crest elevations to contain the water and tailings volumes on an annual basis. The TSF has storage capacity of approximately 321.5Mm³, which is comprised of 275Mm³ of tailings (at a dry density of 1.6 tonnes/m³), 2.4Mm³ of supernatant water and approximately 4.1Mm³ allowance for the design flood (Probable Maximum Flood (PMF)) storage.

1). Startup pond volume is estimated at approximately 2.4 Mm³. 2). Minimum crest elevation includes sufficient storage for tailings, pond and allowance for PMF and wave run-up. 3). Tailings volume is assumed to be 65,000 tpd at a mill availability of approximately 92%.
