BRUCEJACK GOLD MINE PROJECT POTENTIAL INTERACTIONS BETWEEN THE BRUCEJACK GOLD MINE PROJECT AND CHANNEL MORPHOLOGY: PRELIMINARY RESULTS

June 2014
Project #0194151-0105

BRUCEJACK GOLD MINE PROJECT
Potential Interactions between the Brucejack Gold Mine Project
and Channel Morphology: Preliminary Results

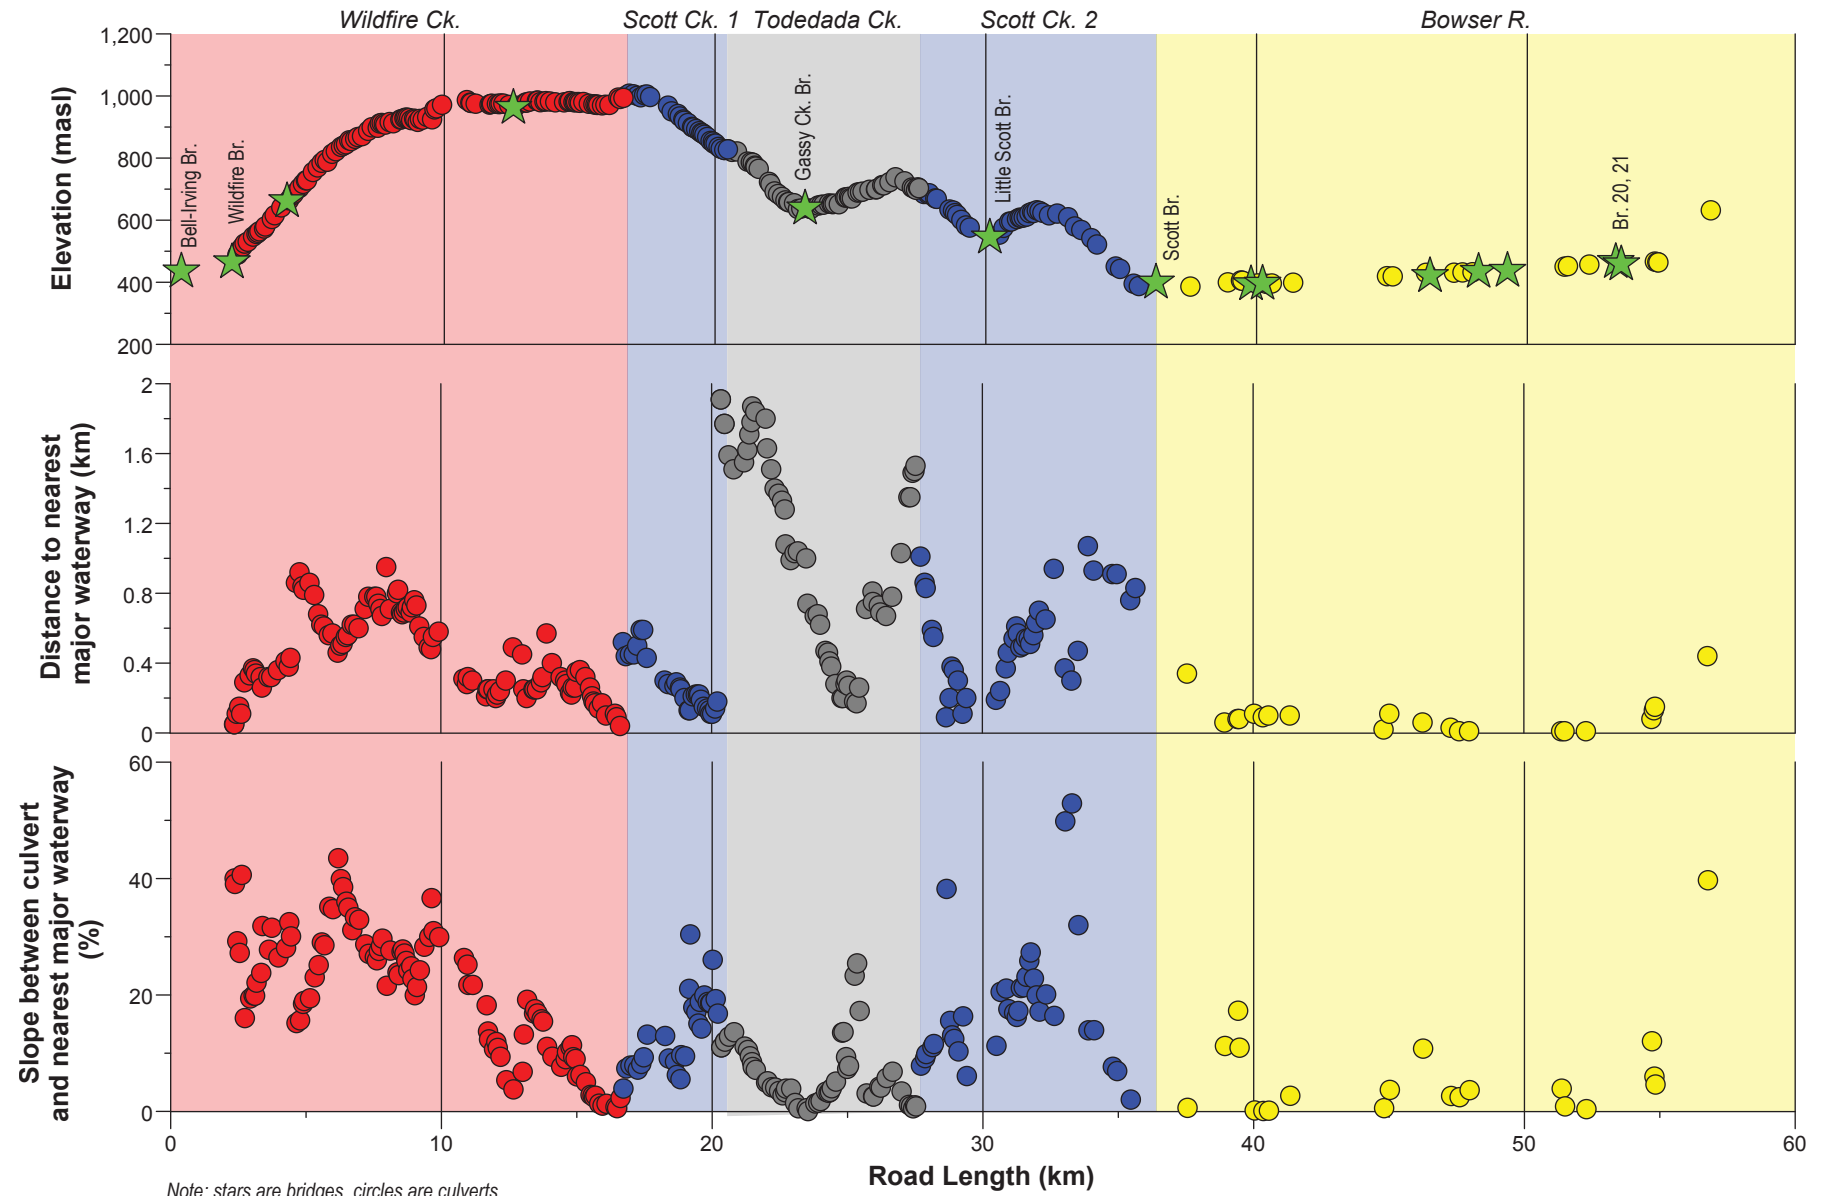
Figure 3.2-1

Elevation, Distance to Nearest Major Stream, and Downhill Slope for the Brucejack Access Road Drainage Crossings

From Highway 37, the road climbs, travels westward, and passes along the north valley wall of Wildfire Creek for about 15 km (Figures 2.1-1 and 3.2-1). There are a large number of culverts in this watershed (n = 106), and watershed size is moderate (Table 2.1-1), leading to the highest culvert density (culverts/km²) of any watershed that the access road traverses (Figure 3.2-2). Culvert rate of occurrence is similar to other watersheds. All but two of the crossings are NCD, cross-drainages, or S6.

After passing out of the Wildfire Creek watershed, the road travels through the upper, steeper reaches of Scott Creek. Beyond this point, the road crosses into the Todedada Creek watershed for slightly over seven kilometres before passing again into the Scott Creek watershed, this time in its lower, flatter reaches (Figures 2.1-2 and 3.2-1).

By the time the road passes into the Scott Creek watershed for the second time, the creek reach slope has diminished (Figure 2.1-2). The road descends from about 680 masl to 440 masl, where it passes into the Bowser River watershed (Figure 3.2-1). It crosses Little Scott Creek at kilometre 30.1, and Scott Creek near Bowser River at kilometre 36.3 (both crossings are bridges).

When the road traverses the floodplain, it is often distant from valley walls (Figure 2.1-4), so the culverts likely do not drain water flowing down the Bowser River valley walls. Not many culverts per kilometer along the road are needed. However, the largest streams crossed by culverts are in this watershed. It contains all S3 (n = 5) and S4 (n = 4) culvert crossings (Figure 3.2-2). These are open-bottom wood culverts. The culverts on the floodplain have low downstream slopes, and are close to Bowser River (Figure 3.2-1).

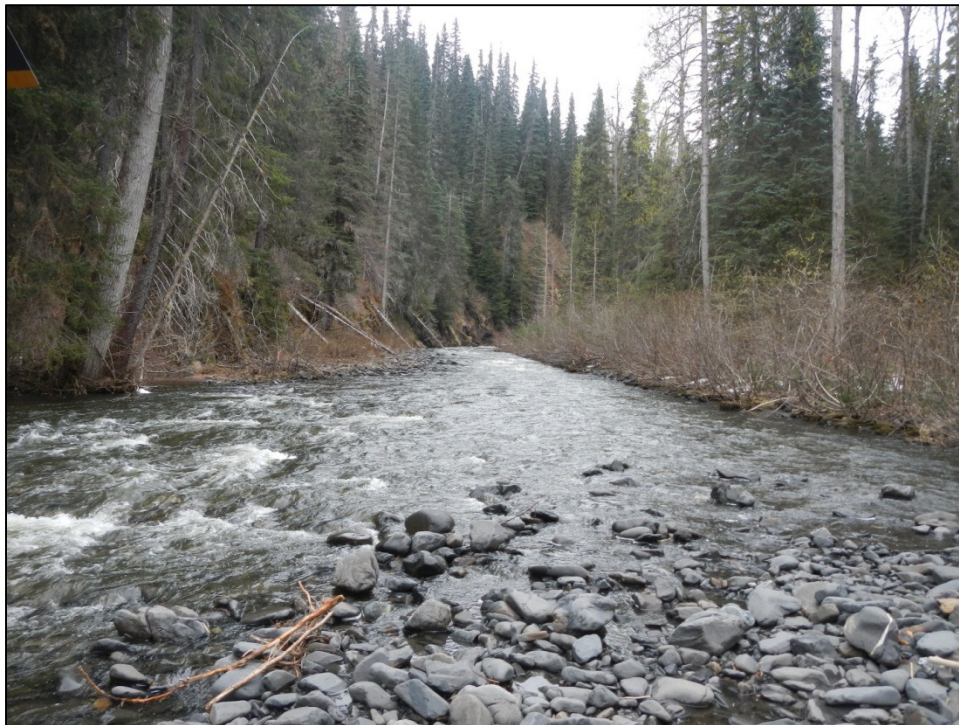
Plate 3.2-1. Wildfire Creek near the “Wildfire-hydro” hydrologic station. View is upstream. Note the coarse-grained bed and treefalls on the right bank (left in photo). Photo taken May 2013.

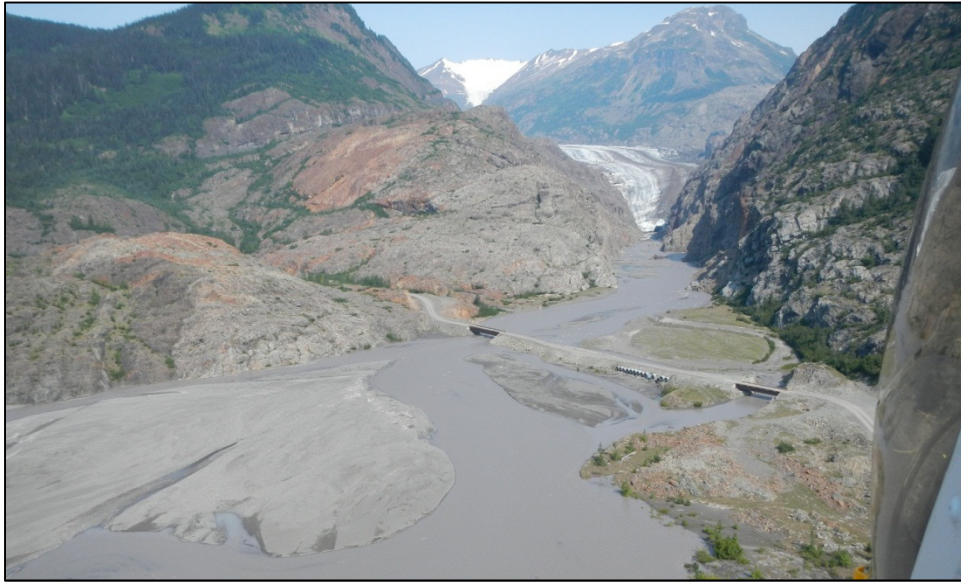
Plate 4.3-1. Bridges 20 on the right and bridge 21 on the left. The Knipple Glacier terminus is in the background. Photo taken July 2013.

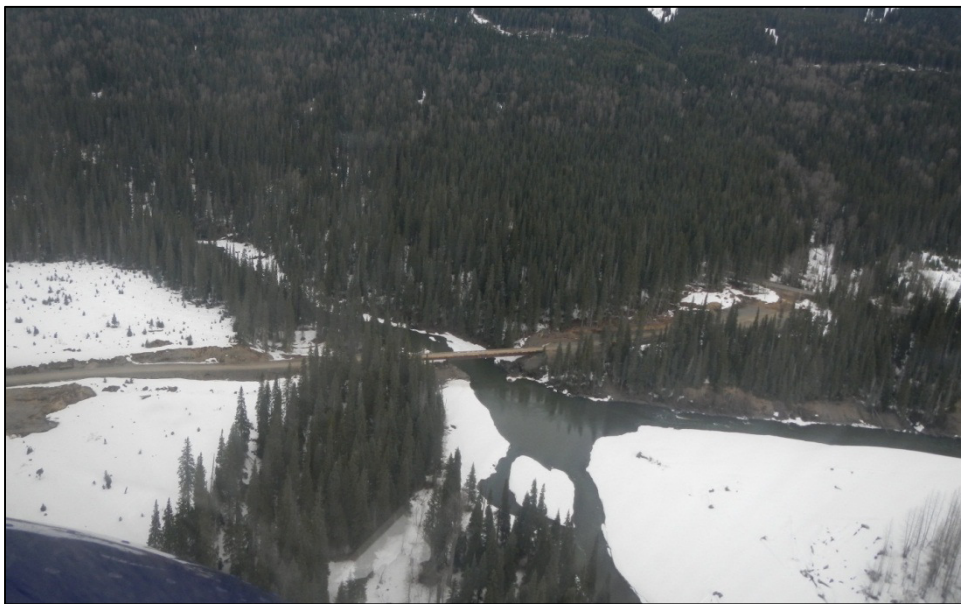
Plate 4.3-2. Bridge over the Bell-Irving River. Photo taken April 2013. Downstream is in the foreground.

However, ranking each reach relative to others provides a means to assess relative reach stability. Summed scores are lowest for bridges crossing low gradient, unconfined, perennial streams. Scores are highest for reaches in the Bowser River valley, especially those spanning active floodplains or braided systems such as Bridge #21. Bridge #20 is immediately adjacent, but receives a lower score, primarily because it is partially confined by bedrock (Plate 4.3-1). Some bridges, such as #3, receive low scores due to their steep gradient, small watershed size, and/or flashy flow regime. The Bell-Irving Bridge receives a low score (i.e., low channel stability risk) despite the large upstream watershed size, due to the lack of instream footings and bedrock banks (Plate 4.3-2).
