Lynn Lake Gold Project: MacLellan Mine Plan Amendment Notice of Alteration / Notice of Change

Federal Information Request Responses – Round 3

Response to IAAC NOC IR-14-3

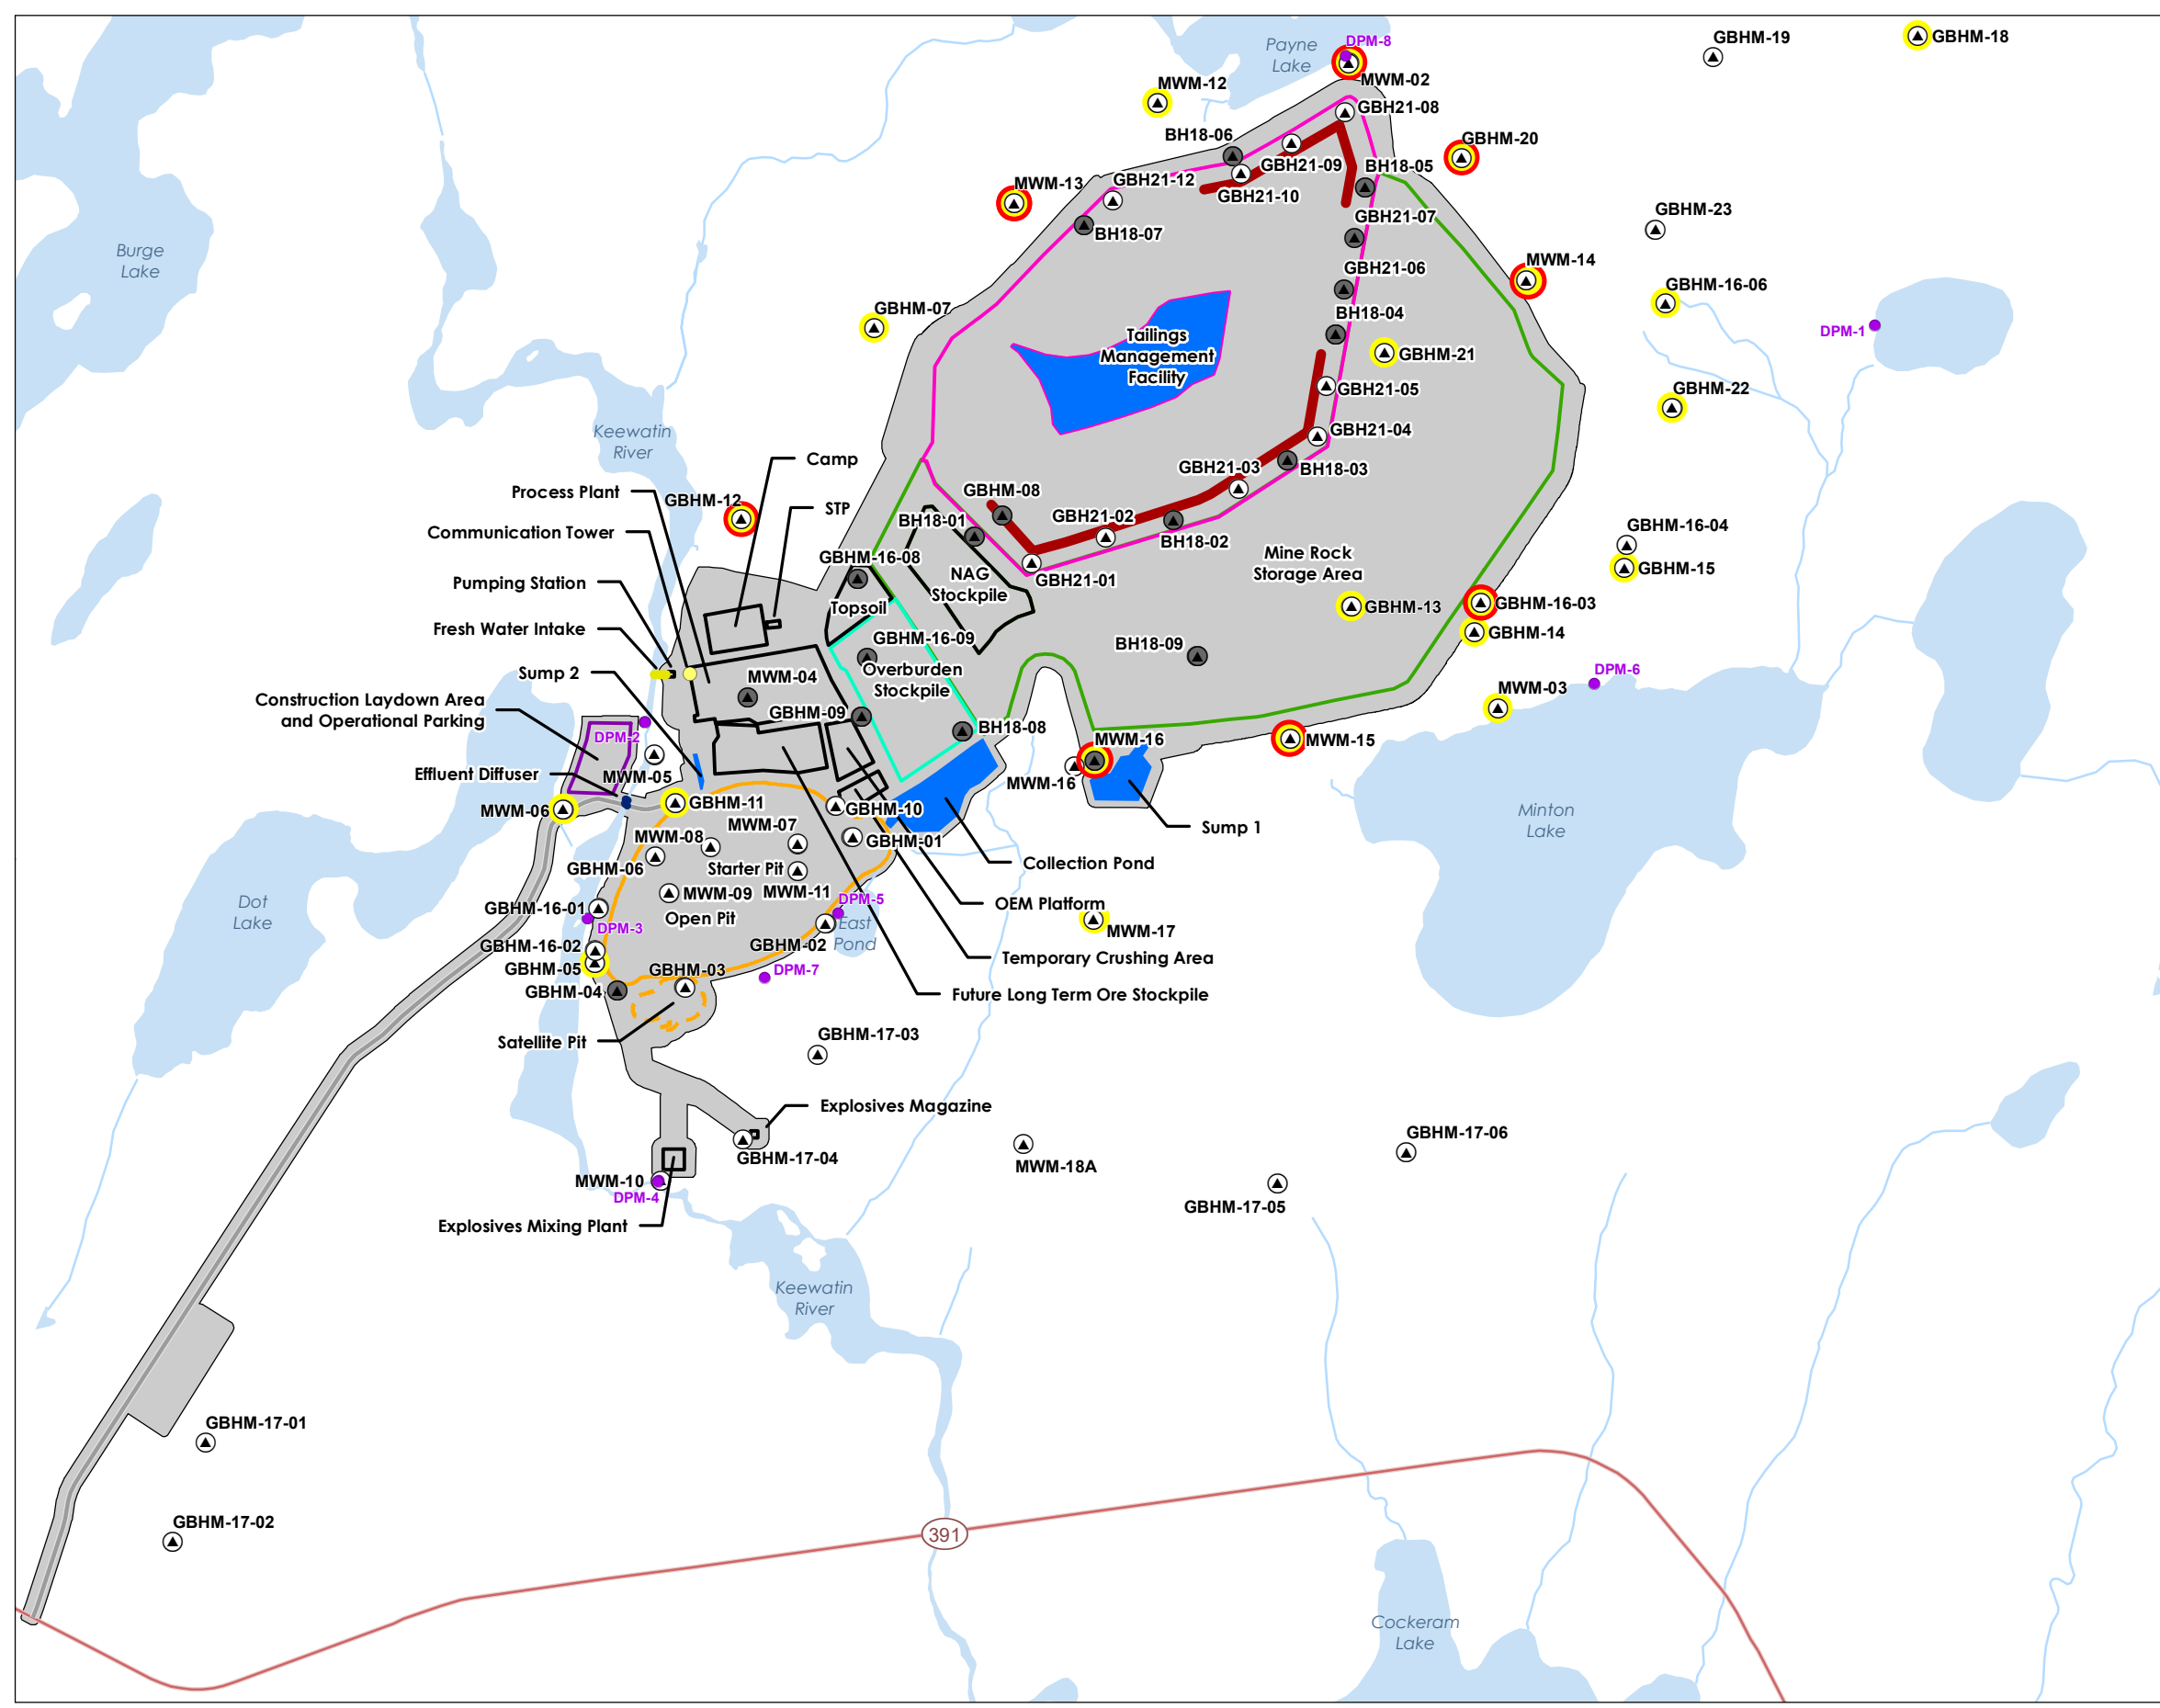
Map No.
NOC IR-14-3

Title
Bedrock Grouting Plan with Groundwater Sampling and Monitoring Locations - MacLellan site

Response:	<ul style="list-style-type: none"> a) Table NOC IR 14-3 presents a summary table showing the reduction in seepage rates for no bedrock grout curtain, a 10 m deep grout curtain, and a 20 m deep grout curtain, where seepage is predicted to flow, via groundwater, to Payne Lake, Minton Lake, and the Plant Site area. See Figure NOC IR-14-3 for the grout curtain location. It is noted that the previous extents of the grout curtain provided in the prior September 19 IR response (NOC IR-14-2) were based on the draft construction drawings, but were then revised during detailed design in relation to discussions regarding mine seepage flows. The detailed design of the grout curtain is still underway and will only be finalized after an upcoming round of Tailings Management Facility (TMF) borehole drilling where engineers will be collecting some additional hydraulic conductivity information of the shallow bedrock. b) Grout curtain long-term behaviour and durability depends on how well the grout curtain is constructed and on various environmental conditions. Grout curtain detailed design is still underway but will consist of a cement – bentonite mix. From a constructability standpoint, stringent QA/QC procedures will be applied for each of the grout mixes to limit bleed water and shrinkage during set as well as to meet flowability and injection pressure criteria so the grout can penetrate into the finer fractures in the bedrock. High hydraulic gradients may cause some erosion over time, changing the pore structure and mechanical properties of the grout curtain. Research data on constructed grout curtains is still being collected and performance monitored, but ultimately, the serviceable life of a grout curtain, when constructed properly, can range from as low as 10 to 15 years in aggressive environments to potentially hundreds of years in hydraulic lower gradient, stable conditions. This timeline aligns well to the MacLellan site operation and closure timeline. c) As presented in the Groundwater Management and Monitoring Plan (GMMP), monitoring wells are located downgradient of the TMF to monitor for quality of groundwater and validate the predictions from the EIS. Figure NOC-IR-14-3 presents the location of the wells monitored for groundwater quality relative to the TMF and the grout curtain. The groundwater monitoring wells are located adjacent to the TMF and Mine Rock Storage Area to allow early detection for potential changes in groundwater quality trends. The GMMP also includes an adaptive
