Project No.	3134
Location	Springpole, ON
Document Reference	FFC-NL-3134-002
Date	March 2021

2.0 OVERBURDEN AND SHALLOW BEDROCK GROUNDWATER FLOW SYSTEM

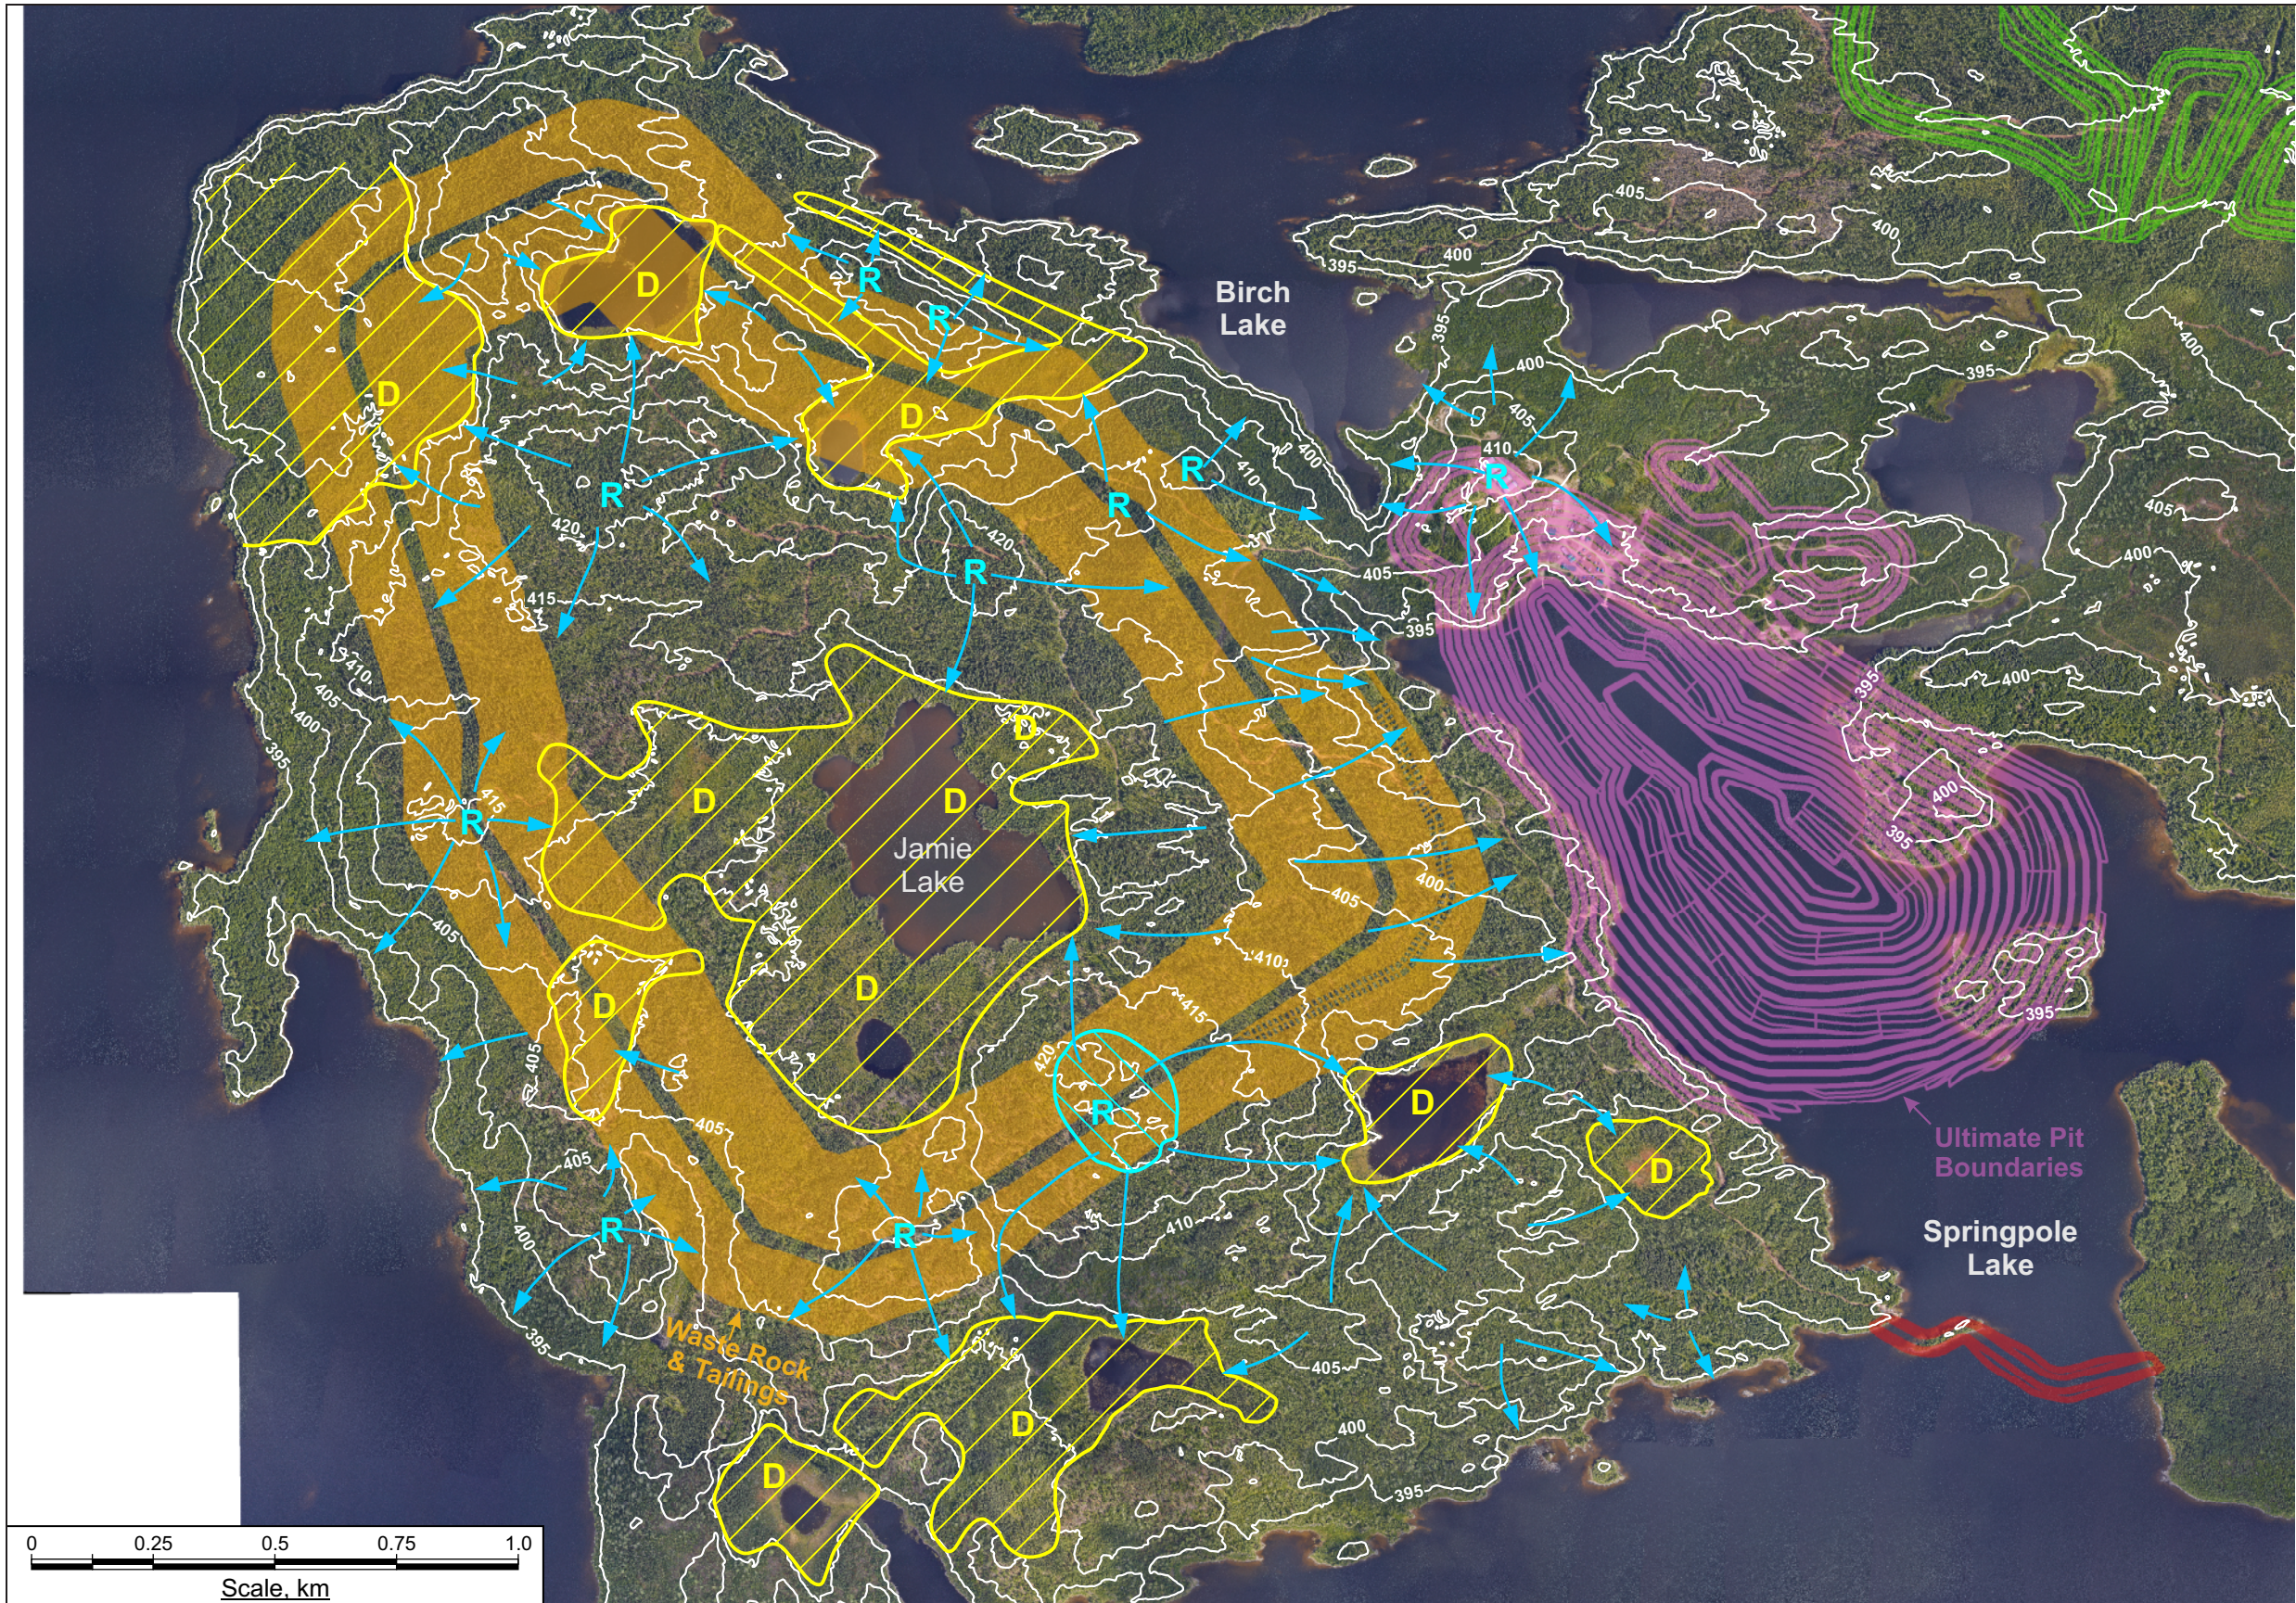
Figure 1.3

- R Recharge area
- D Discharge area
- Inferred flow direction
- Elevation contours in metre

Contour map from Lidar data showing local groundwater recharge (R) and discharge (D) areas with flow lines and perimeter of proposed waste rock storage area.

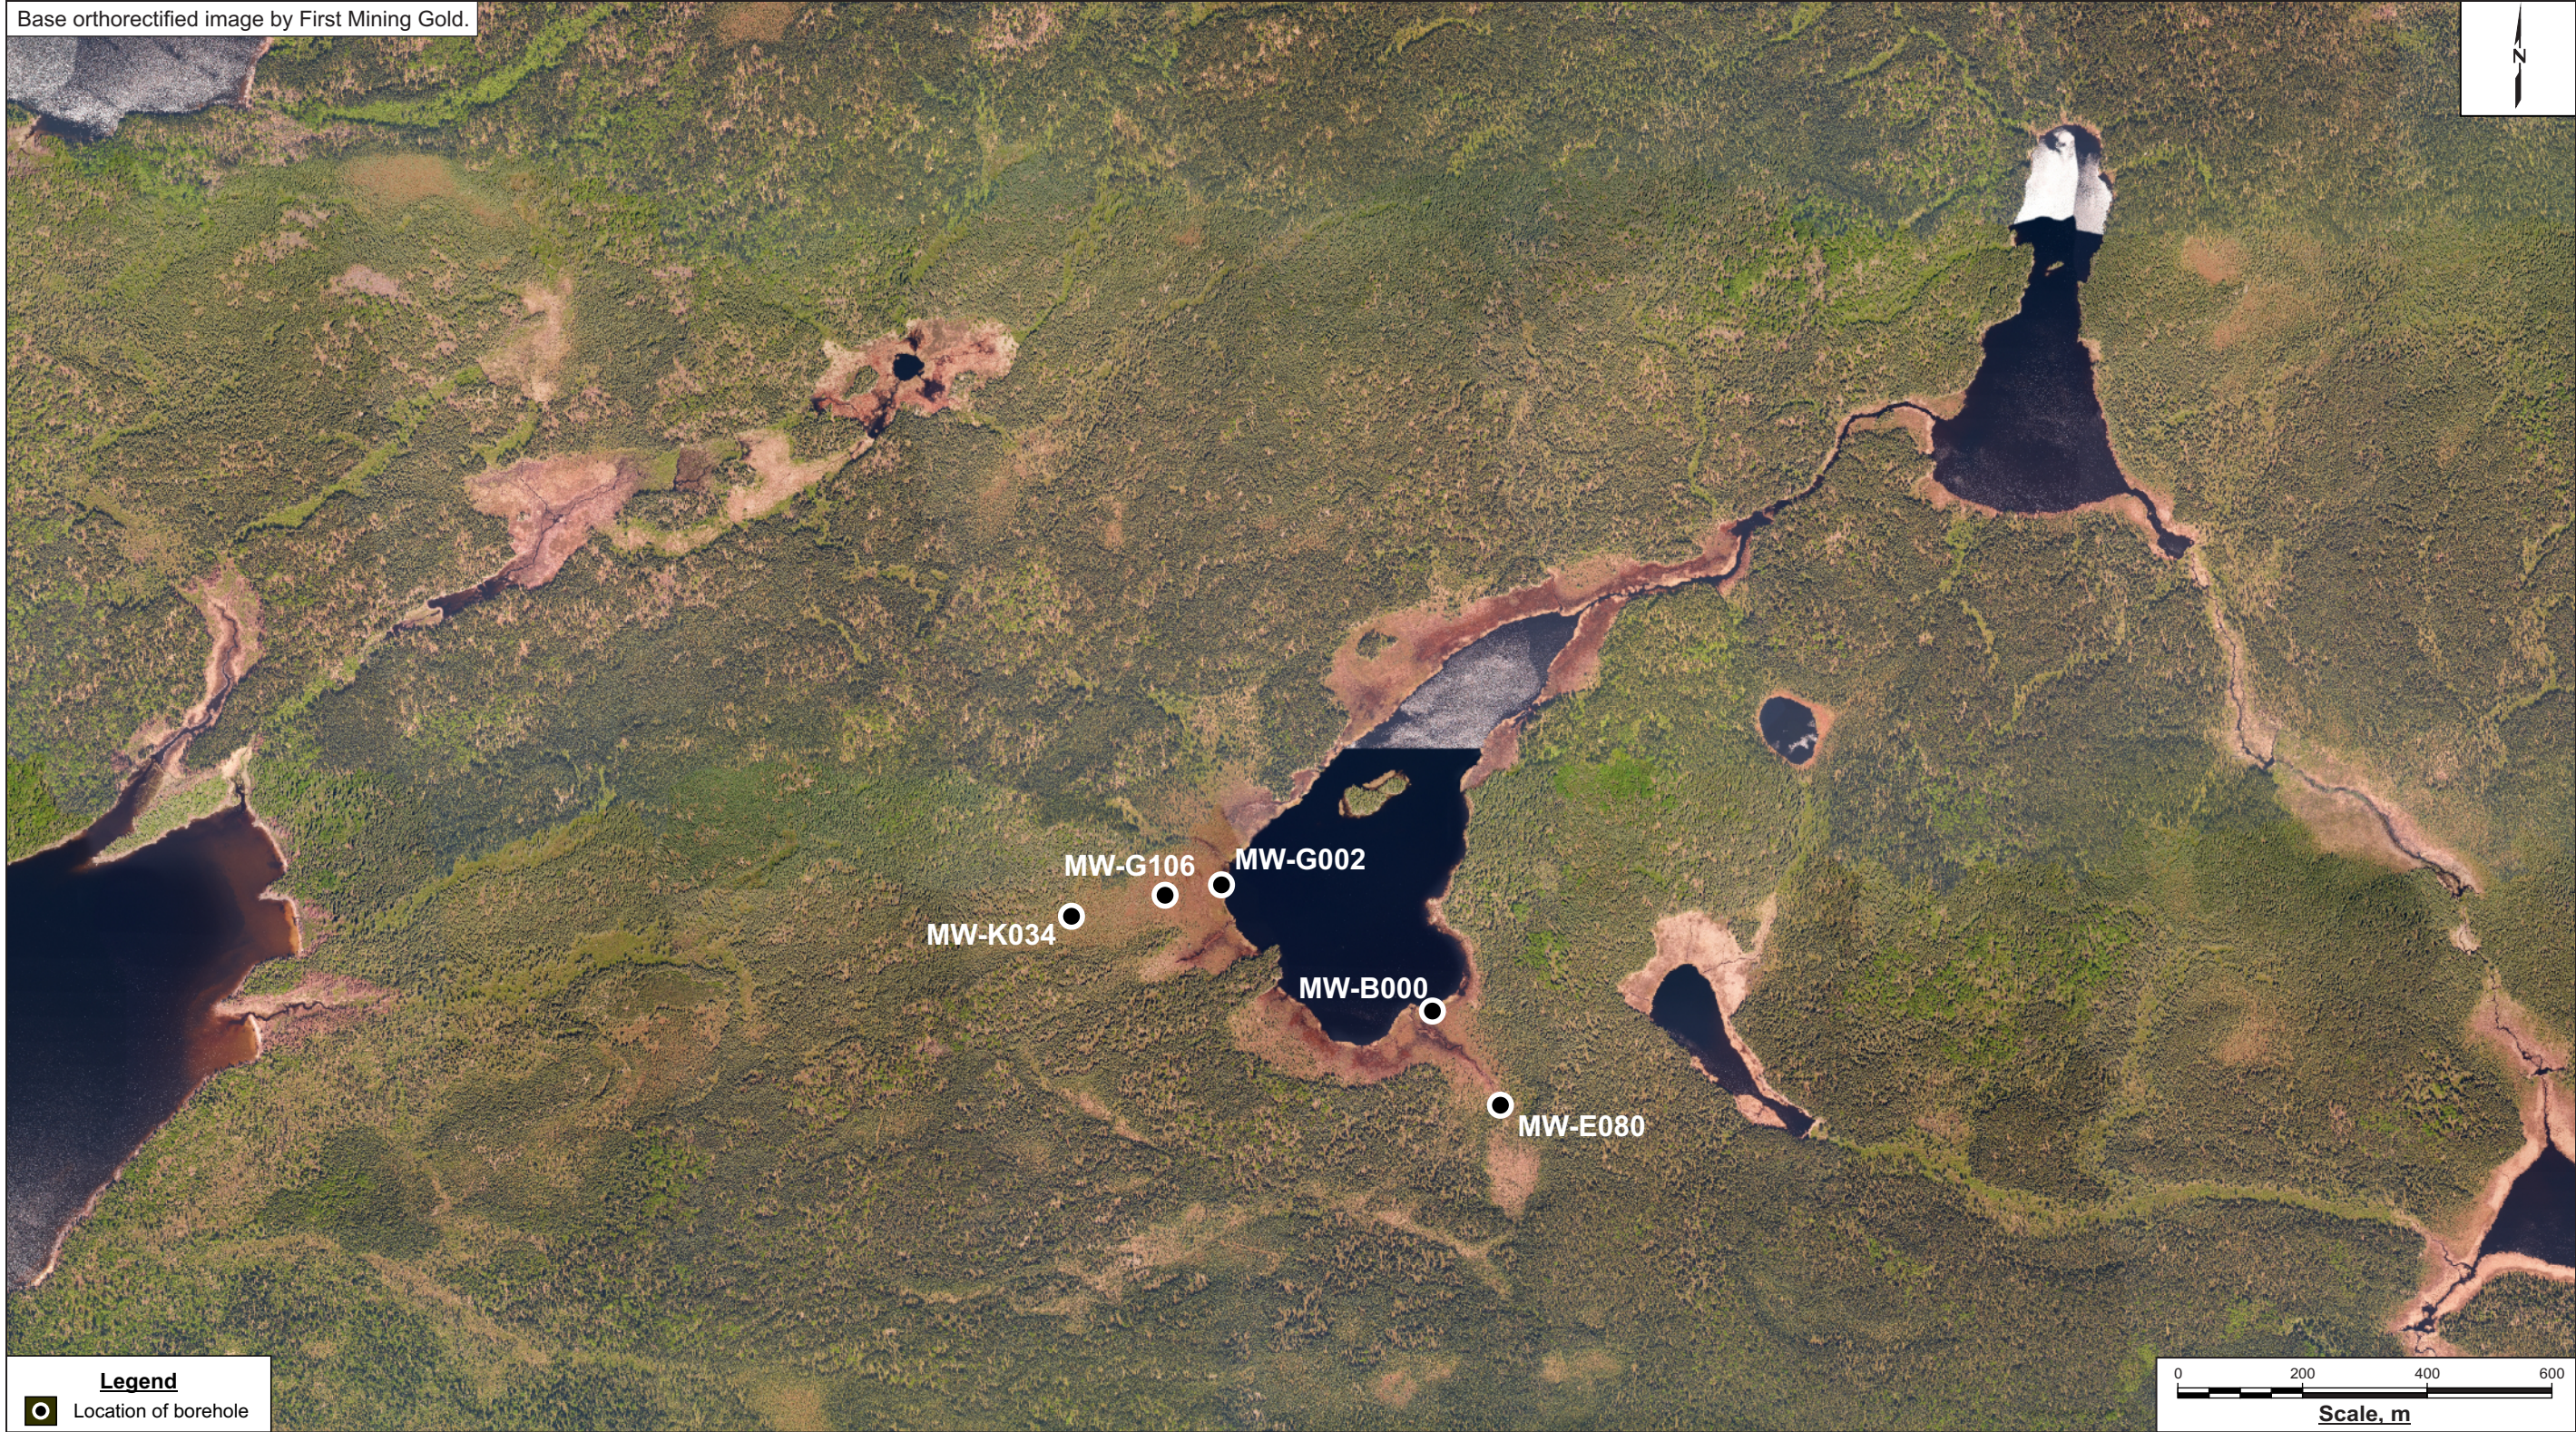
Figure 2.2 Location of the five auger holes and five drive points advanced at different locations in the Tailings Management Area (TMA).

Figure 2.2 shows the location of the five auger holes and five drive points that were advanced in 2019 at different locations in the original Tailings Management Area (TMA) (**Appendix A**), which is located approximately 5 km southeast of the proposed open pit. The auger holes were

advanced using a hand-operated open-head auger unit which provided samples of the underlying material. The bog or peat layer thickness ranged from 2.64 m to 8.5 m. Close to the west end of the central lake, at the lake shoreline, the bog or peat layer (G002) appeared to be floating. The fine to medium sand layer below the peat layer was dense and difficult to penetrate. Refusal on rock was obtained at approximately 9.5 m of depth at this hand auger location. The one-inch (25.4 mm) stainless steel drive points were advanced using an electric jack-hammer to refusal on rock or very dense sand. The low water levels in the drive points are assumed to reflect time-lag in the piezometers due to low permeability of the surrounding overburden. The field data, detailed logs and GPR profiles for this area are provided in **Appendix A**.

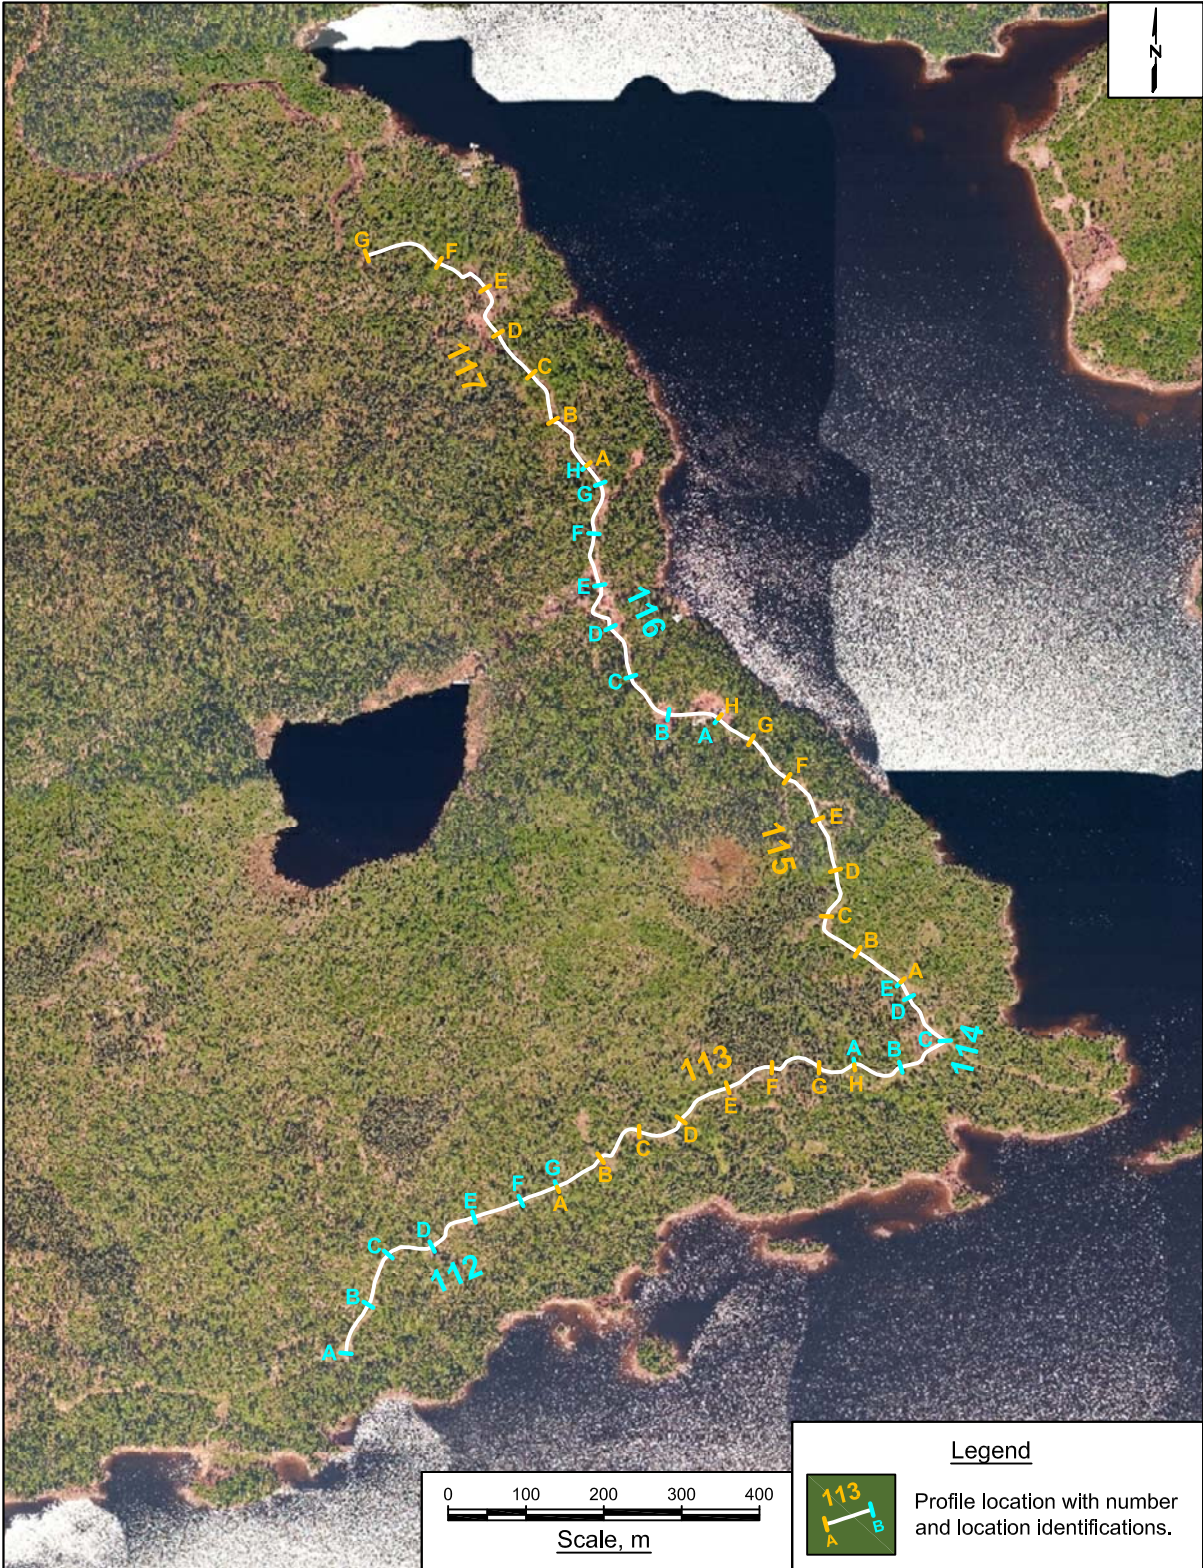
Figure 2.6a Locations of GPR profiles along the southeast trail in the area of the proposed Mine Rock & Tailings.

In 2019 and 2020 program, GPR surveys were conducted along the south edge and the north-eastern edge of the proposed Mine Rock and Tailings storage area using either a dual frequency GPR antenna or a single frequency antennae to map depths to bedrock and to locate possible clay zones. **Figures 2.6a, 2.6b** and **2.6c** show the location of the GPR survey lines that were completed in the proposed Mine Rock and Tailings storage area and the immediate north end of

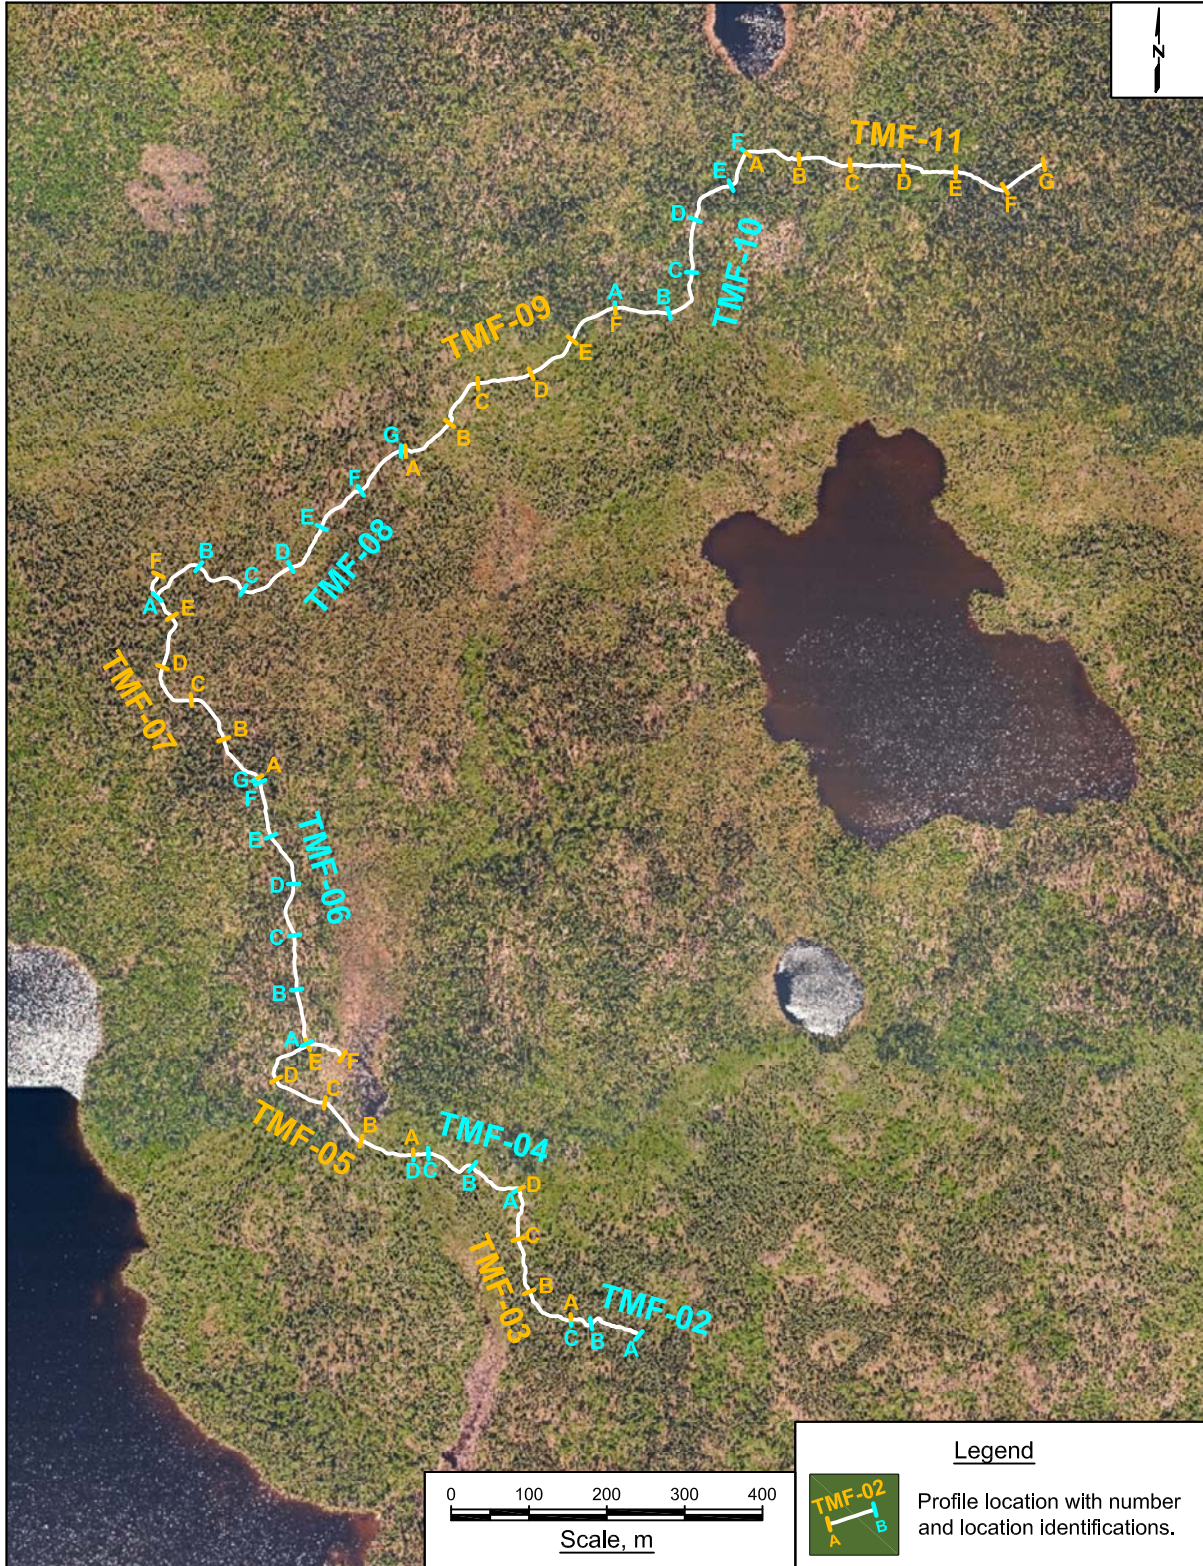
Figure 2.6b Locations of GPR profiles along the northwest trail in the area of the proposed Mine Rock & Tailings.

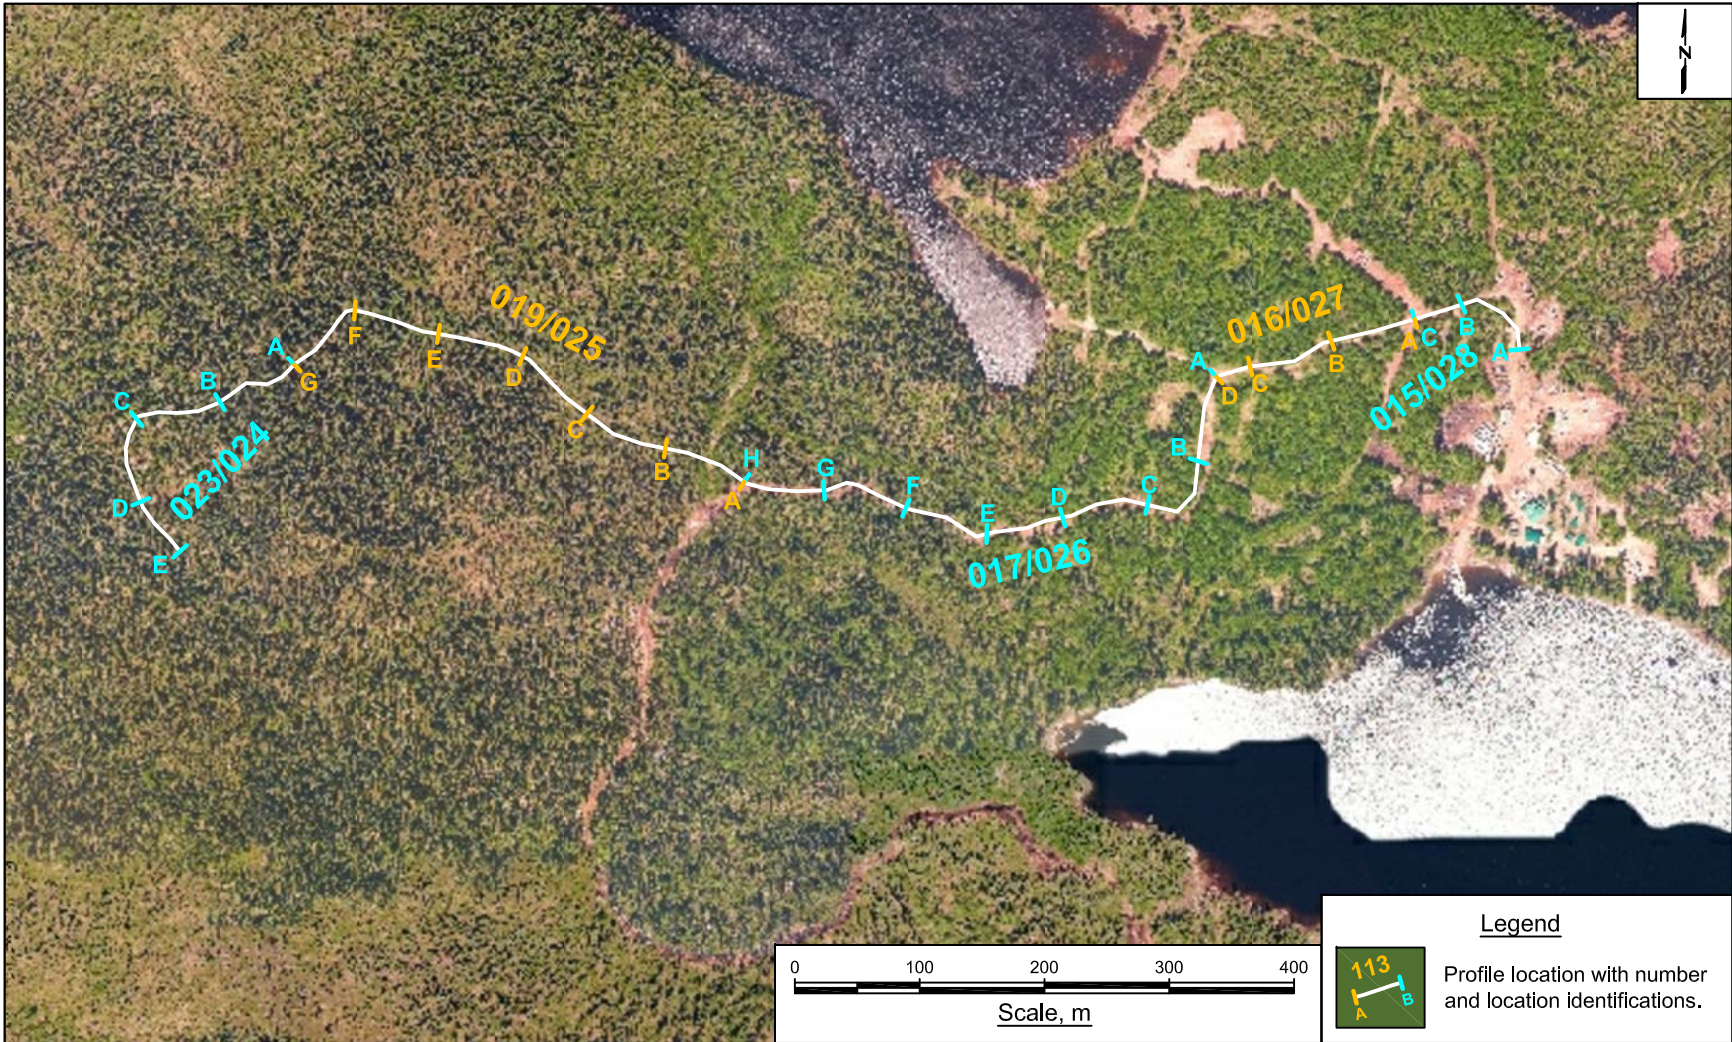
Figure 2.6c Locations of GPR profiles along the existing trail between Birch Lake and Springpole Lake.

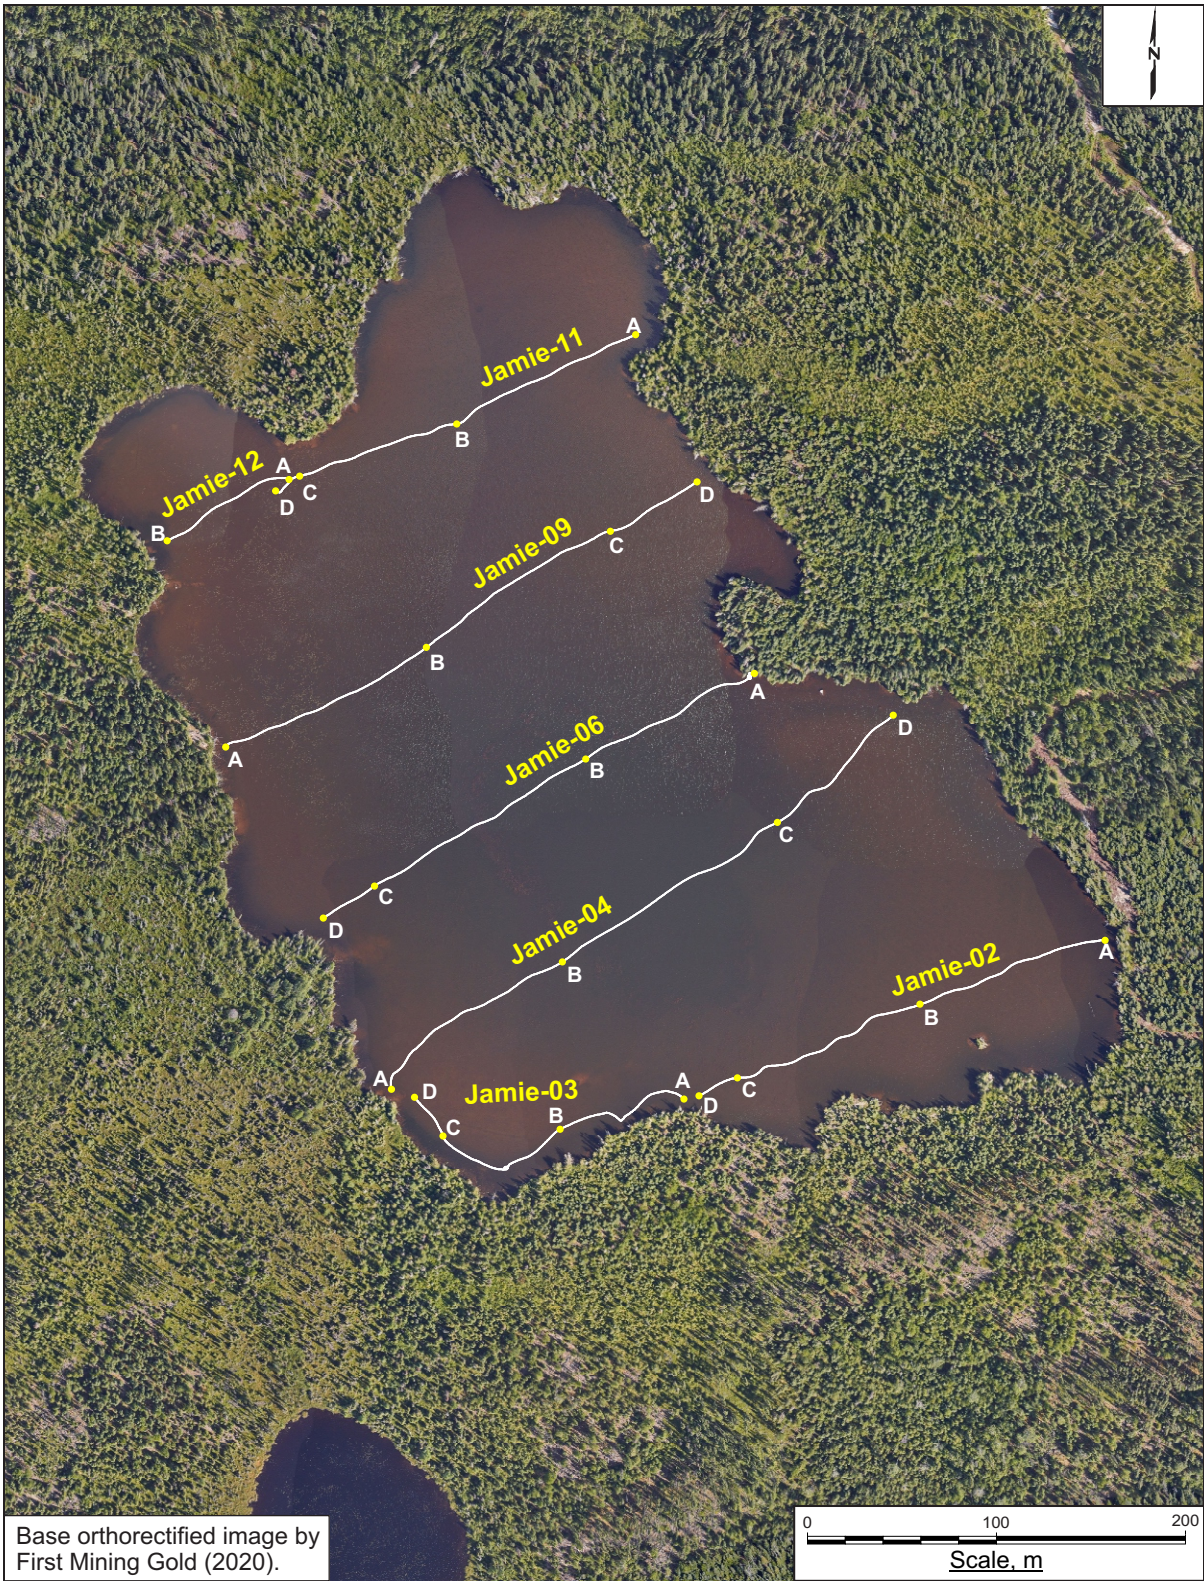
Figure 2.7 Location of the GPR survey conducted on the water (lake) surface at Jamie Lake in August 2020.

The surface of Jamie Lake (**Figure 2.7**) is elevated with respect to Springpole Lake and Birch Lake. A GPR survey was conducted along a number of transects to obtain images of the lake bottom. **Figure 2.8** shows a typical lake bottom GPR image for Jamie Lake that shows the small boulders or cobbles along with lake-bottom sediments. The soft sediments create a low permeability layer on the bottom of the lake that impedes recharge to the underlying fractured bedrock and is expected to reduce the impacts of the overall open pit dewatering on Jamie Lake. However, Jamie Lake is expected to be filled with tailings and the lake sediments will impede pore fluids that originate in the tailings from migrating into the underlying fractured bedrock. Collection of piston cores from the lake ice cover can confirm the presence and permeability characteristics of the lake bottom sediments. The full suite of lake bottom GPR images are presented in Fracflow (2020b).

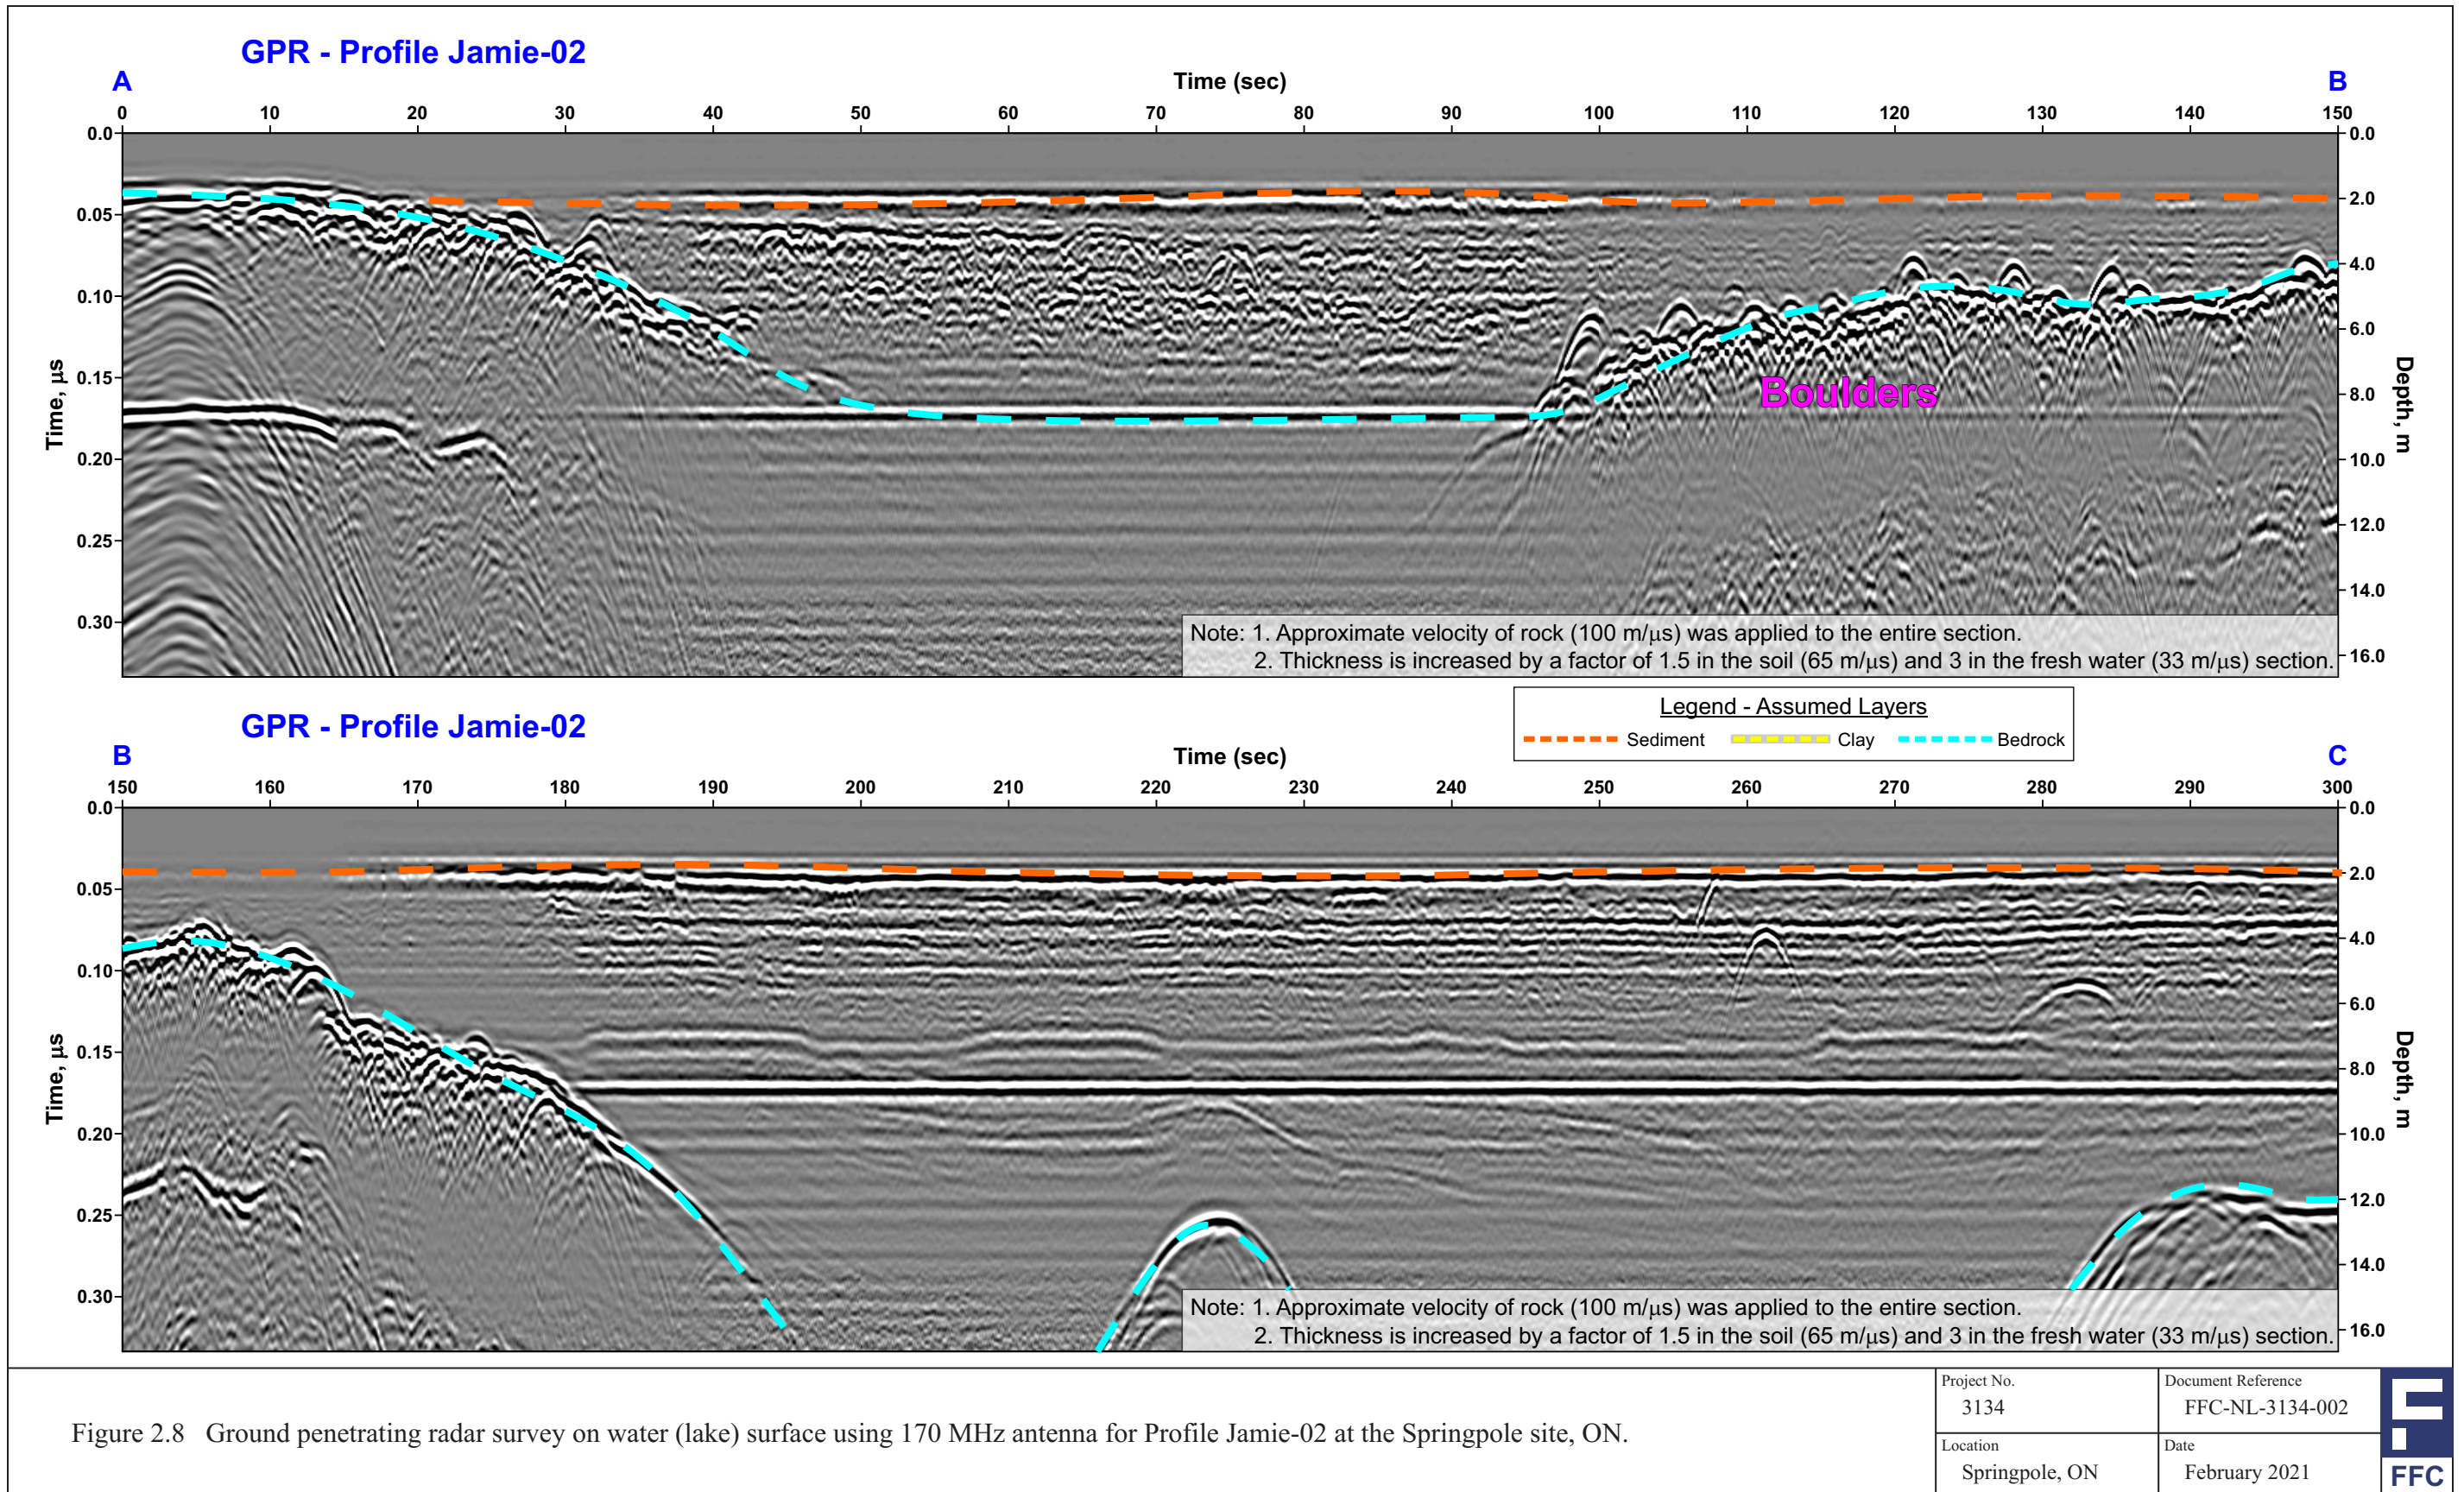
Figure 2.8 Ground penetrating radar survey on water (lake) surface using 170 MHz antenna for Profile Jamie-02 at the Springpole site, ON.
