**Overall Geotechnical Report on
the Pipeline Route Rev. R for the
Enbridge Northern Gateway Project
Bruderheim, Alberta to Kitimat, BC**

Submitted to:
Northern Gateway Pipelines Inc.
Calgary, Alberta

Submitted by:
**AMEC Earth & Environmental,
a division of AMEC Americas Limited**

September 9, 2009

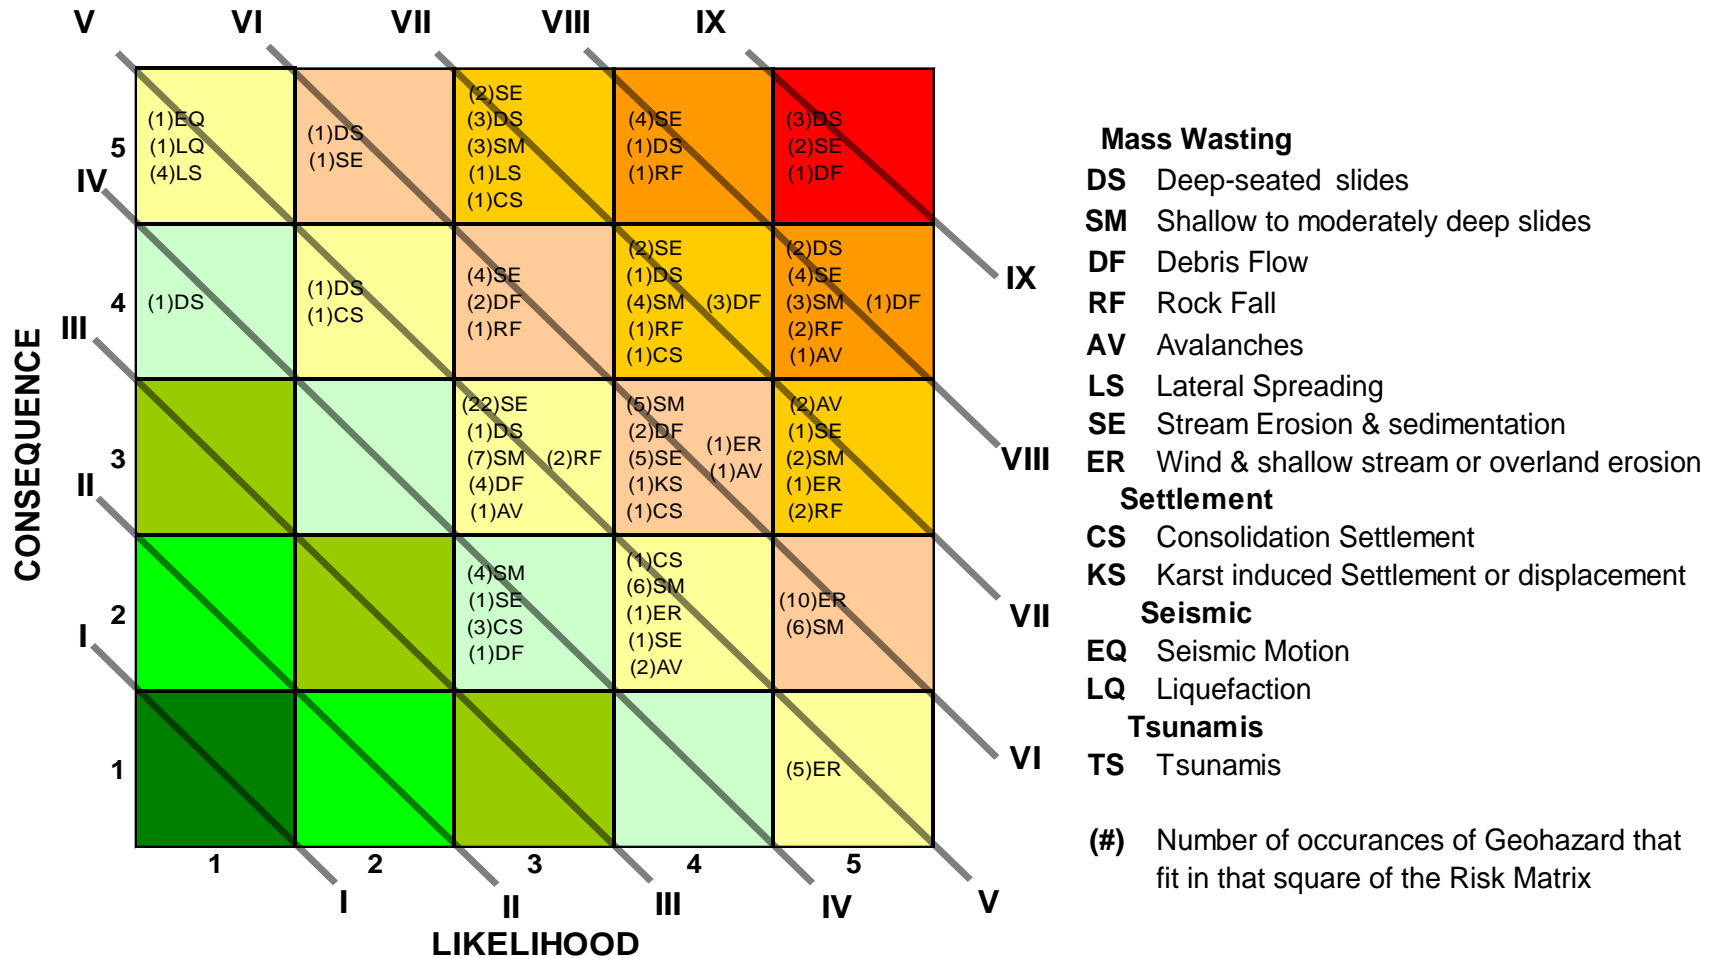
Figure 4.1 Unmitigated Risk Matrix Summary

REV P RISK MATRIX SUMMARY (UNMITIGATED)

The results of the risk assessment are summarized on [Table C-1 \(Appendix C\)](#) and on [Figures 4.1 to 4.7](#). [Figures 4.1 and 4.2](#) present Risk Assessment Matrices for the entire pipeline route for the unmitigated and mitigated cases, respectively. [Figures 4.3 through 4.7](#) (later in the report) present the Risk Assessment Matrices broken down by physiographic regions for both the unmitigated and mitigated cases.

The results of the Risk Analysis are summarized graphically on [Figures 4.1 to 4.7](#). These figures show matrices in which Hazard Likelihood is plotted on the X axis and Consequence is plotted on the Y axis. The grey lines running diagonally across the cells and the cell shading indicate zones of roughly equal Risk (Risk = Hazard x Consequences). Within each cell, the number of occurrences of different Terrain Hazard categories and the type of category are listed (bracketed numbers on [Figures 4.1 and 4.2](#)). The type of Hazard is indicated by the two letter abbreviations. Numbers not in brackets ([Figures 4.3 to 4.7](#)) indicate the actual terrain hazard. The numbers are organized by Physiographic Region and refer to [Table C-1](#) that provides a detailed breakdown of each Hazard discussed.

[Figures 4.1](#) (unmitigated risks) and [4.2](#) (mitigated risks) summarize the Terrain Hazard Risks for the entire pipeline route. Mitigation methods and additional details are discussed in [Table C-1](#).

The unmitigated Risks shown on [Figure 4.1](#) indicate a significant number of high Risks. As shown on [Figure 4.2](#), mitigation results in significantly decreased risks. Three low to moderate risks remain in Risk categories IV and V.

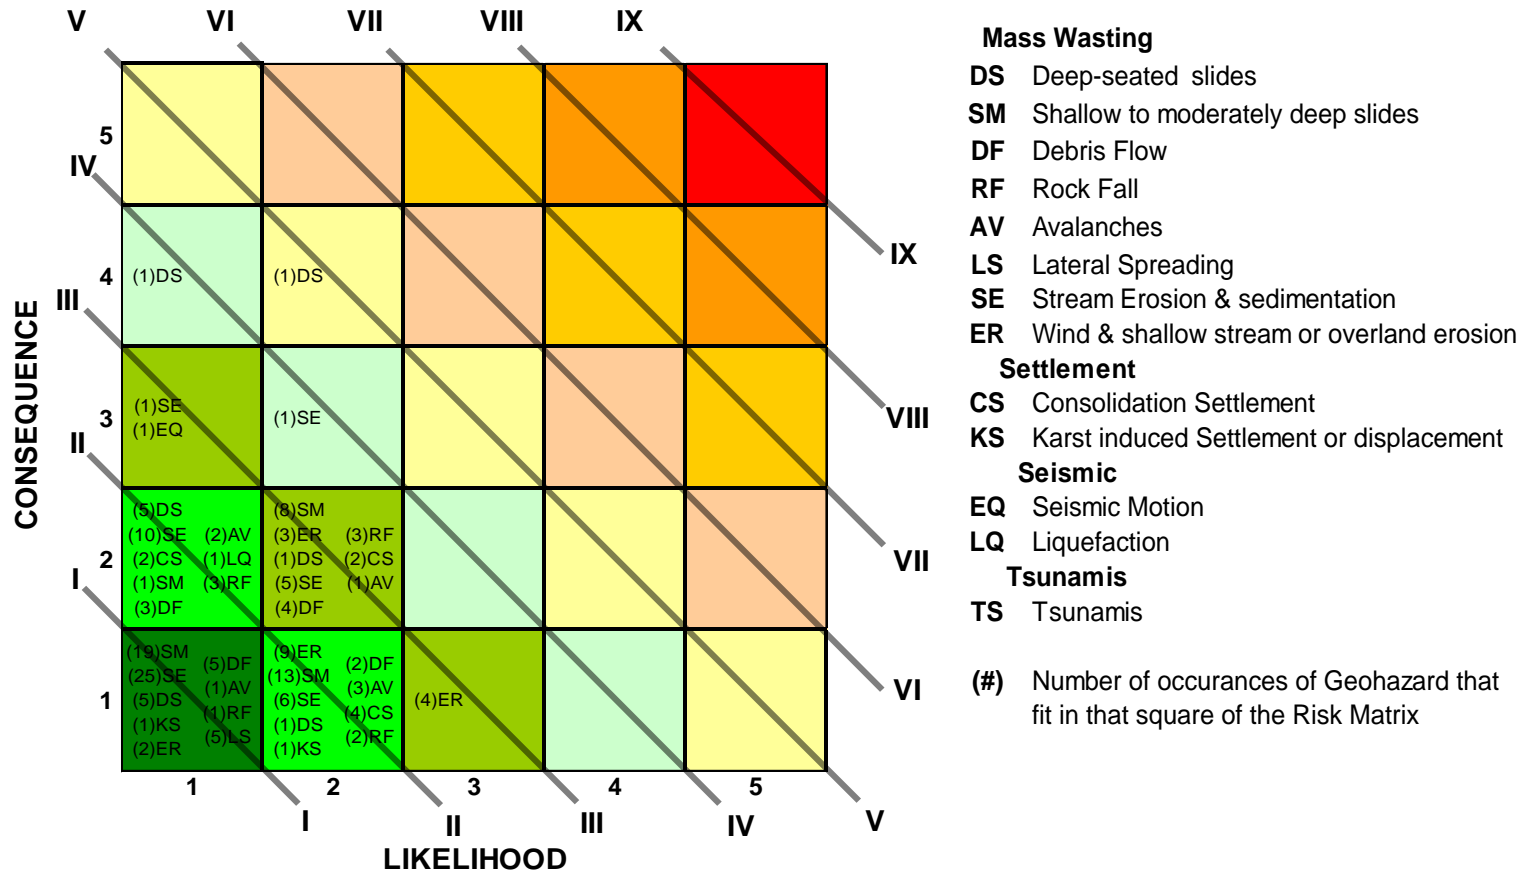
Figure 4.2 Mitigated Risk Matrix Summary

REV P RISK MATRIX SUMMARY (MITIGATED)

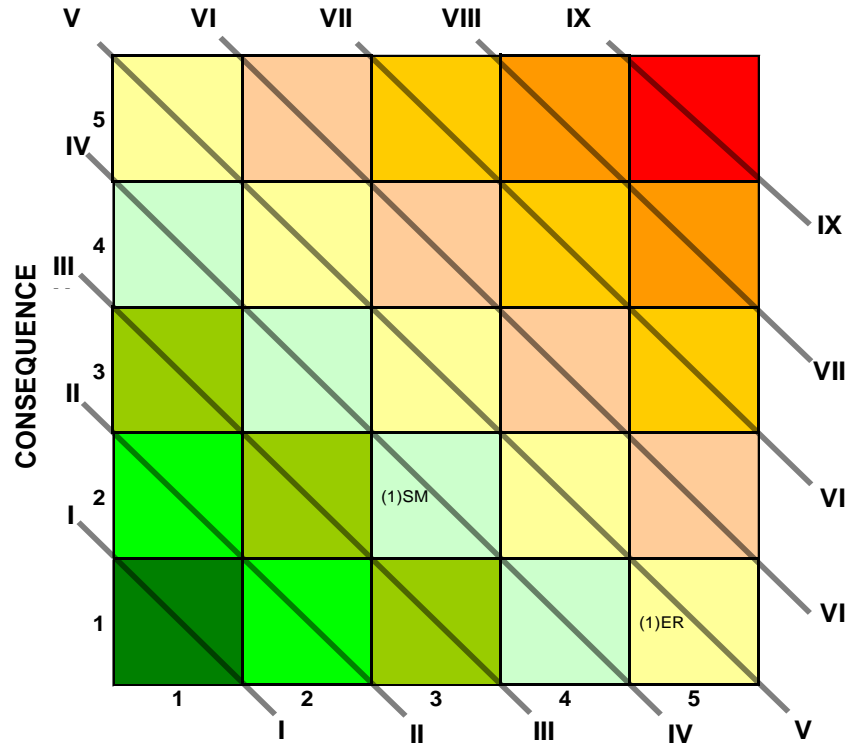
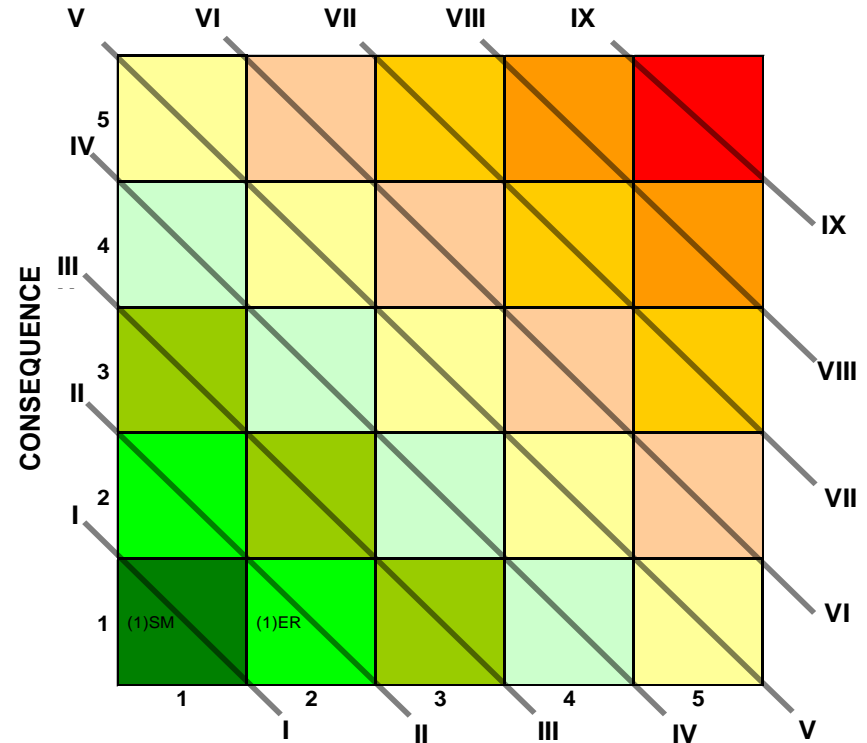
Figure 4.3 Eastern Alberta Plains Risk Assessment Matrices

**EASTERN ALBERTA PLAINS RISK MATRIX SUMMARY
 (UNMITIGATED)**

**EASTERN ALBERTA PLAINS RISK MATRIX SUMMARY
 (MITIGATED)**

Figures 4.3 to 4.7 show the risk matrices for the unmitigated and mitigated risks for the individual Physiographic Regions. The lists of risks indicate the site numbers (unbracketed number) that correspond to the sites in Table C-1. These matrices indicate that the remaining low to moderate risk sites after mitigation are at the Iosegun River (stream lateral erosion), and at the east and west approach slopes to the Little Smoky River. The results of the risk assessments may change during ongoing engineering and detailed design as well as a result of crossing method choices and design.

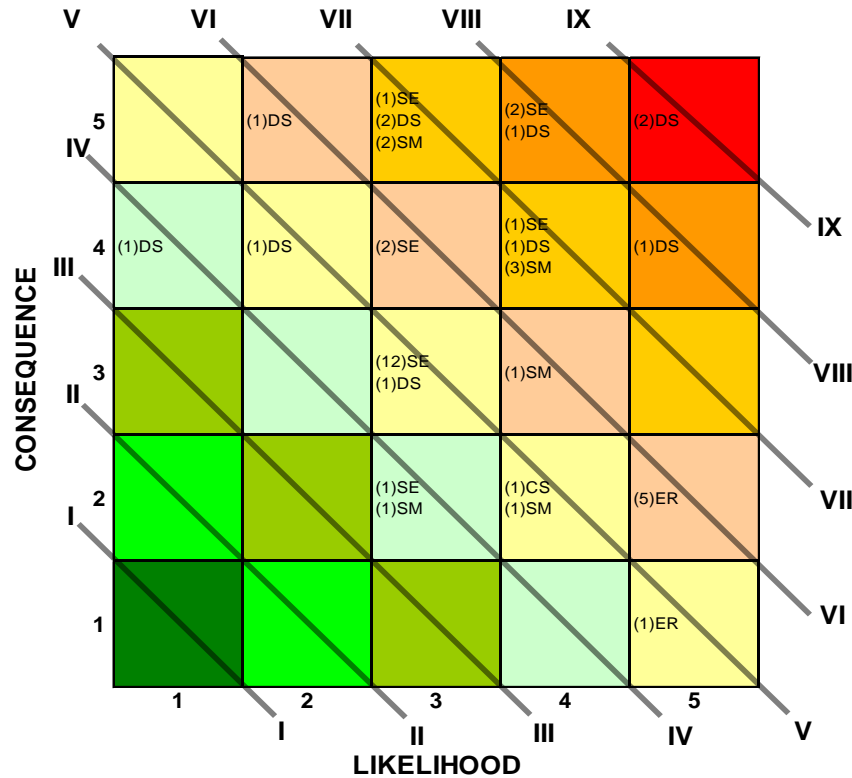
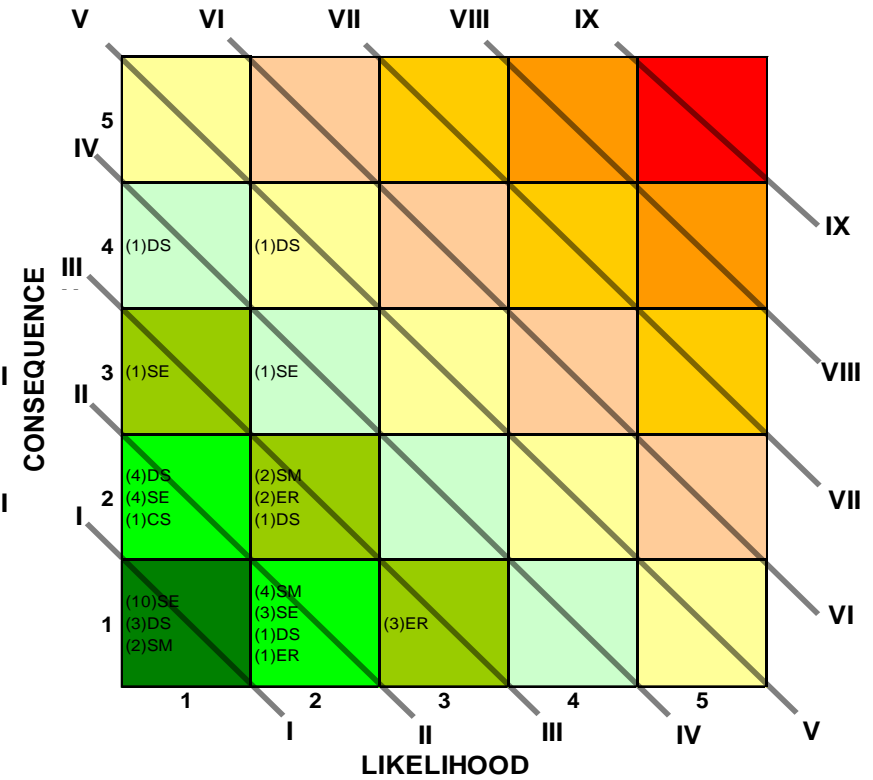
SOUTHERN ALBERTA UPLANDS RISK MATRIX SUMMARY (UNMITIGATED)

SOUTHERN ALBERTA UPLANDS RISK MATRIX SUMMARY (MITIGATED)

RISK CLASS	GEOHAZARD CODE
I	
II	
III	5DS
IV	12SM, 41SE
V	3SE, 4SE, 10SE, 13SE, 14SE, 16ER, 17SE, 18CS, 23SE, 24SE, 28DS, 29SE, 31SE, 32SM, 38SE, 43SE, 47DS
VI	7SE, 8SM, 19DS, 25ER, 26ER, 27SE, 37ER, 40ER, 44ER
VII	6SE, 9DS, 11SM, 15SM, 21DS, 22SE, 35DS, 36SM, 39SM, 42SM
VIII	20SE, 30DS, 34SE, 46DS
IX	33DS, 45DS

RISK CLASS	GEOHAZARD CODE
I	3SE, 4SE, 6SE, 9DS, 10SE, 12SM, 15SM, 22SE, 23SE, 29SE, 30SE, 34SE, 41SE, 43SE, 45DS
II	5DS, 7SE, 8SM, 13SE, 14SE, 16ER, 18CS, 24SE, 27SE, 28DS, 31SE, 32SM, 33DS, 36SM, 38SE, 42SM, 46DS, 47DS
III	11SM, 20SE, 25ER, 26ER, 35DS, 37SM, 39SM, 40ER, 44ER
IV	17SE, 19DS
V	21DS
VI	
VII	
VIII	
IX

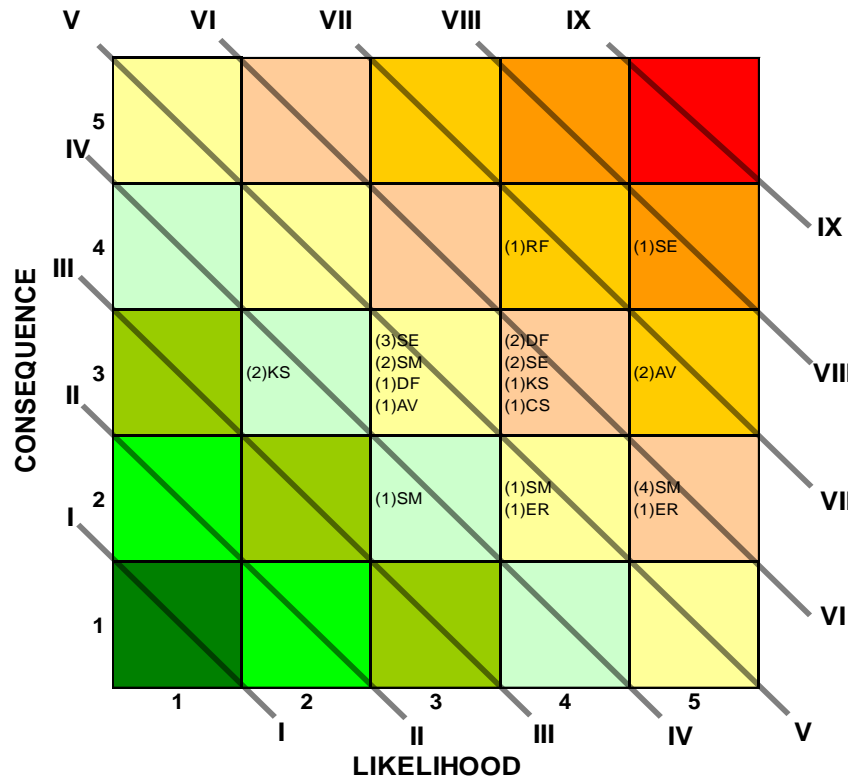
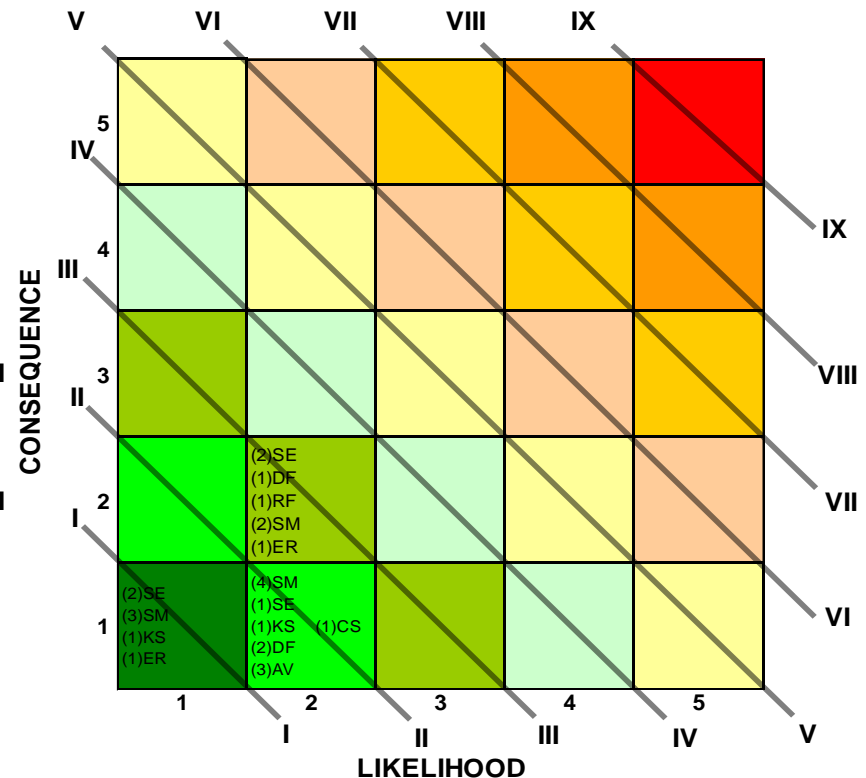
Figure 4.5 Rocky Mountains Risk Assessment Matrices

**ROCKY MOUNTAINS RISK MATRIX SUMMARY
(UNMITIGATED)**

**ROCKY MOUNTAINS RISK MATRIX SUMMARY
(MITIGATED)**

RISK CLASS	GEOHAZARD CODE
I	
II	
III	
IV	49SM, 55KS, 61KS
V	49SE, 51SE, 53SE, 54SM, 56SM, 64SM, 69DF, 71AV, 74ER
VI	50DF, 57SE, 58DF, 60SM, 65KS, 66CS, 67ER, 68SE, 70SM, 72SM, 73SM
VII	59AV, 62 AV, 63RF
VIII	52SE
IX

RISK CLASS	GEOHAZARD CODE
I	51SE, 53SE, 60SM, 61KS, 64SM, 65KS, 67ER
II	48SM, 49SE, 54SM, 55KS, 56SM, 58DF, 59AV, 62AV, 66CS, 68SE, 69DF, 71AV, 73SM
III	50DF, 52SE, 57SE, 63RF, 70SM, 72SM, 74ER
IV	
V	
VI	
VII	
VIII	
IX

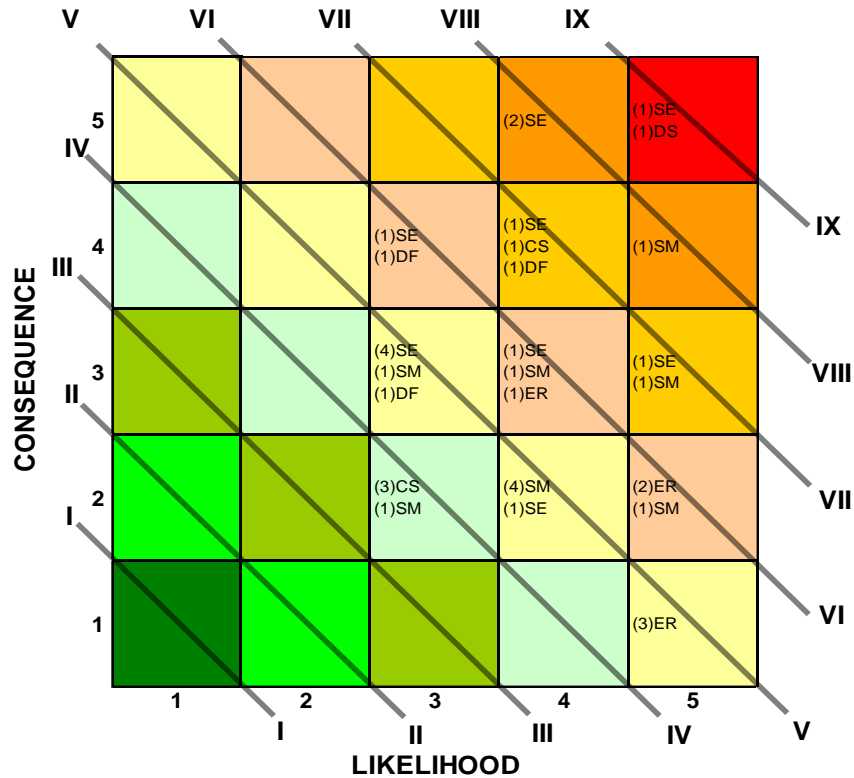
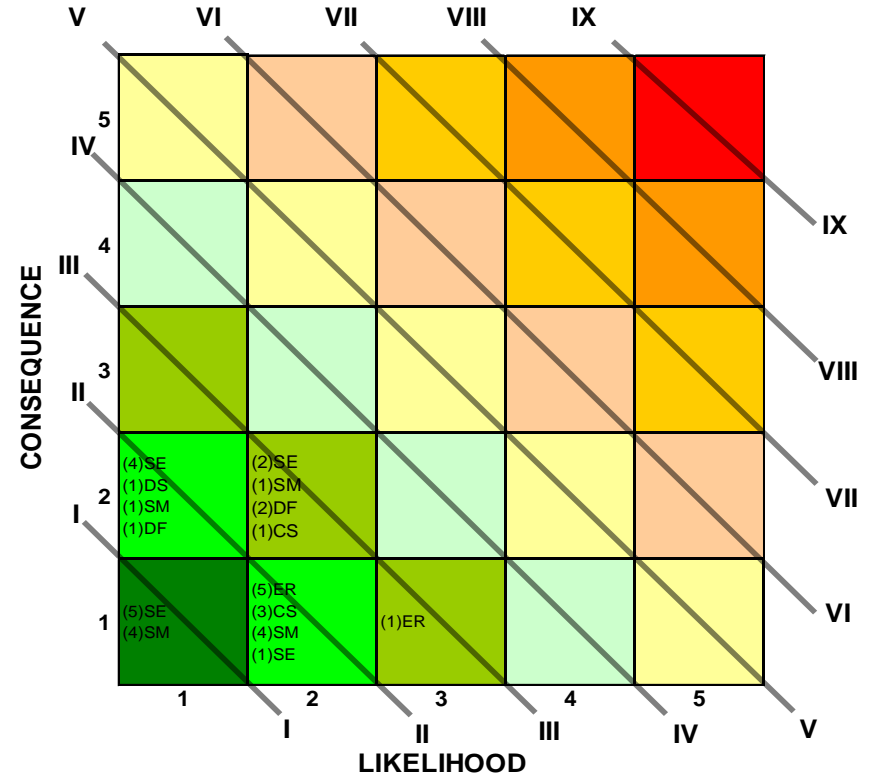
Figure 4.6 Interior Plateau Risk Assessment Matrices

**INTERIOR PLATEAU RISK MATRIX SUMMARY
(UNMITIGATED)**

RISK CLASS	GEOHAZARD CODE
I	
II	
III	
IV	76CS, 88CS, 89CS, 101SM
V	75SM, 78SM, 79SE, 80ER, 81SM, 82SE, 83ER, 85ER, 92SM, 102SE, 103SM, 108SE, 109SE, 110DF
VI	84SM, 87SE, 90SE, 93ER, 98SM, 99ER, 104ER, 107DF
VII	86SE, 96CS, 97SE, 100SM, 106DF
VIII	77SE, 95SM, 105SE
IX	91SE, 94DS

**INTERIOR PLATEAU RISK MATRIX SUMMARY
(MITIGATED)**

RISK CLASS	GEOHAZARD CODE
I	75SM, 77SE, 82SE, 87SE, 95SM, 98SM, 101SM, 102SE, 108SE
II	76CS, 78SM, 79SE, 80ER, 81SM, 83ER, 84SM, 86SE, 88CS, 89CS, 90SE, 92SM, 93ER, 97SE, 99ER, 100SM, 104ER, 109SE, 110DF, 85ER, 91SE, 96CS, 103SM, 105SE, 106DF, 107DF
III	
IV	
V	
VI	
VII	
VIII	
IX

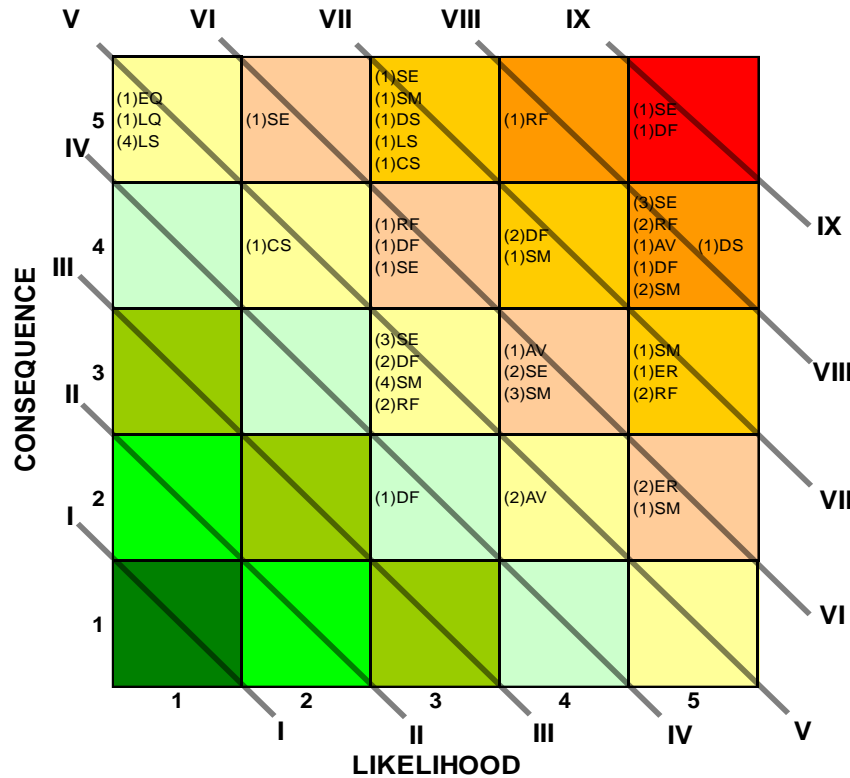
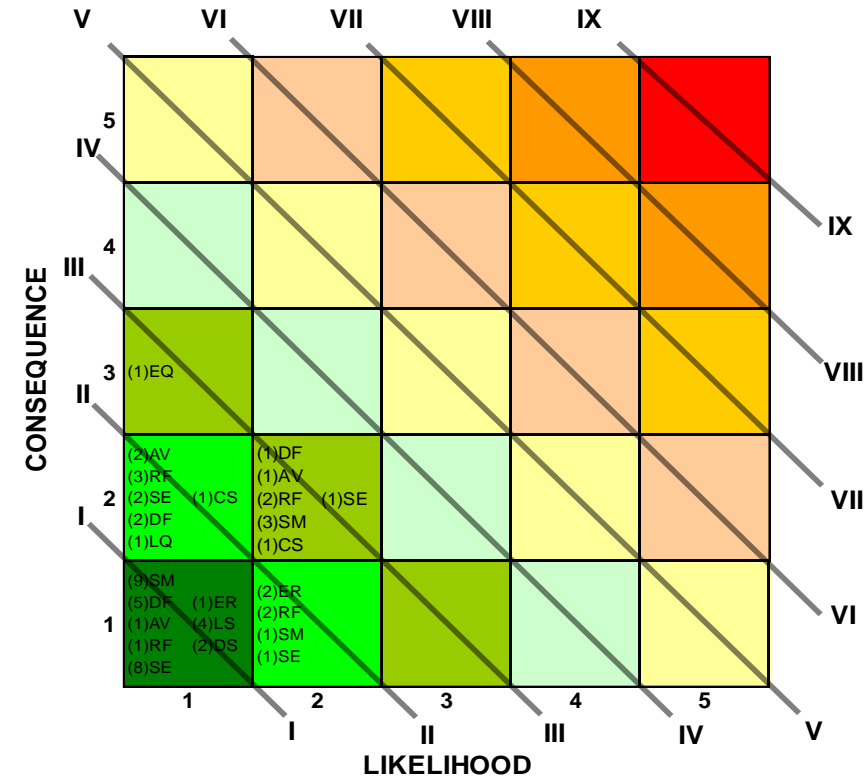
**COAST MOUNTAINS RISK MATRIX SUMMARY
 (UNMITIGATED)**

**COAST MOUNTAINS RISK MATRIX SUMMARY
 (MITIGATED)**

RISK CLASS	GEOHAZARD CODE
I	
II	
III	
IV	116DF
V	111EQ, 117AV, 119AV, 122RF, 133SE, 142LS, 143SM, 146SM, 147LS, 148LS, 149SM, 152LS, 153SM, 154SE, 158LQ, 159DF, 163SE, 168CS, 169DF, 170RF
VI	112SM, 113ER, 115SM, 120RF, 123SE, 124SM, 128SM, 129SE, 130DF, 132AV, 138ER, 151SE, 156SE
VII	121DF, 131SM, 140ER, 141RF, 144RF, 155SE, 157CS, 160SM, 162DF, 165SM, 166DS, 167CS
VIII	114SE, 118RF, 125AV, 134DF, 135RF, 136SE, 137SE, 139SM, 145DS, 150SM, 161RF
IX	126SE, 127DF

RISK CLASS	GEOHAZARD CODE
I	112SM, 114SE, 115SM, 116DF, 119AV, 120RF, 123SE, 124SM, 126SE, 127DF, 128SM, 136SE, 139SM, 140ER, 142LS, 143SM, , 145DS, 147LS, 148LS, 149SM, 150SM, 151SE, 152LS, 153SM, 154SE, 156SE, 159DF, 162DF, 163SE, 166DS, 167LS, 169DF
II	113ER, 117AV, 118RF, 122RF, 125AV, 129SE, 130DF, 131SM, 133SE, 134DF, 135RF, 137SE, 138ER, 144RF, 158LQ, 168CS, 170RF
III	111EQ, 121DF, 132AV, 141RF, 146SM, 155SE, 157CS, 160SM, 161RF, 165SM
IV	
V	
VI
