**APPENDIX H
HYDROGEOLOGY TECHNICAL SUPPORT DOCUMENT**

ADDENDUM – HYDROGEOLOGY

RESPONSE LETTER TO COMMENTS ON THE IAMGOLD CÔTÉ GOLD PROJECT ENVIRONMENTAL IMPACT STATEMENT (EIS)/DRAFT ENVIRONMENTAL ASSESSMENT (EA) REPORT TECHNICAL SUPPORT DOCUMENT: HYDROGEOLOGY

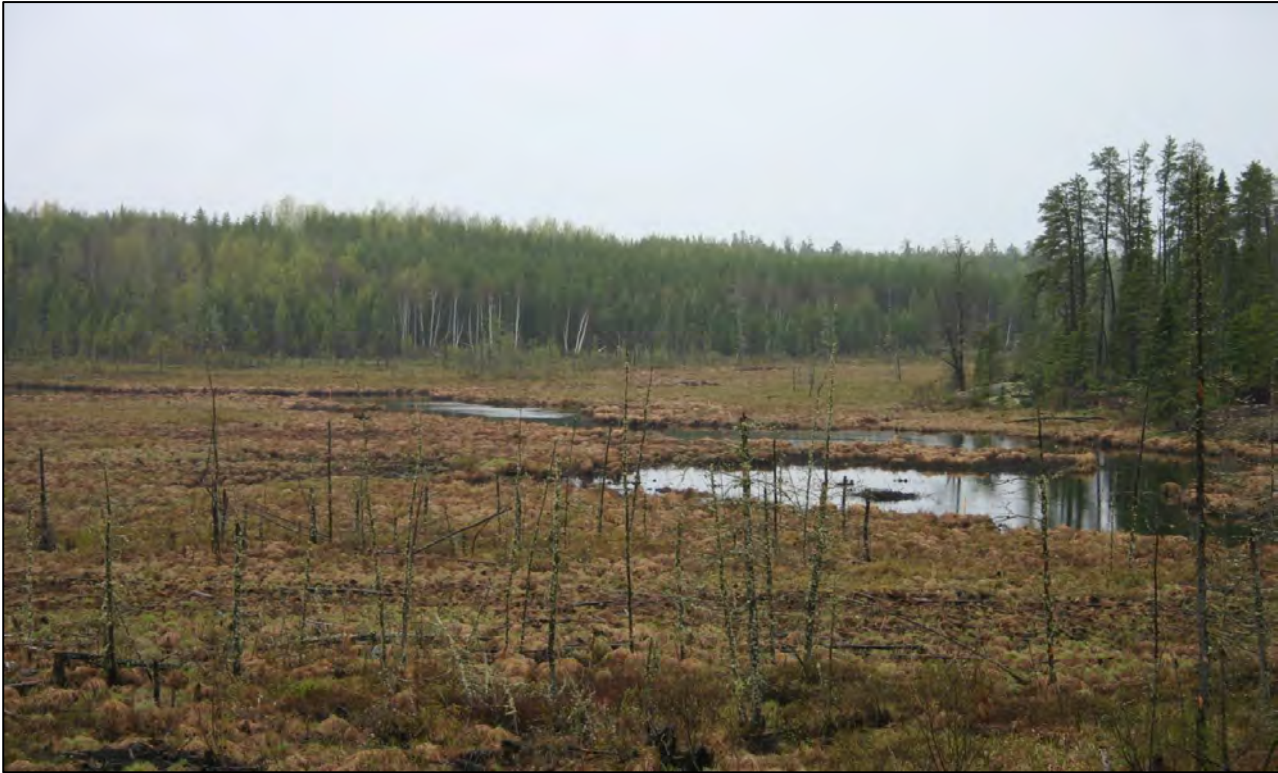
The following photos depict the typical terrain observed within the proposed open pit and proposed TMF, respectively. Photograph 1 is taken from the top of a hill at the northeast portion of the proposed open pit, looking west across the proposed open pit with the Mollie River flowing through the middle, outcropping bedrock on the right side and forest-covered hills in the background. Photograph 2 is taken from the road at the north end of the proposed TMF, near Unnamed Lake #1, looking south at Bagsverd Creek in the central portion of the proposed TMF, outcropping bedrock on the right side and forest-covered hills in the background.

Photograph 1: Looking west at Mollie River flowing through central portion of proposed open pit

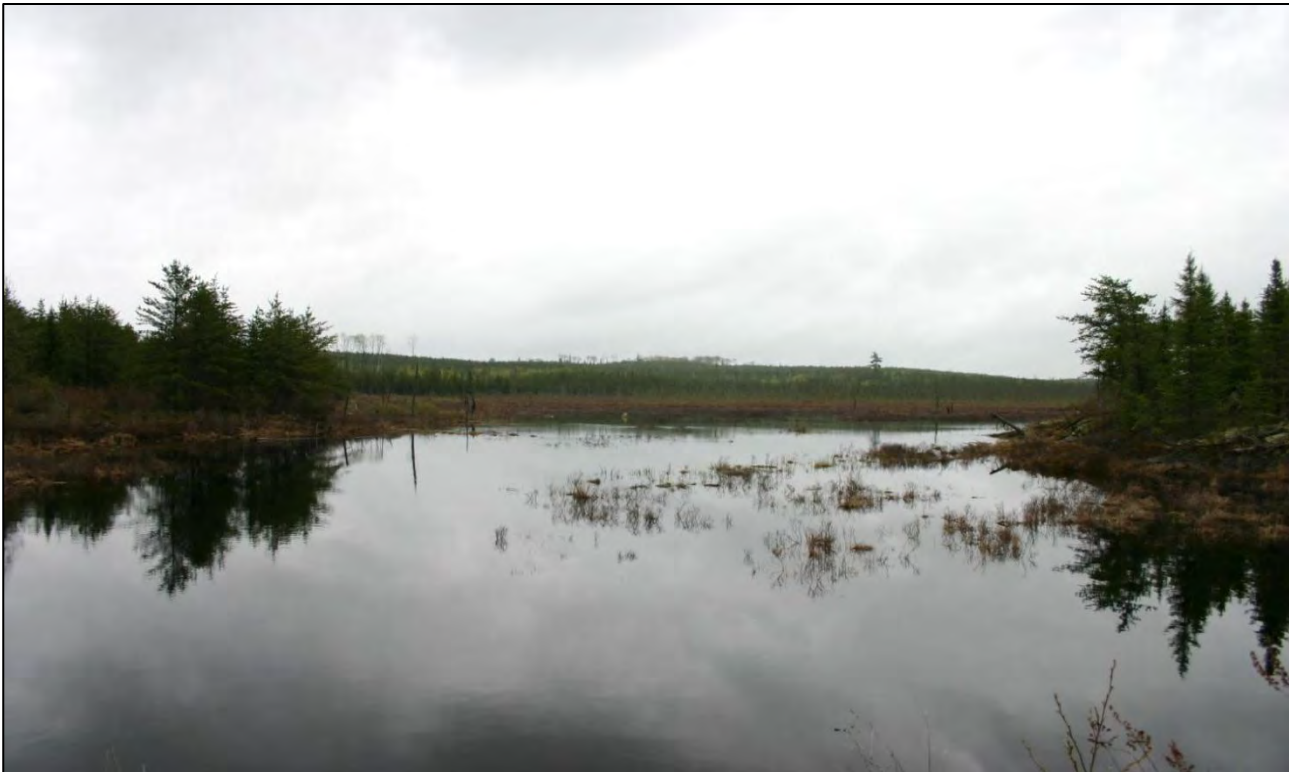
Photograph 2: Looking south at Bagsverd Creek in central portion of Tailings Management Facility

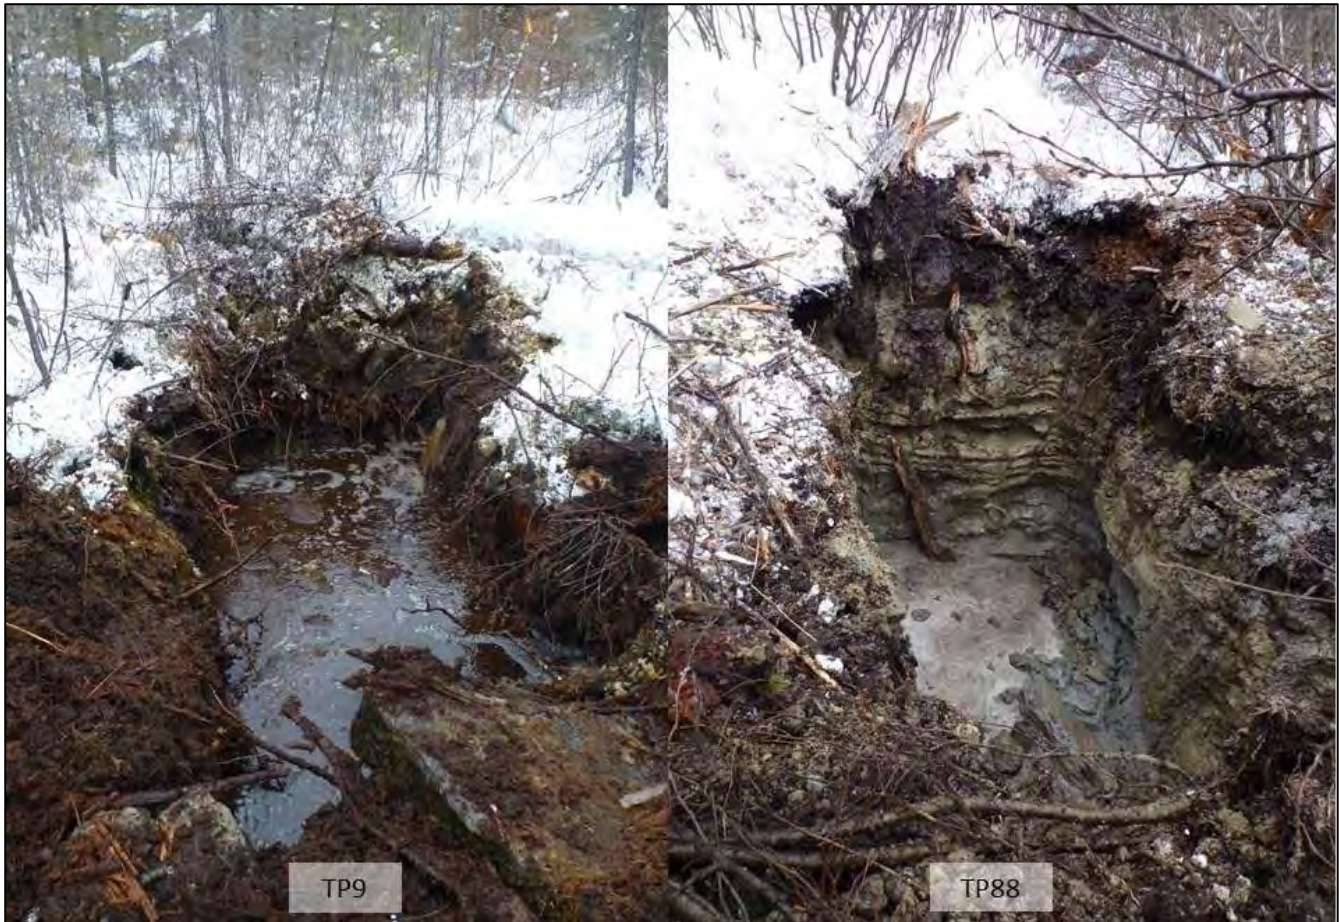
at least 2.7 m of sand. Depth to bedrock could not be established in either test pit due saturated ground conditions and sidewall caving.

Photograph 4: Typical ground conditions and overburden stratigraphy in low-lying areas.
