**APPENDIX H
HYDROGEOLOGY TECHNICAL SUPPORT DOCUMENT**

CÔTÉ GOLD PROJECT

ENVIRONMENTAL
ASSESSMENT REPORT

TECHNICAL SUPPORT
DOCUMENT:
HYDROGEOLOGY

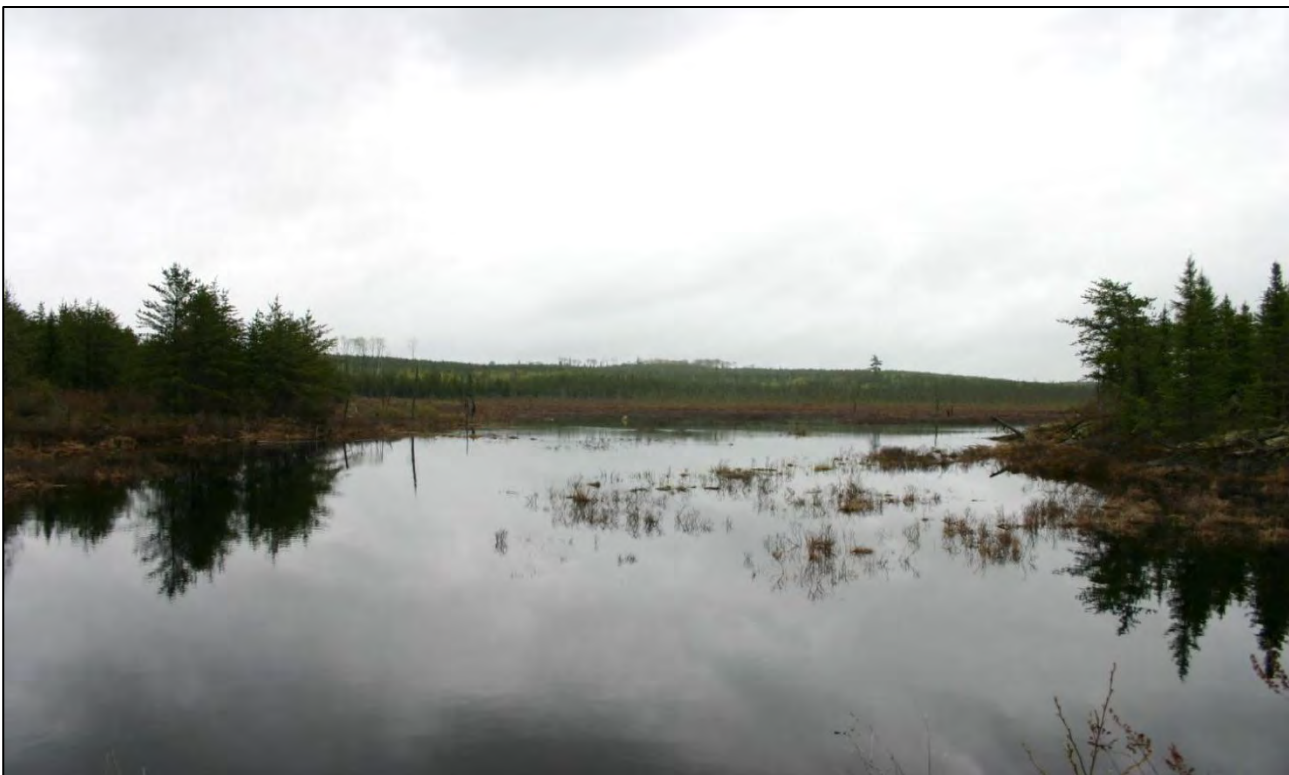
Photograph 2: Looking south at Bagsverd Creek in central portion of Tailings Management Facility

The following photos depict the typical terrain observed within the proposed open pit and proposed TMF, respectively. Photograph 1 is taken from the top of a hill at the northeast portion of the proposed open pit, looking west across the proposed open pit with the Mollie River flowing through the middle, outcropping bedrock on the right side and forest-covered hills in the background. Photograph 2 is taken from the road at the north end of the proposed TMF, near Unnamed Lake #1, looking south at Bagsverd Creek in the central portion of the proposed TMF, outcropping bedrock on the right side and forest-covered hills in the background.

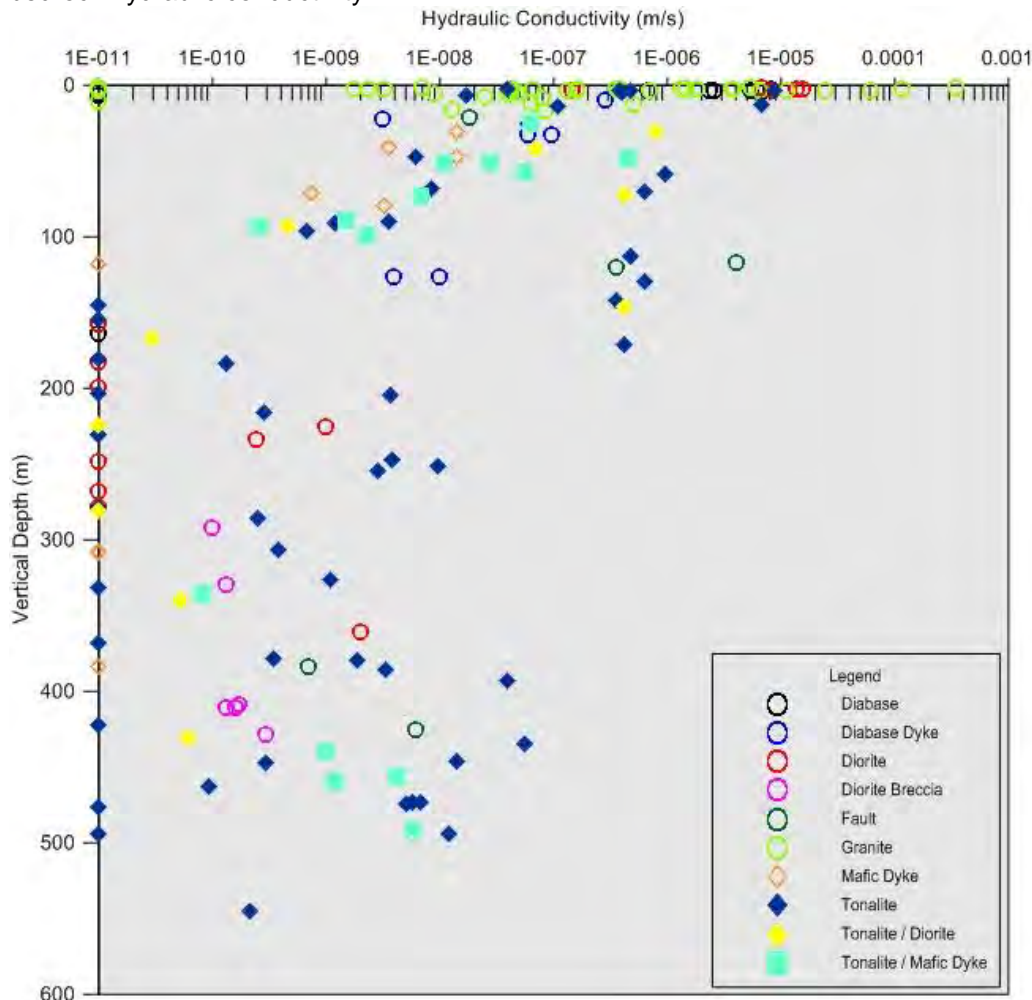
Figure 10: Bedrock Hydraulic Conductivity versus Bedrock Depth and Lithology

The hydraulic conductivity of the shallow bedrock (i.e. the upper 10 m) encountered throughout the Project site is highly variable, spanning eight orders of magnitude ranging from 1.0×10^{-11} m/s to 3.4×10^{-4} m/s, with a geomean of 1.0×10^{-7} m/s. As depicted on Figure 10, the bedrock hydraulic conductivity was less variable and typically decreased with depth. Test data on Figure 10 have also been presented against rock type and structure. These results indicate that bedrock structure and rock type exert little to moderate influence on bedrock hydraulic conductivity.

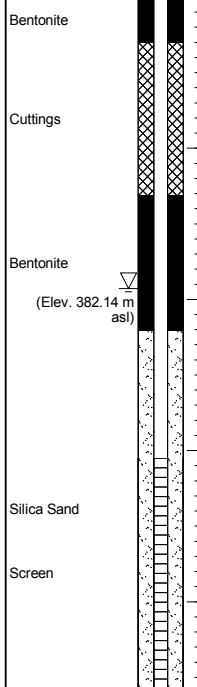
- Riser pipe stick-up = 0.83 m.
 - Well pipe diameter = 0.05 m.
 - Water level measured on June 27, 2012 (2.758 m btp)

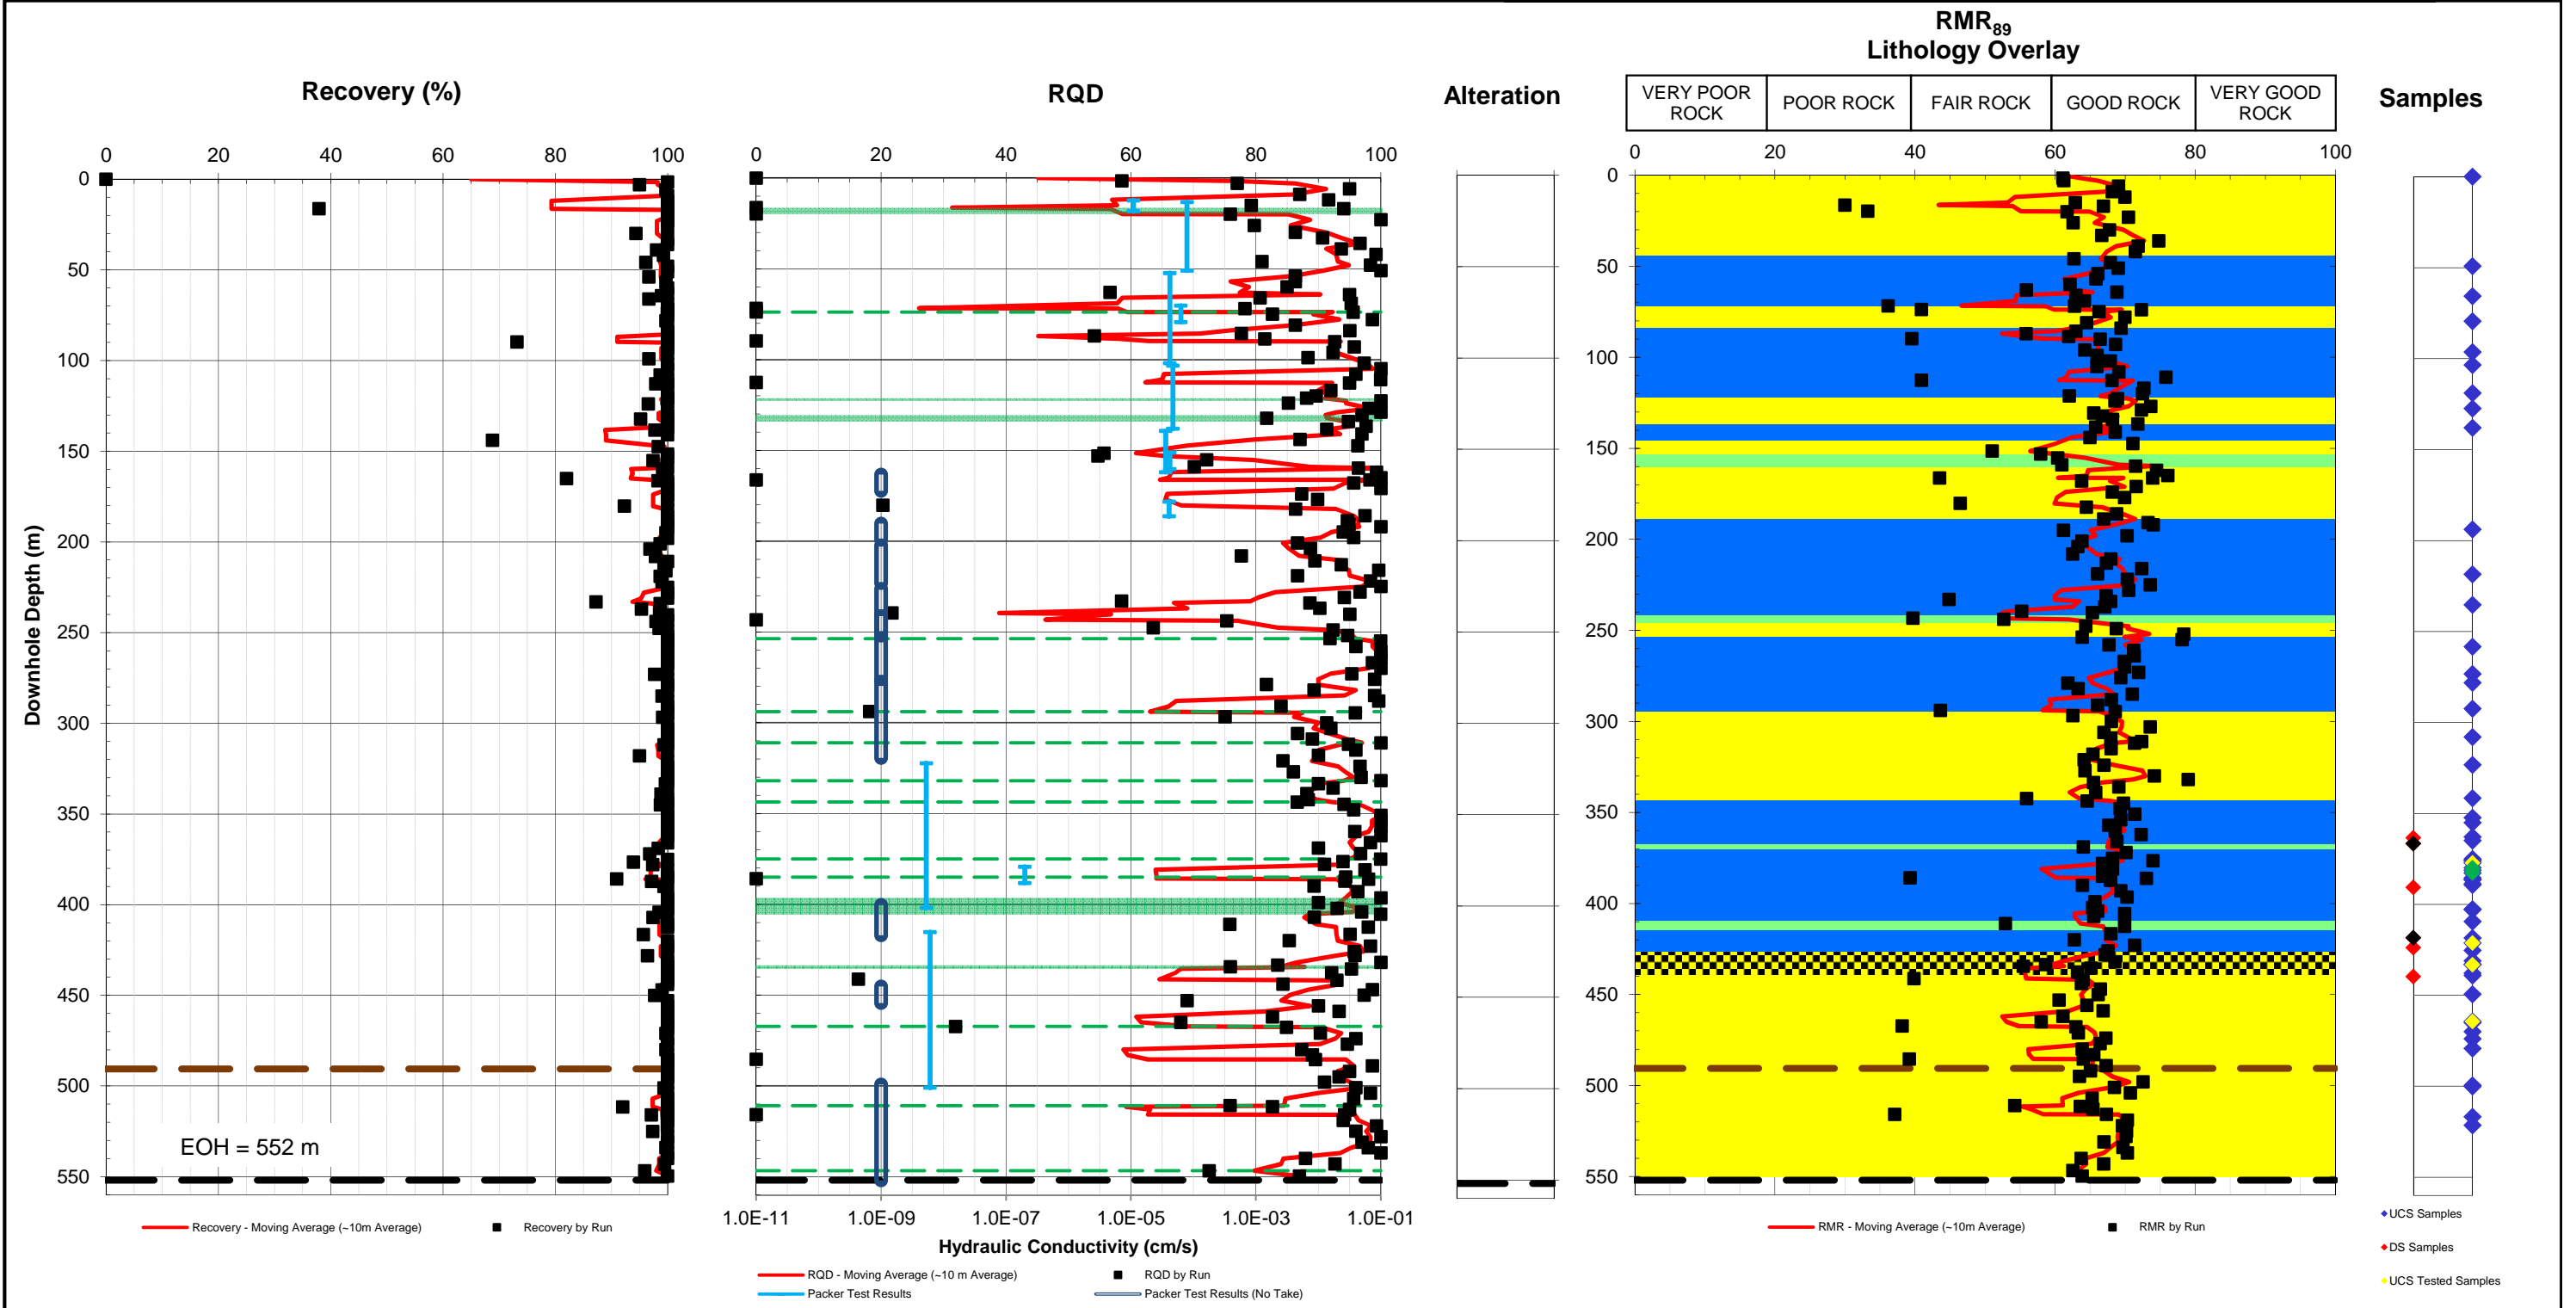
IAMGOLD CORPORATION		
CÔTÉ GOLD PROJECT		
DOWNHOLE PLOTS FOR DRILLHOLE GT-12-02		
<i>Knight Piésold</i> CONSULTING	P/A NO. NB101-497/2	REF. NO. 1
	FIGURE F1.2	
		REV 0

NOTES:
 1. LITHOLOGY IS FROM GEOLOGY LOGS PROVIDED BY IAMGOLD (SEPTEMBER, 2012).
 2. FAULT ZONES BASED ON GEOMECHANICAL LOGGING AND MAY NOT CORRESPOND WITH GEOLOGY LOGS.
 3. WATER LEVEL MEASURED AT AN AVERAGE DOWNHOLE DEPTH OF 5.4 m.

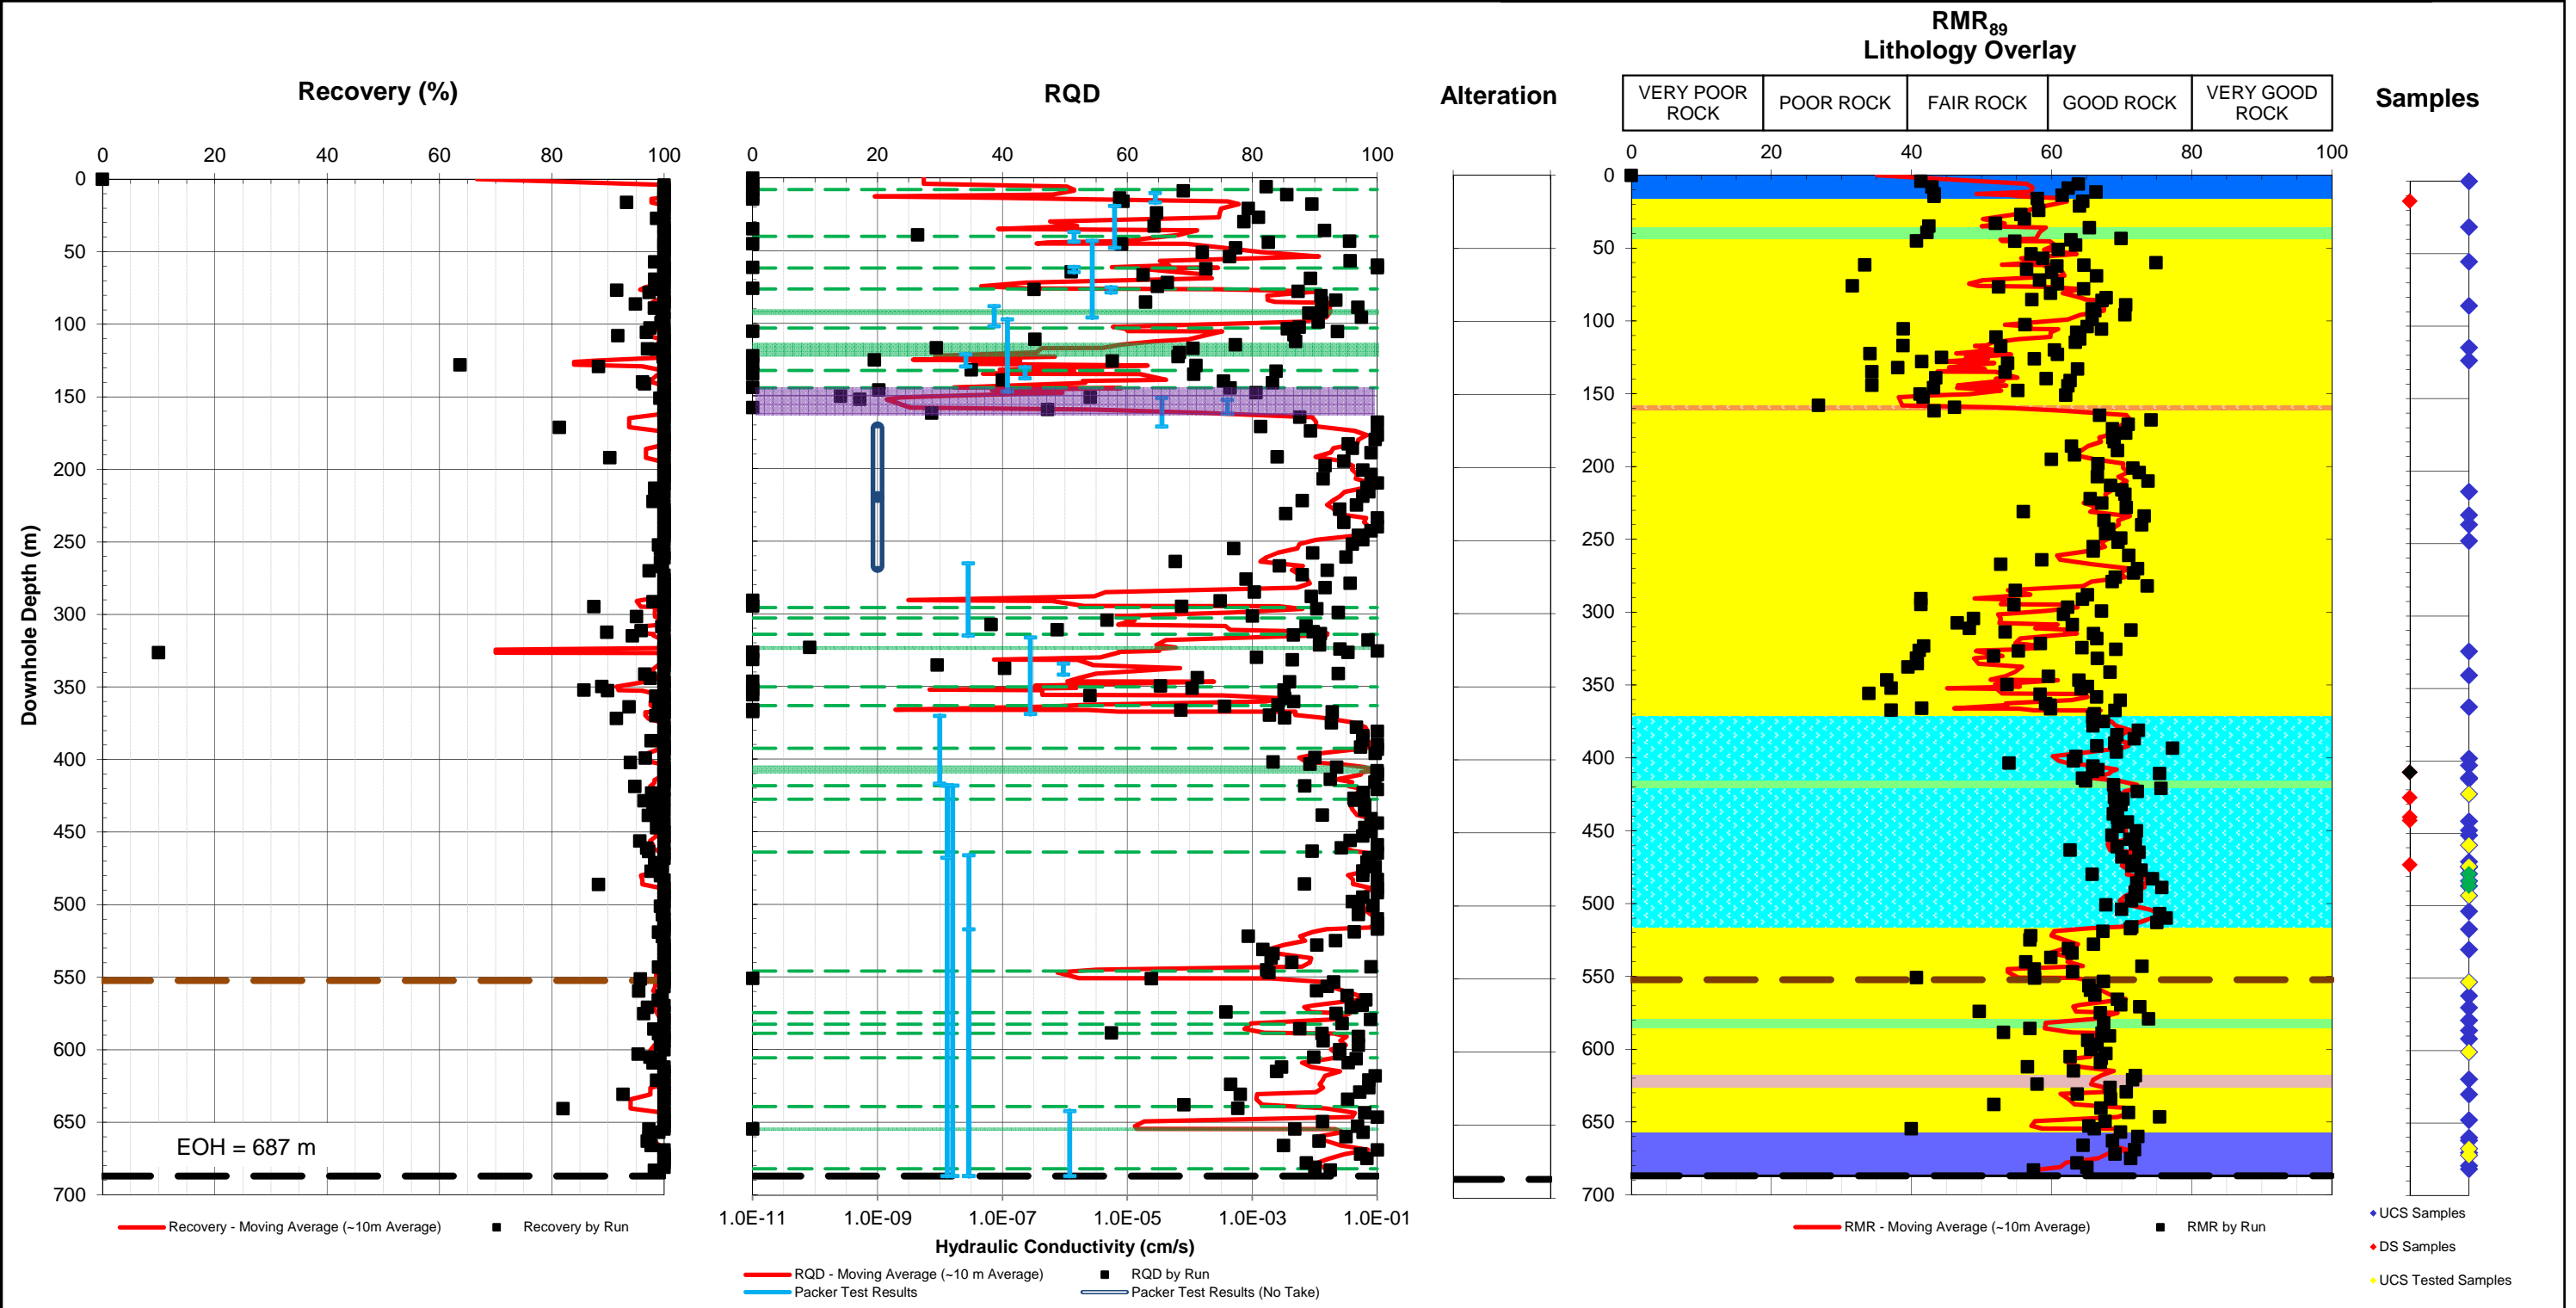
IAMGOLD CORPORATION		
CÔTÉ GOLD PROJECT		
DOWNHOLE PLOTS FOR DRILLHOLE GT-12-04		
Knight Piésold CONSULTING	P/A NO. NB101-497/2	REF. NO. 1
	FIGURE F1.4	
		REV 0

NOTES:
 1. LITHOLOGY IS FROM GEOLOGY LOGS PROVIDED BY IAMGOLD (SEPTEMBER, 2012).
 2. FAULT ZONES BASED ON GEOMECHANICAL LOGGING AND MAY NOT CORRESPOND WITH GEOLOGY LOGS.
 3. WATER LEVEL MEASURED AT AN AVERAGE DOWNHOLE DEPTH OF 3.0 m.

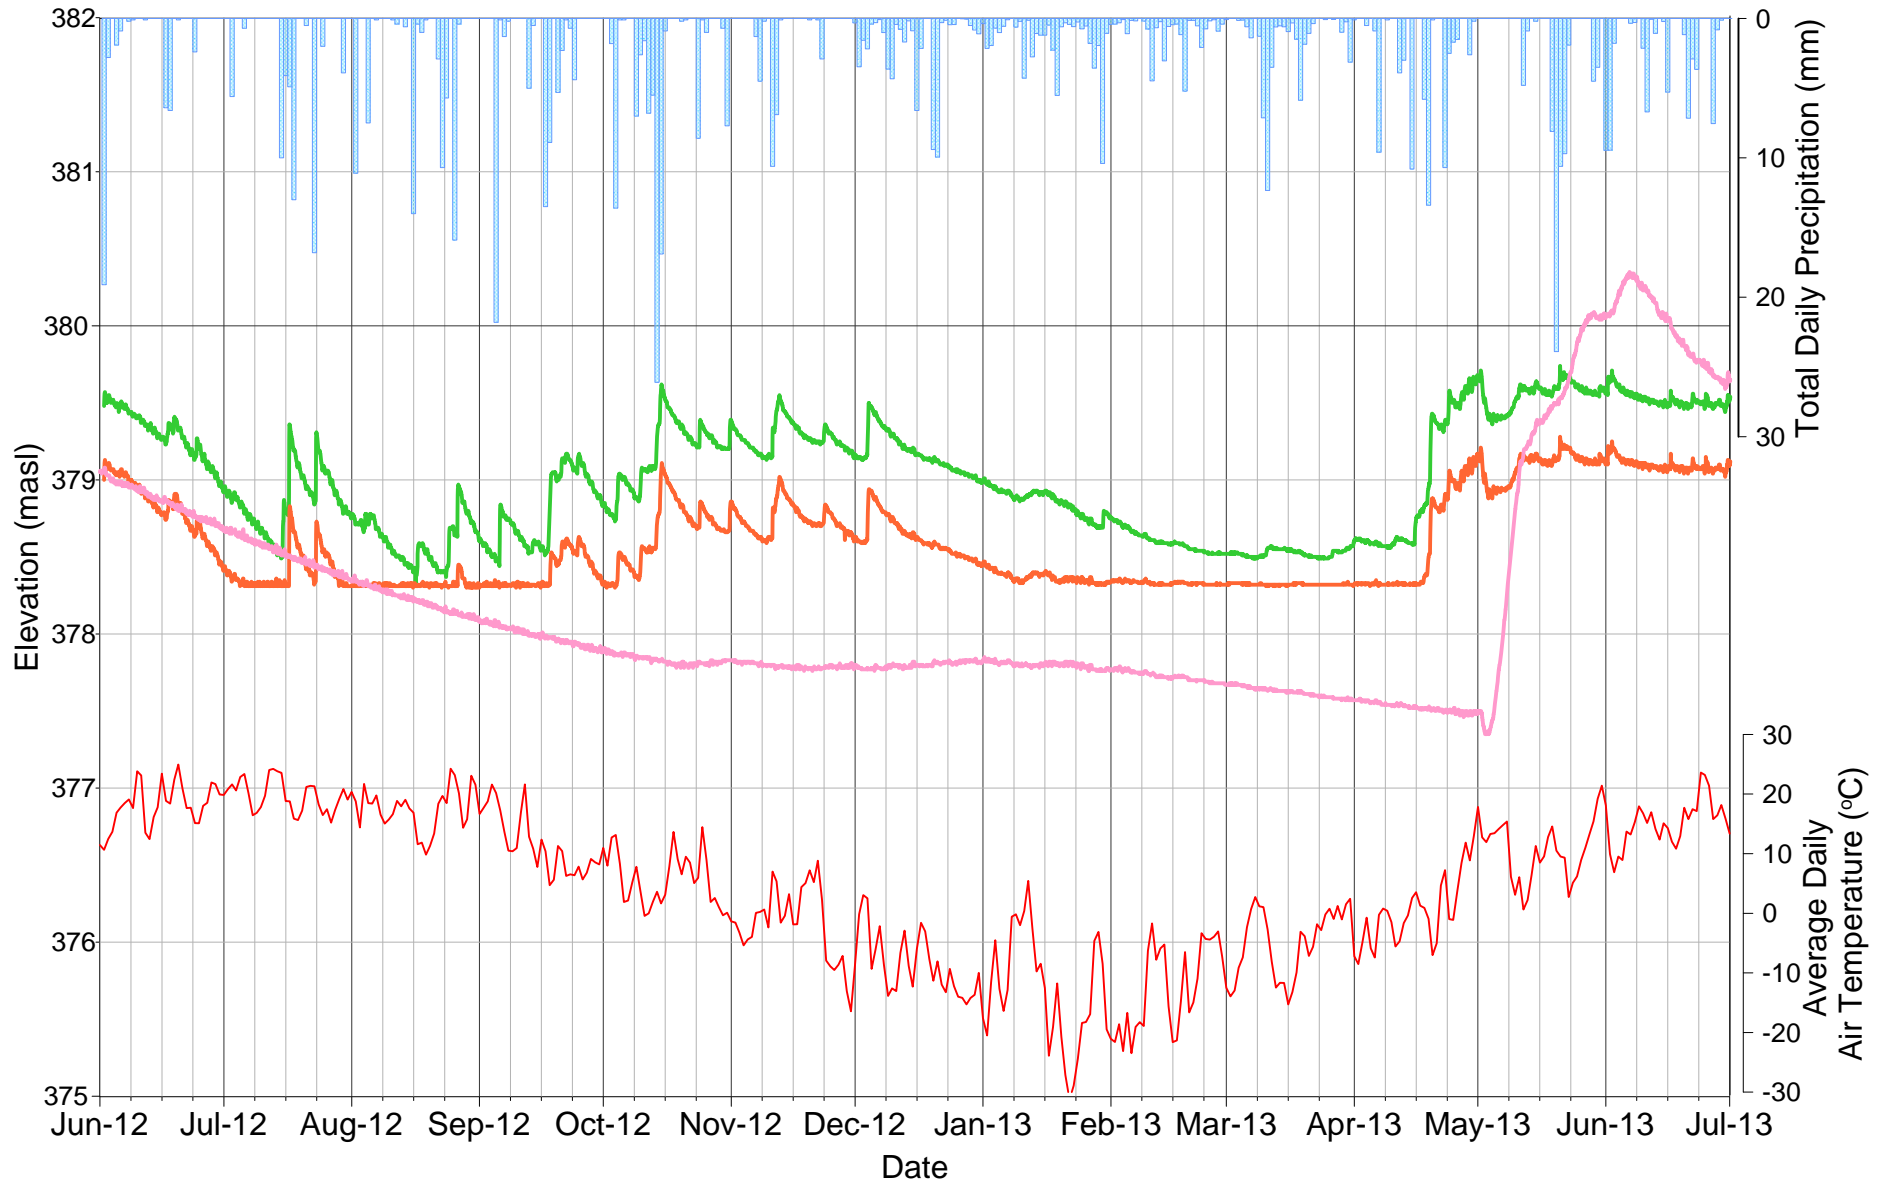
***Note:** Flat sections in the data for DH12-TMF-31B represent occasions where the water level dropped below the data logger, therefore data is not representative of groundwater elevation

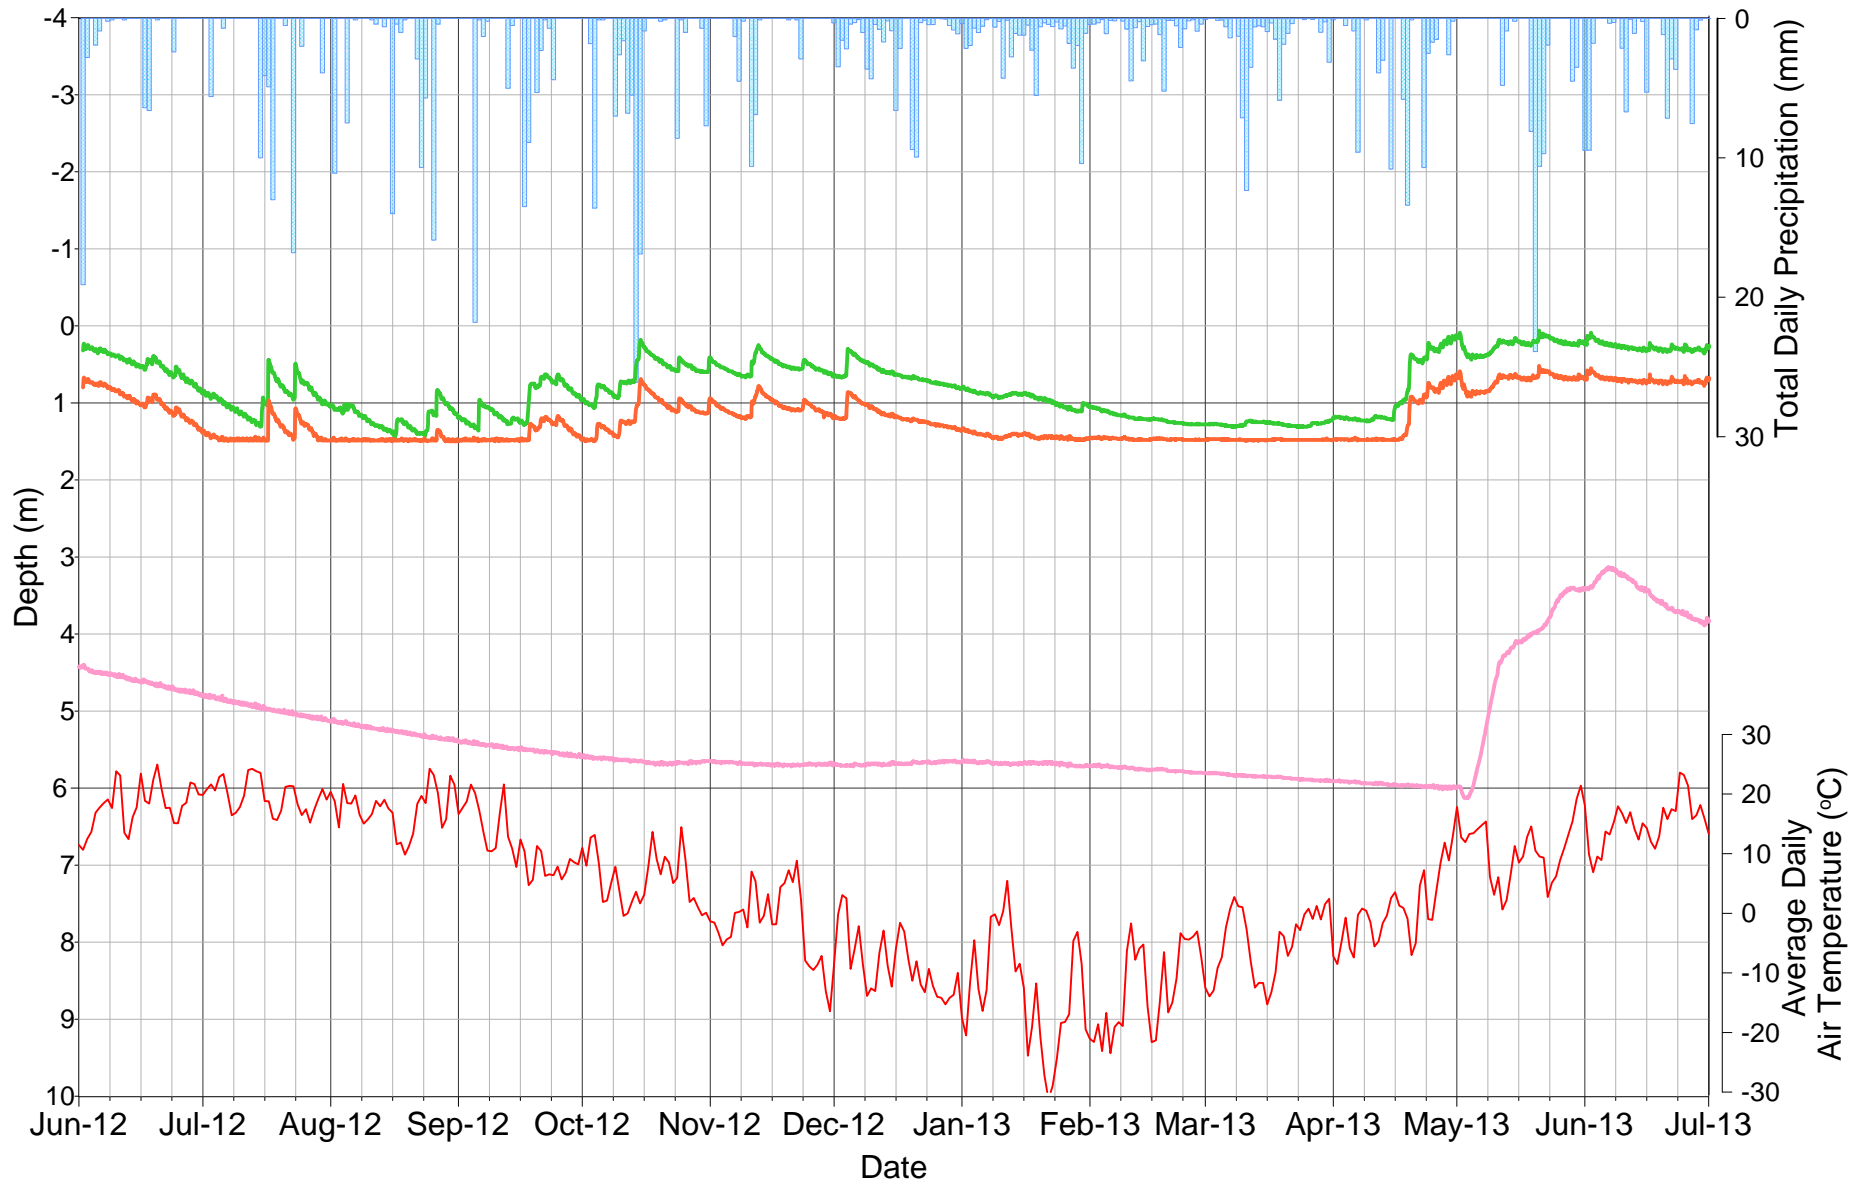
*Note: Flat sections in the data for DH12-TMF-31B represent occasions where the water level dropped below the data logger, therefore data is not representative of groundwater depth
