SPRINGBANK OFF-STREAM RESERVOIR PROJECT
ENVIRONMENTAL IMPACT ASSESSMENT
VOLUME 4: APPENDICES
APPENDIX M: AQUATIC ECOLOGY

Attachment 8A Fish Passage Analysis
March 2018

Attachment 8A **FISH PASSAGE ANALYSIS**

Reference: Springbank Off-stream Storage Project (SR1) – Hydraulic Modeling to Support Fish Passage Assessment

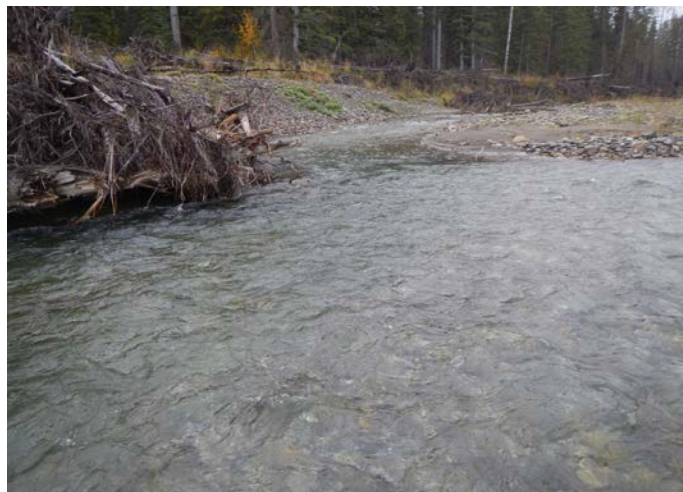
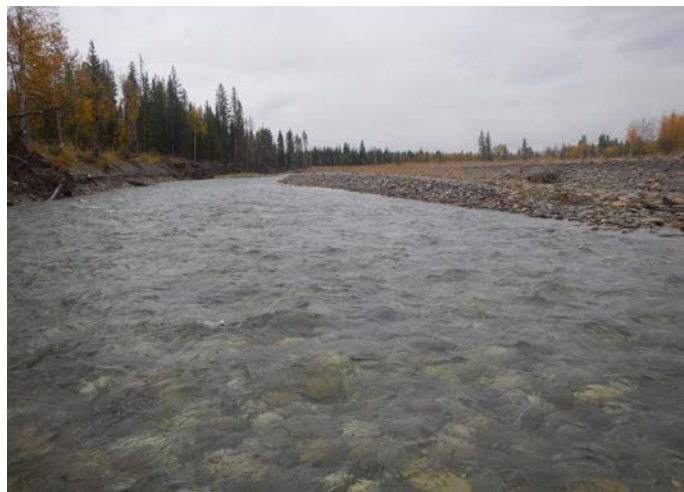
Photo 1: Looking upstream from T1 at woody debris and depth cover.

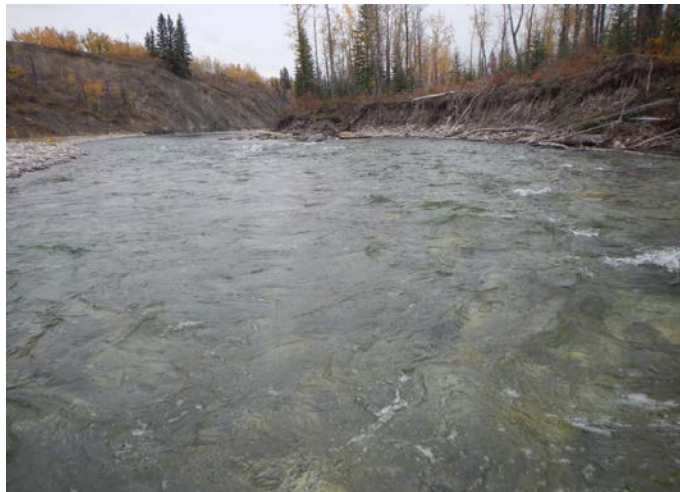
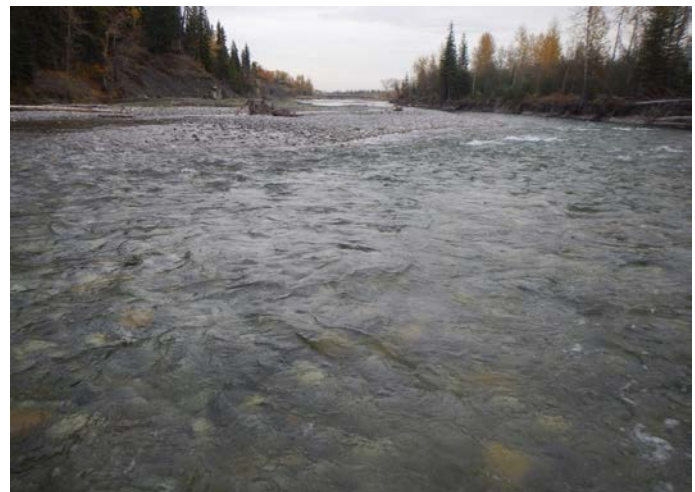
Photo 1: Looking downstream from T2 at run/riffle habitat and woody debris.
