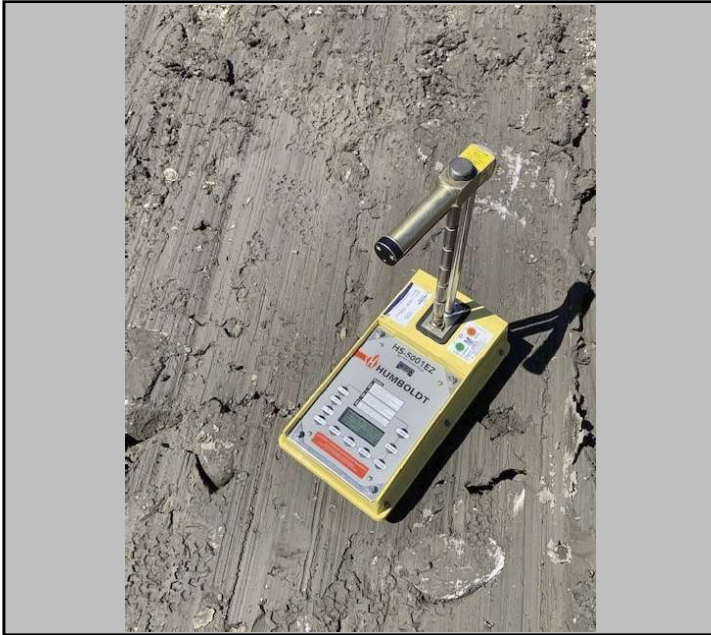
Photo #: 1

Compaction Test being completed on CCL Lift 2
Panel 2

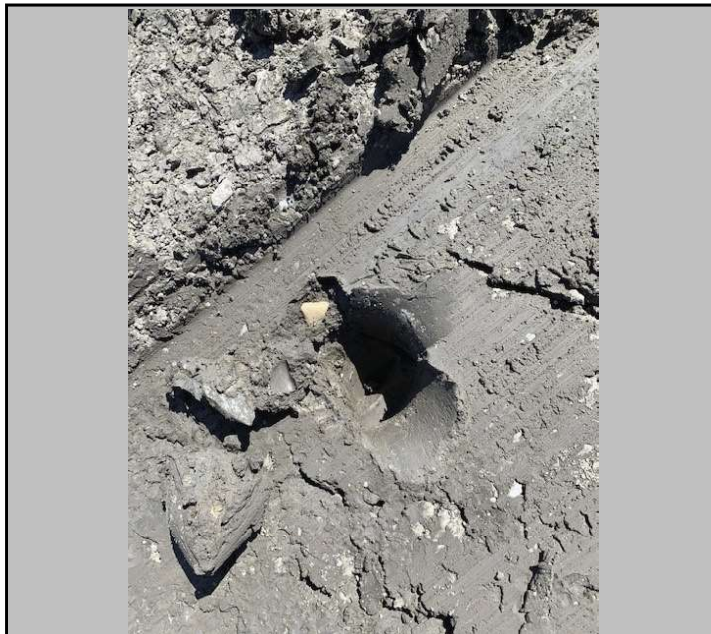
Photo #: 3

Location of EMRS21-L2-132 sample.

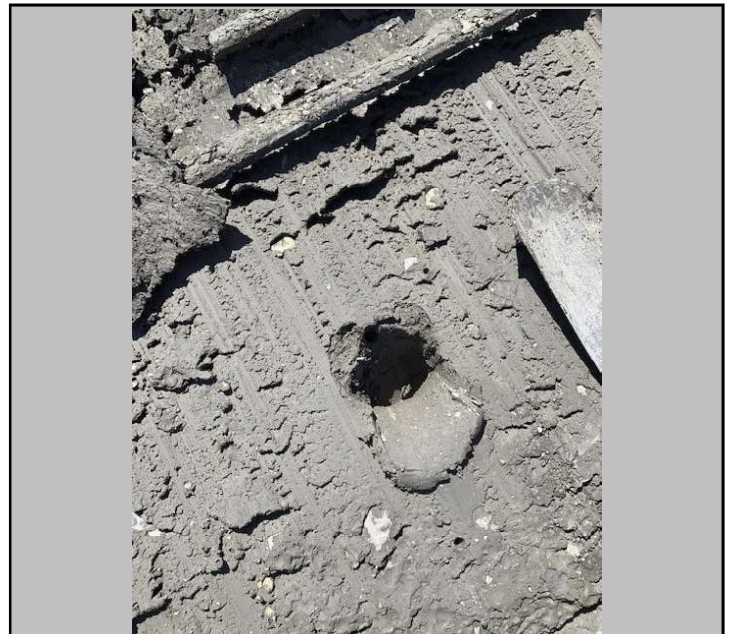
Photo #: 4

Location of EMRS21-L2-133 sample.

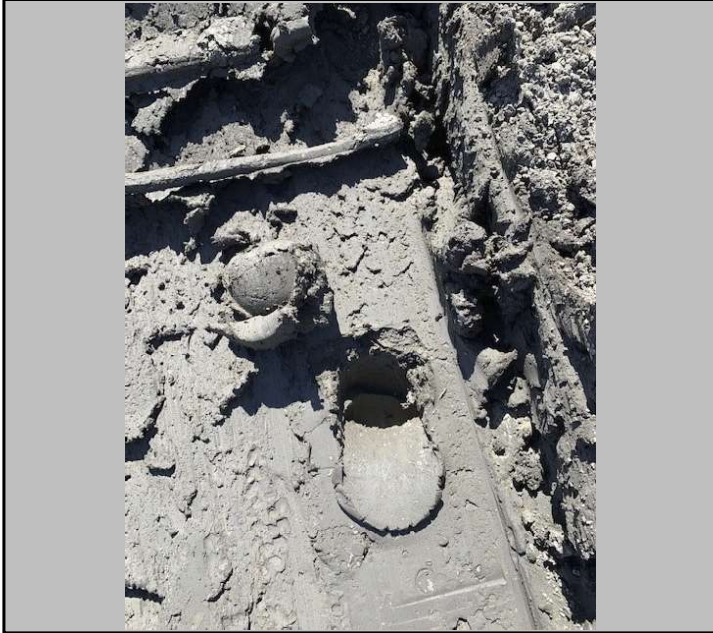
Photo #: 5

Location of EMRS21-L2-134 sample.

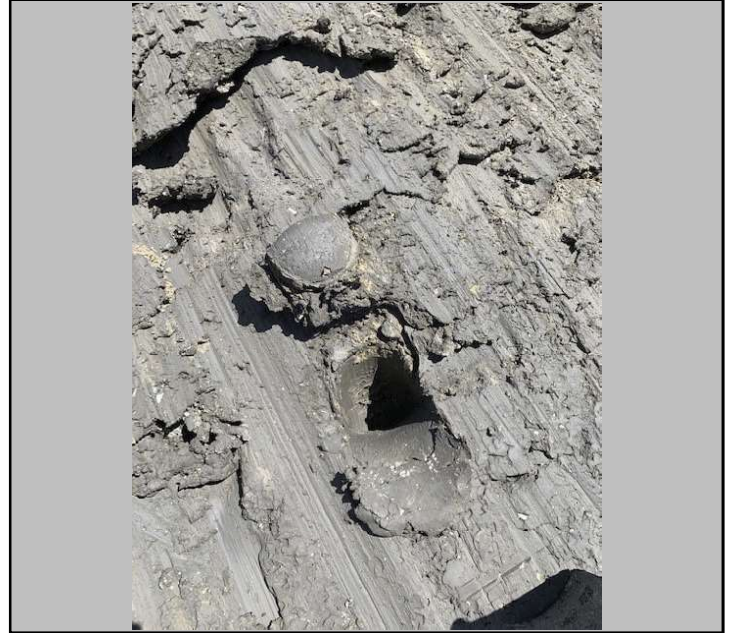
Photo #: 6

Location of EMRS21-L2-135 sample.

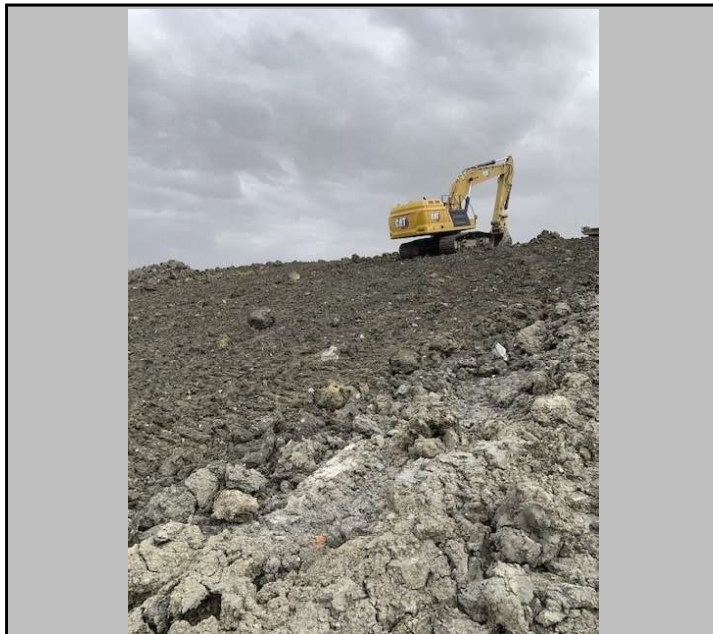
Photo #: 7

CAT 349 excavator working to bulk NCL material down the slope.

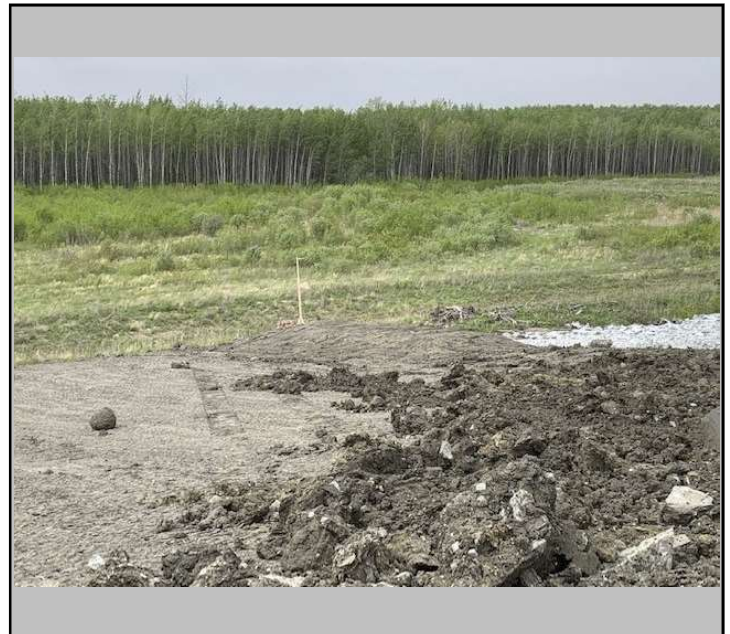
Photo #: 8

NCL Lift 3 placement on Panel 2. Also, covered burrito in the background.

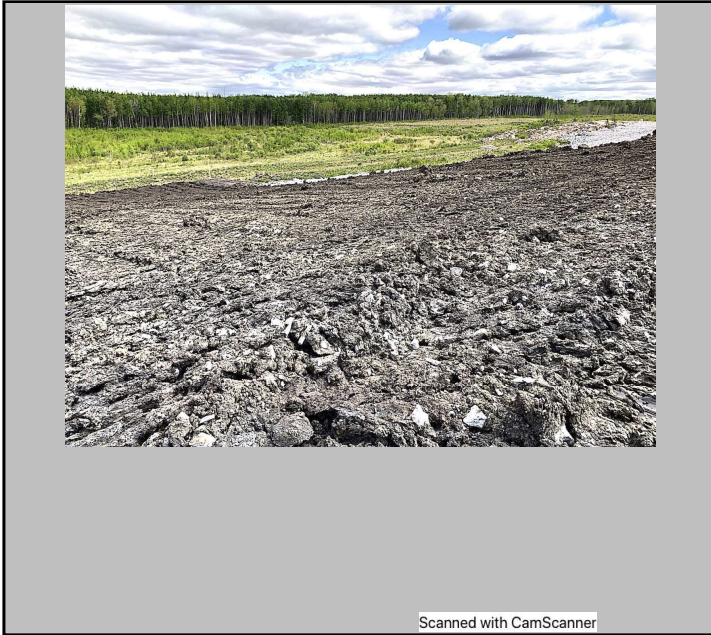
Photo #: 1

NCL Lift 3 Panel 2.

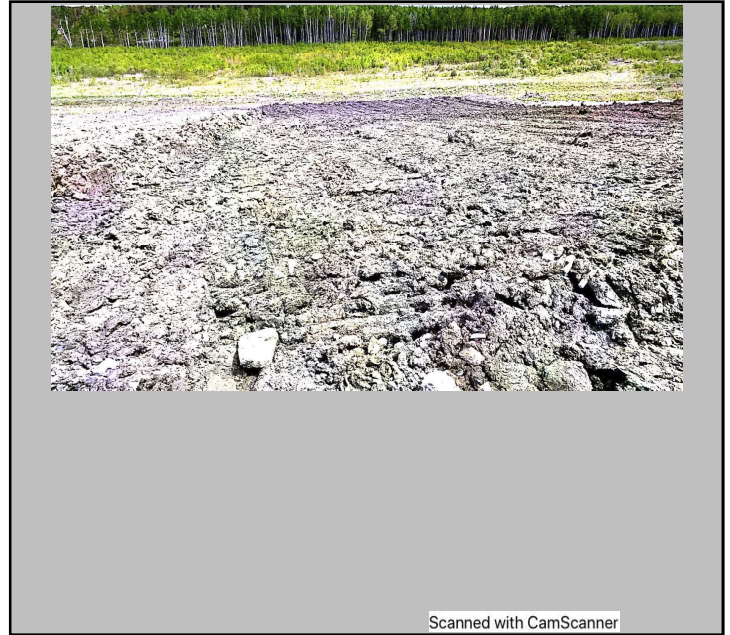
Photo #: 2

NCL Lift 3 Panel 2.

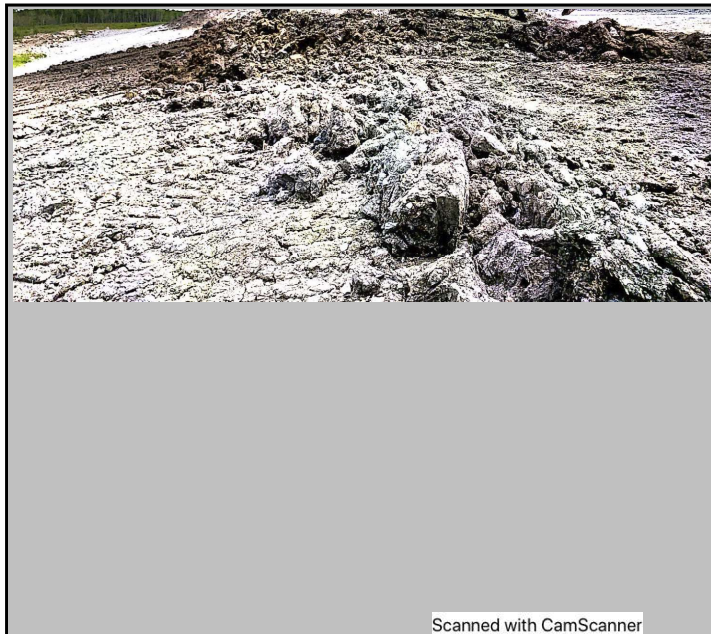
Photo #: 3

Starting placement of NCL Lift 4 Panel 2.

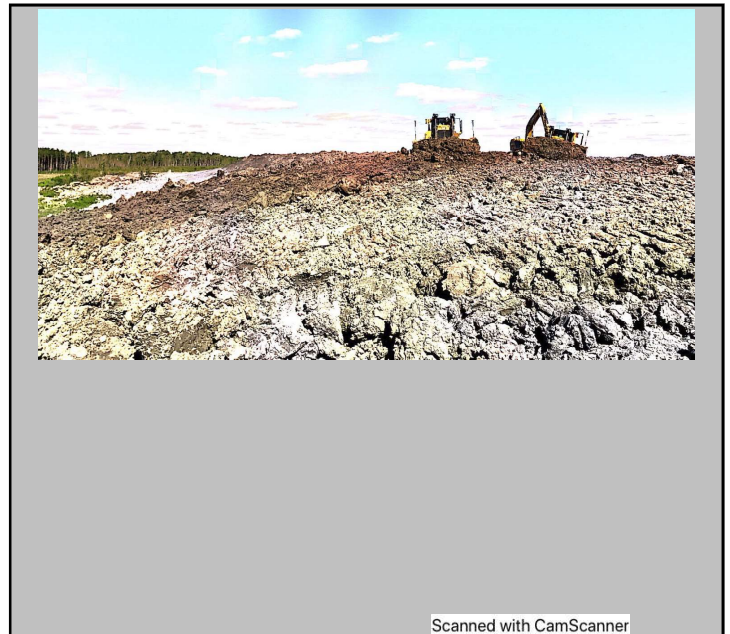
Photo #: 4

D8-1, D8-2, & CAT 349 bulking and pushing NCL Lift 4 down the slope on Panel 2.

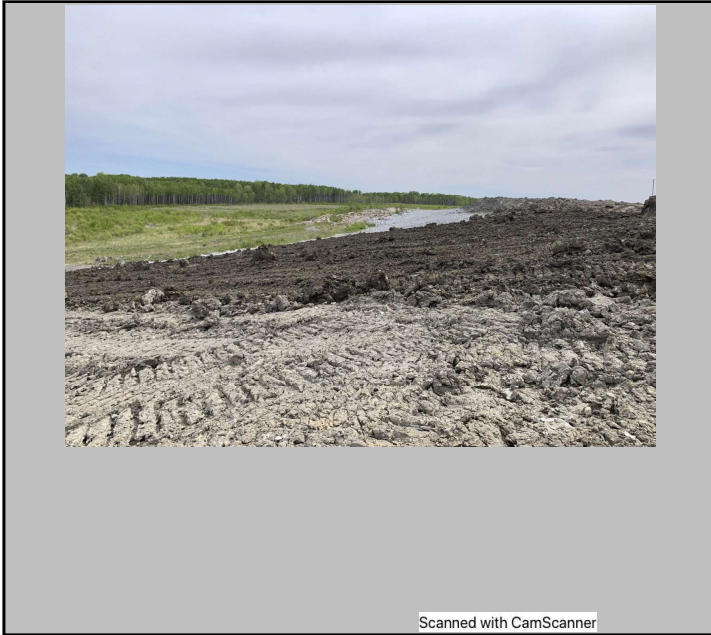
Photo #: 1

Placing of NCL L4 on Panel 2

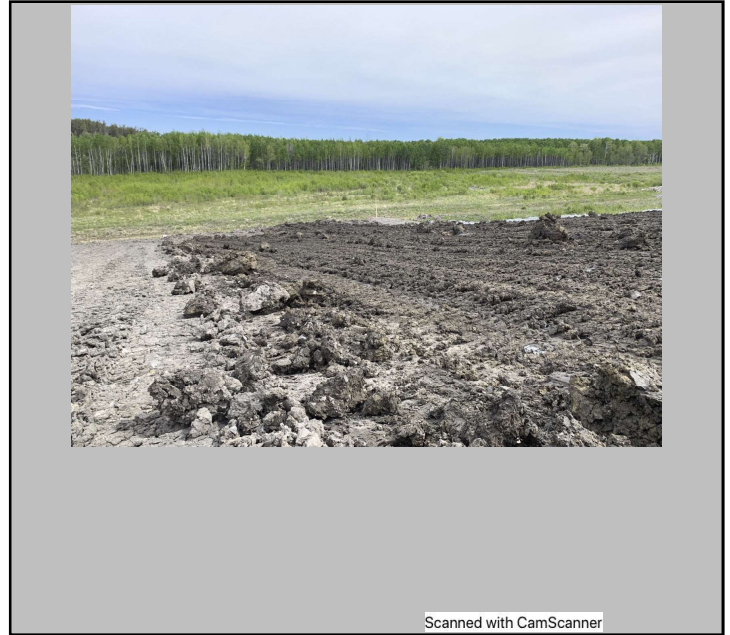
Photo #: 2

Placing of NCL L4 on Panel 2

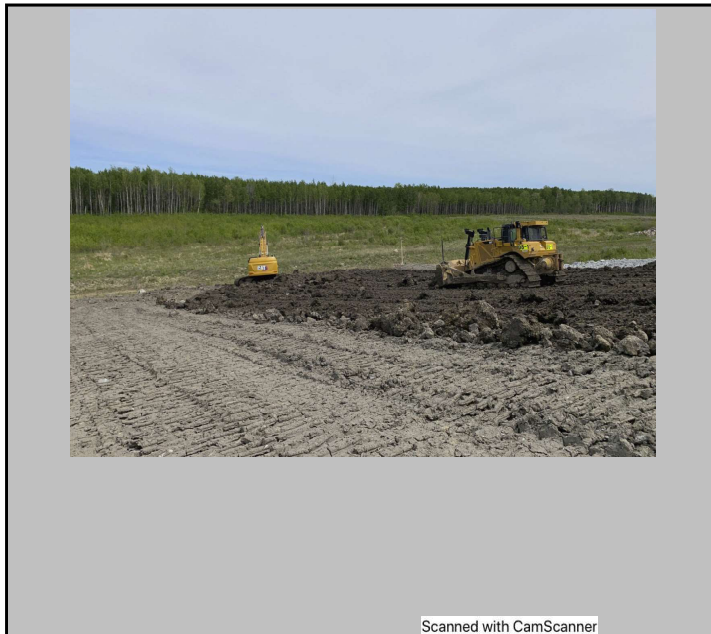
Photo #: 3

NG grading NCL L4 on Panel 2

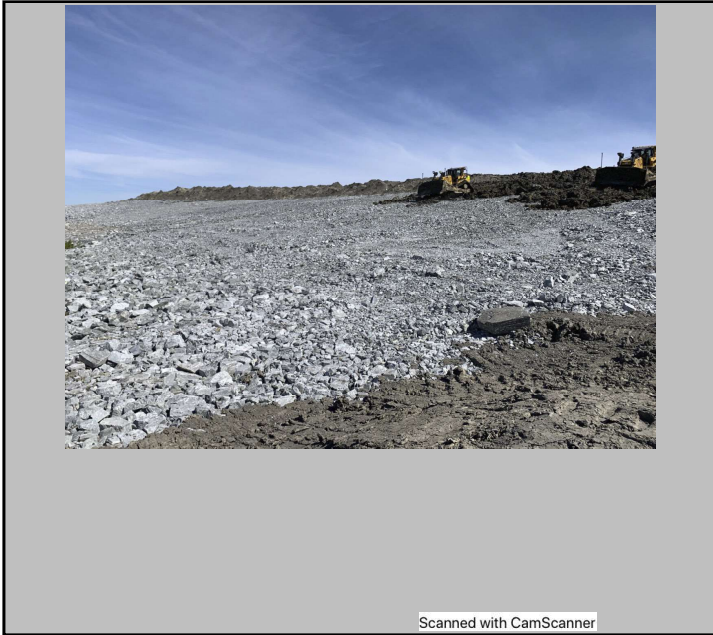
Photo #: 5

NG D8 dozers starting to push CCL L1 on Panel 3.

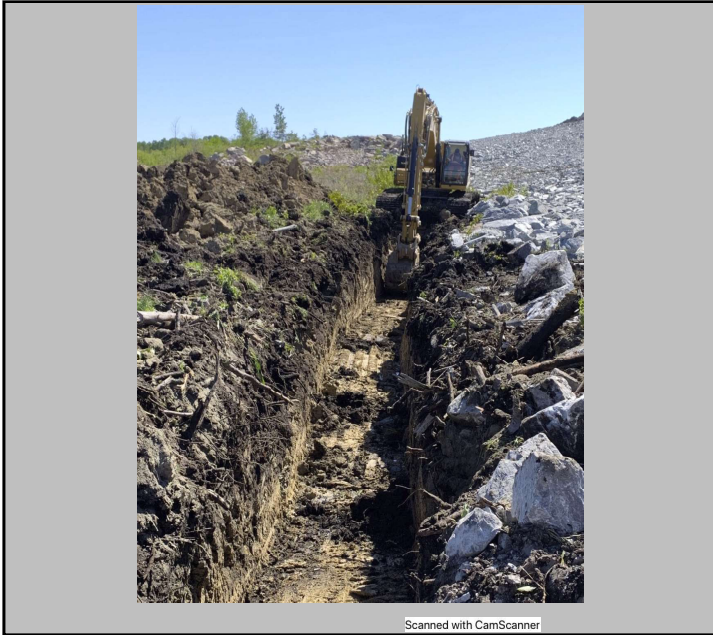
Photo #: 1

NG excavating key trench at approx. 2+844.

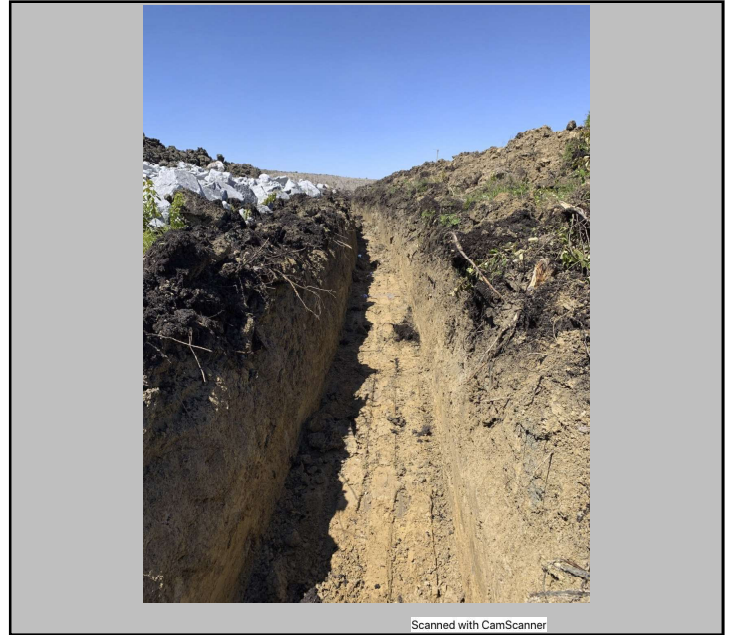
Photo #: 2

Excavated key trench at STA 2+792 to 2+844.

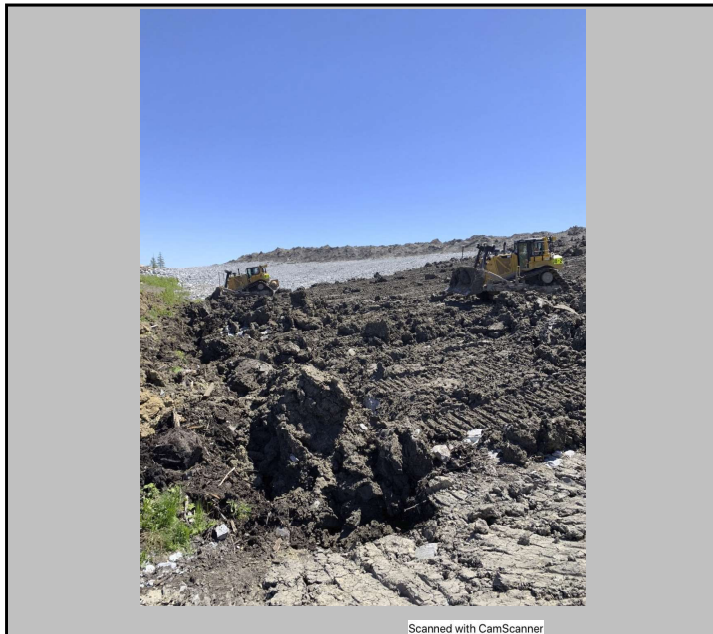
Photo #: 3

NG placing material in key trench at STA 2+792 to 2+844.

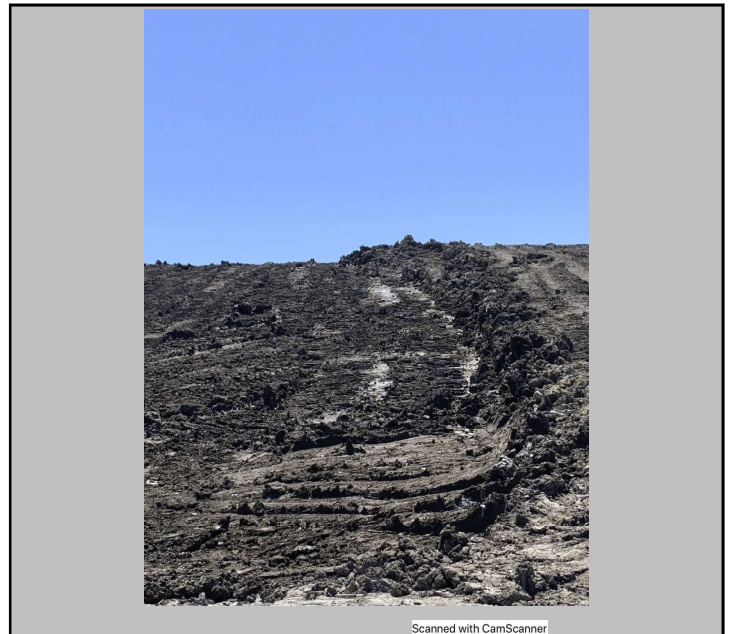
Photo #: 4

Transition area between Panel 2 and Panel 3.

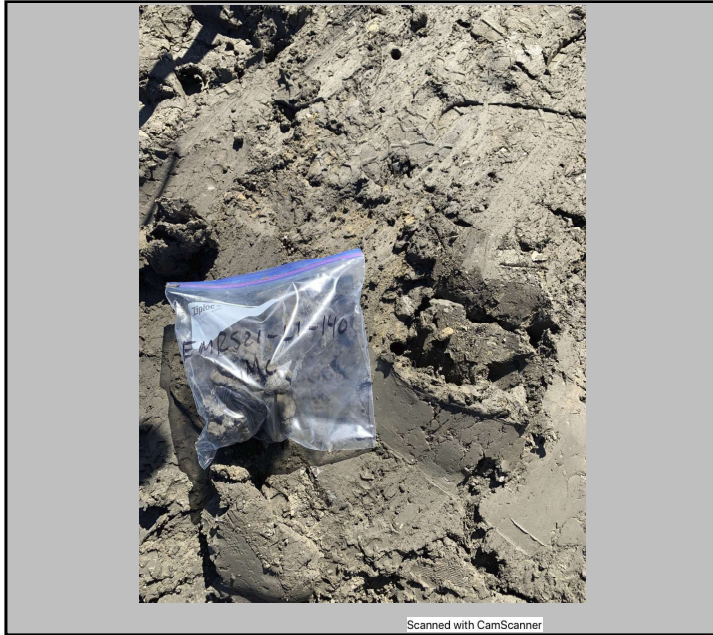
Photo #: 5

Sample EMRS21-L1-140.

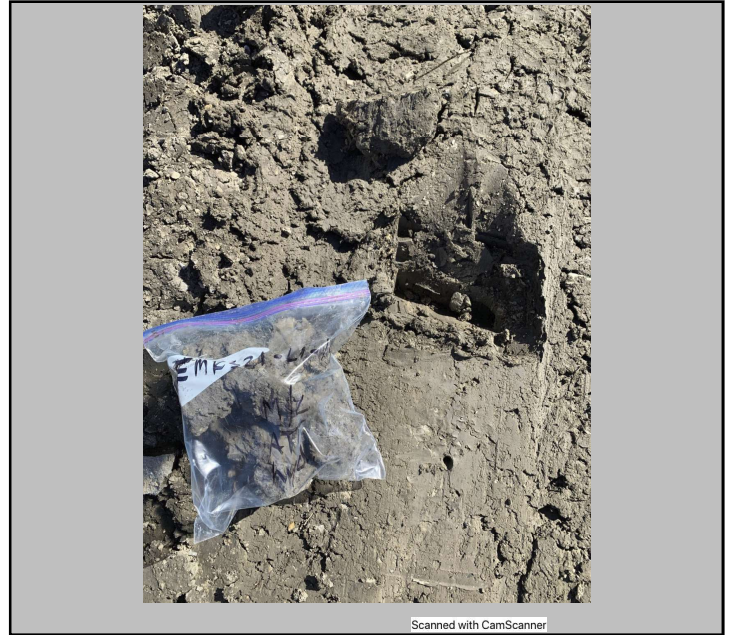
Sample EMRS21-L1-141.

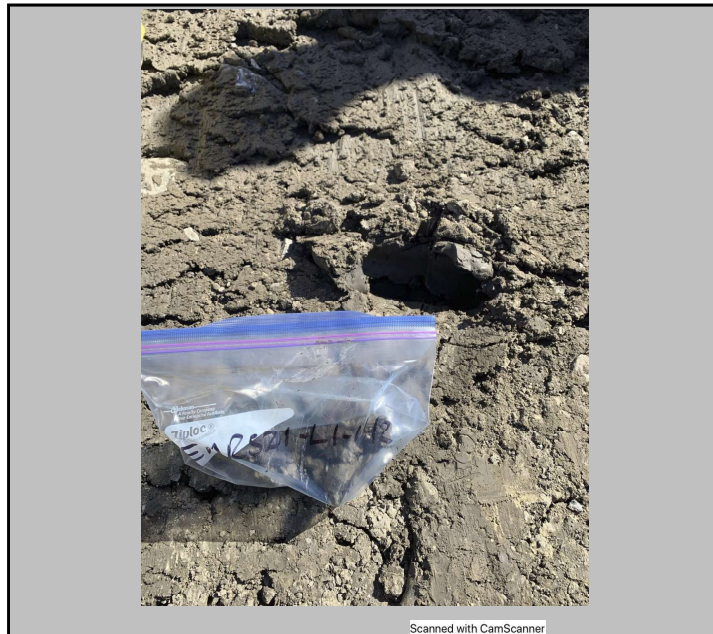
Sample EMRS21-L1-142

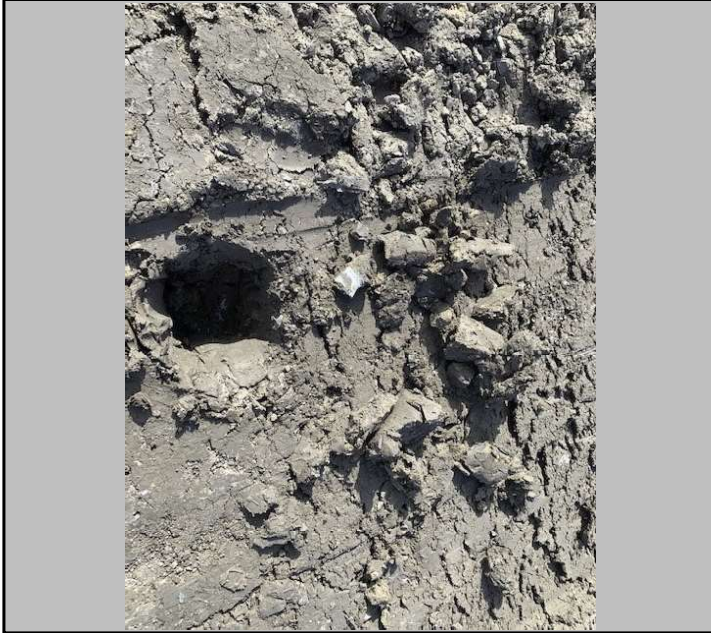
Photo #: 1

Location of Sample EMRS21-L1-S143

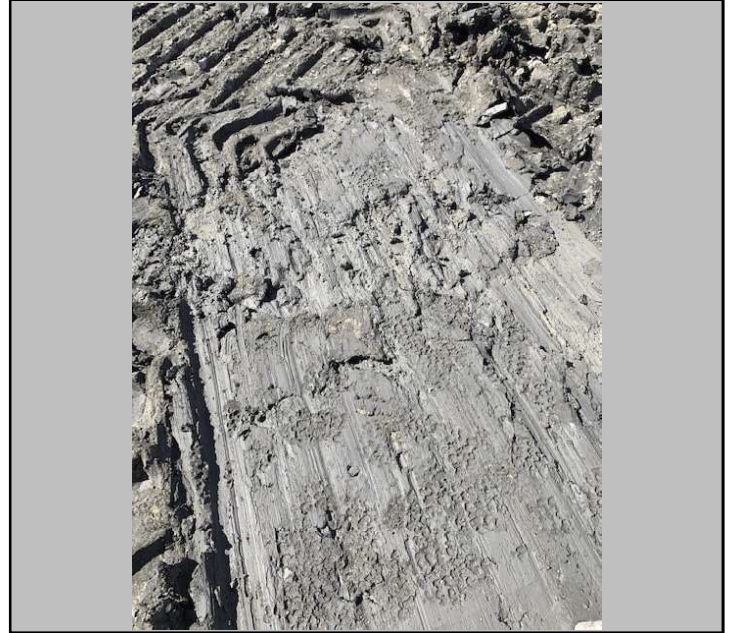
Photo #: 2

Wet spot where density test EMRS21-L1-D34 was taken.

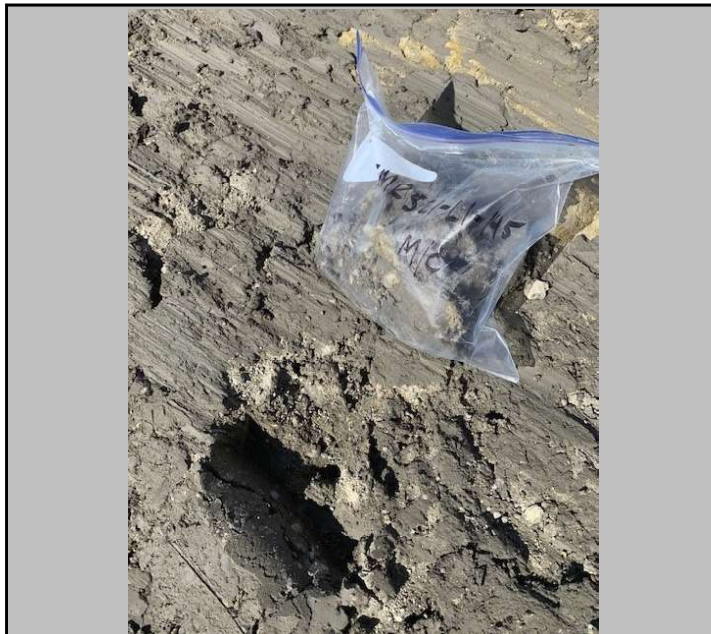
Photo #: 3

Location of Sample EMRS21-L1-S145

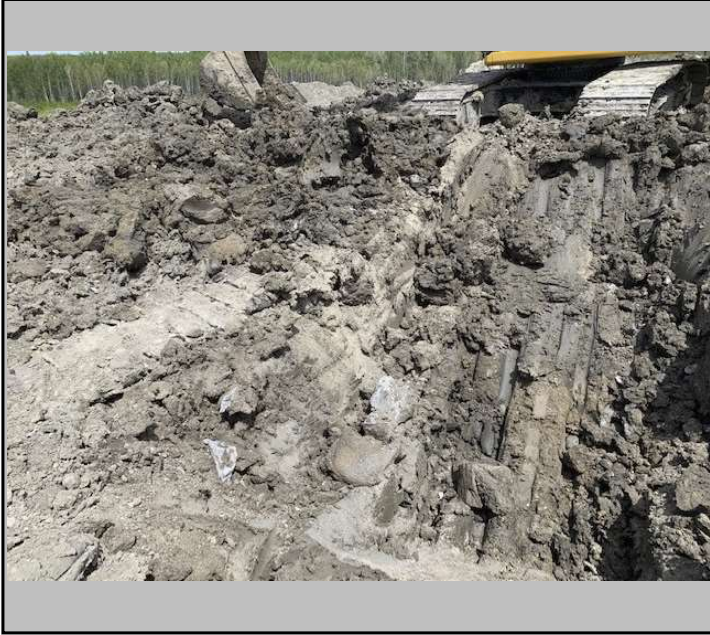
Photo #: 5

Location of sample EMRS21-SP-106.

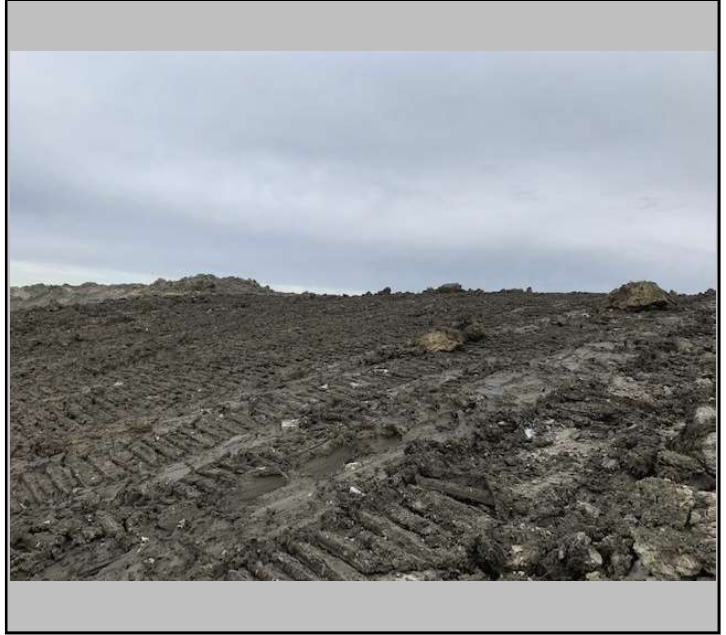
Photo #: 6

CCL L2 being placed on Panel 3.

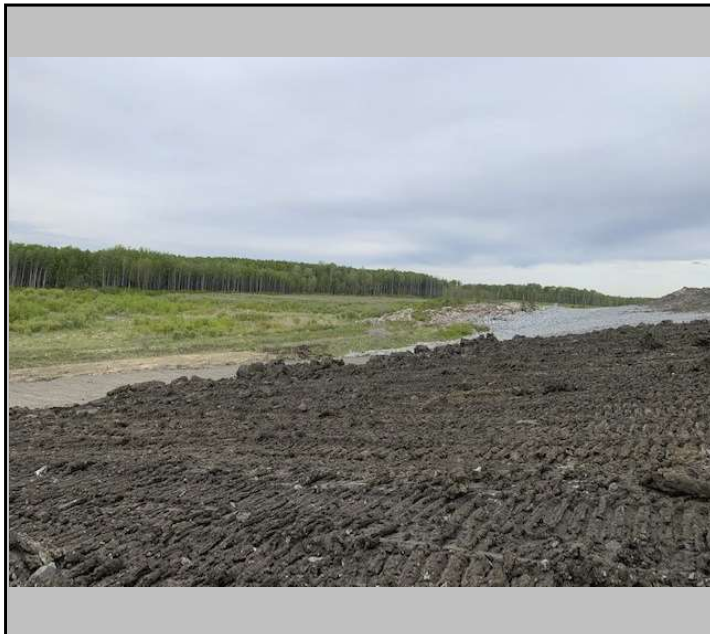
Photo #: 7

CCL L2 being placed on Panel 3.

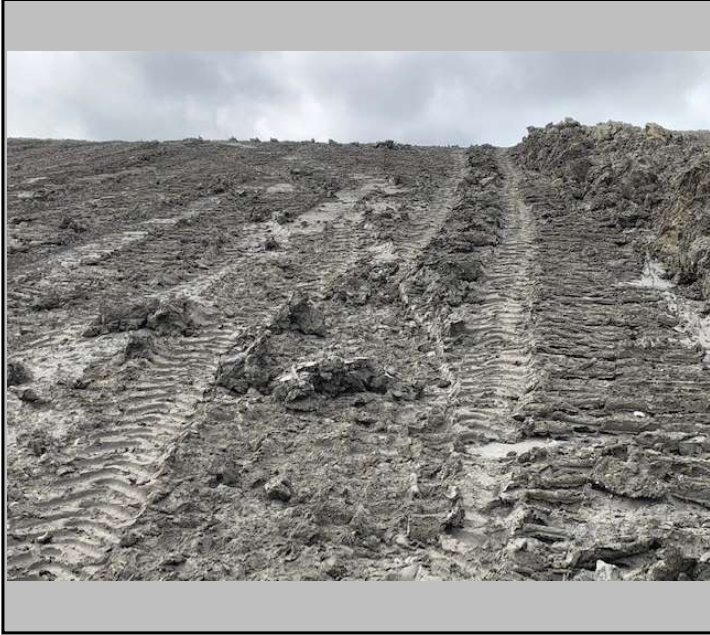
Photo #: 1

Results of packer making a pass at 10:00 am this morning after it rained.

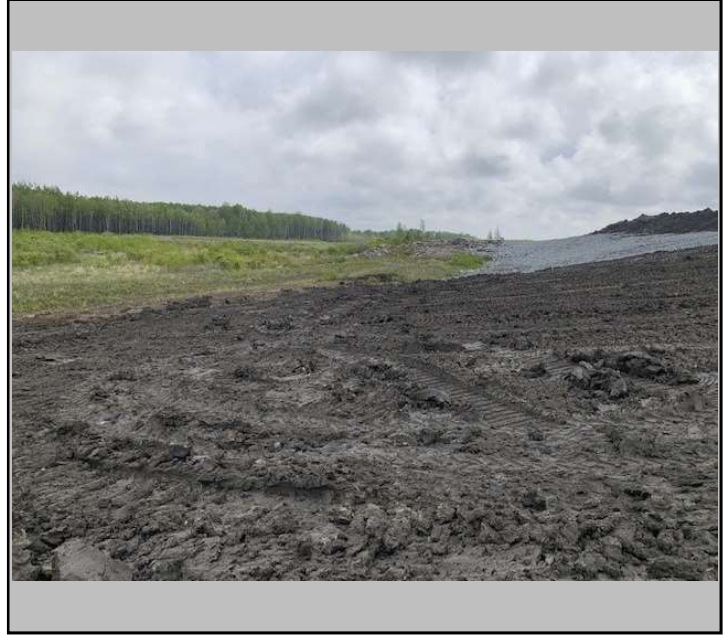
Photo #: 2

CCL L2 Panel 3 before compaction. Material was sticking to dozers and not grading well.

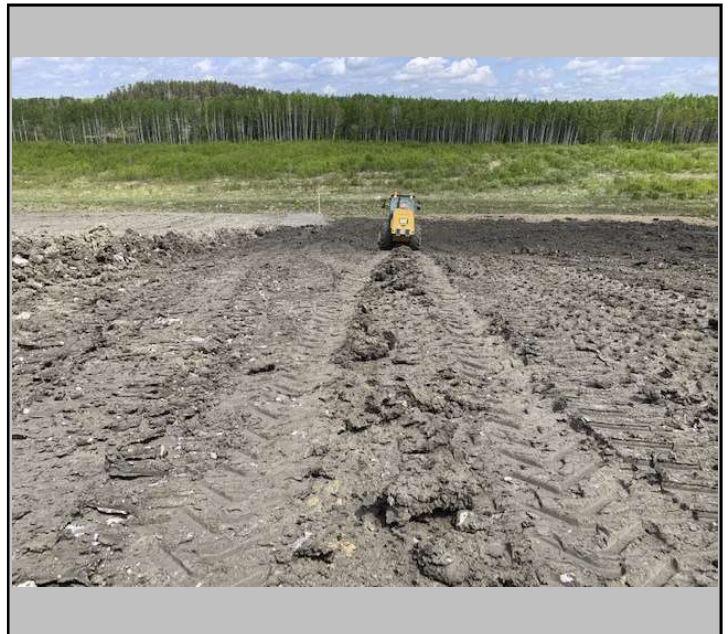
Photo #: 4

Packer attempting to compact CCL L2 material on Panel 3.

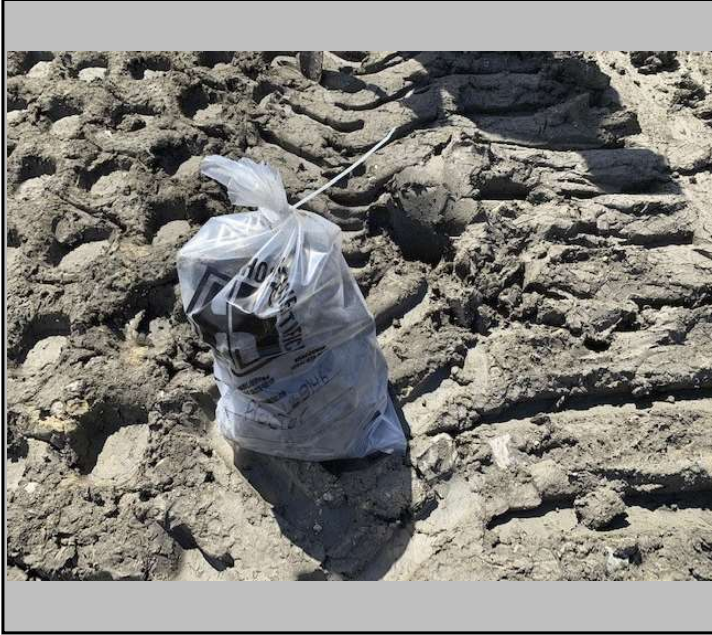
Photo #: 5

Sample EMRS21-L2-S146
Proctor

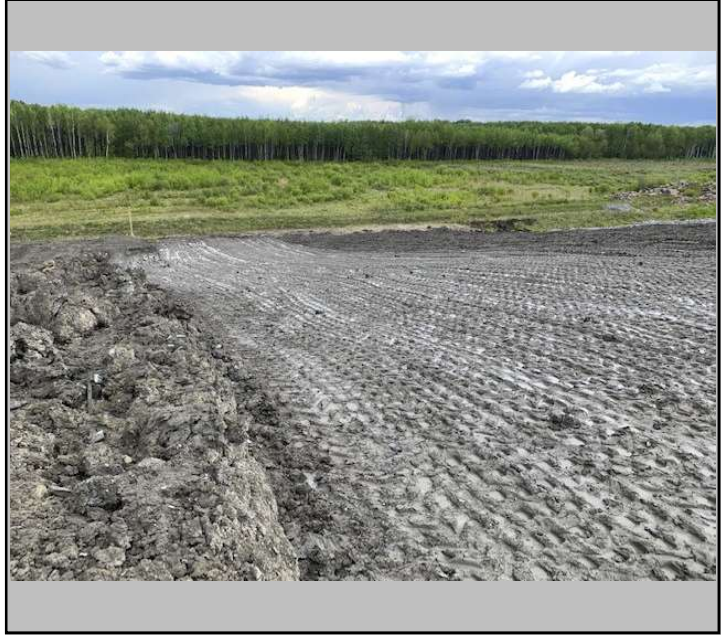
Photo #: 6

Panel 3 during rain delay at the end of the day.

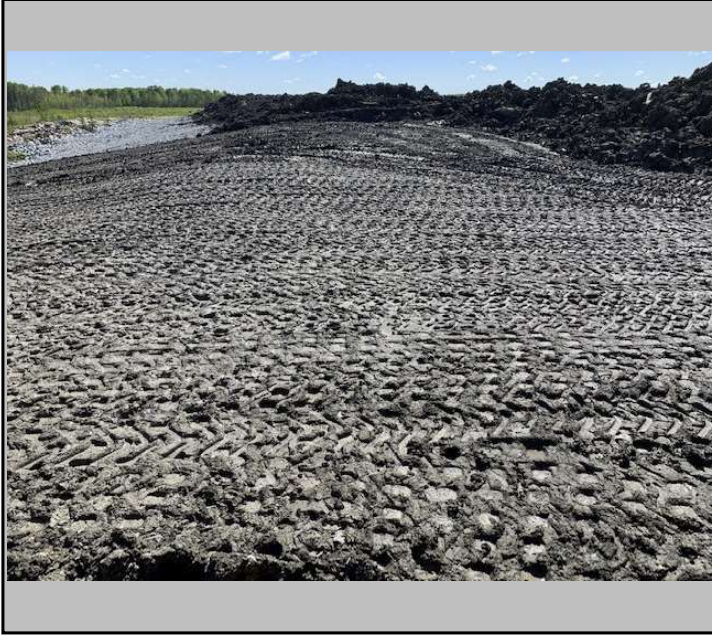
Photo #: 1

Panel 3, CCL Lift 2 this morning.

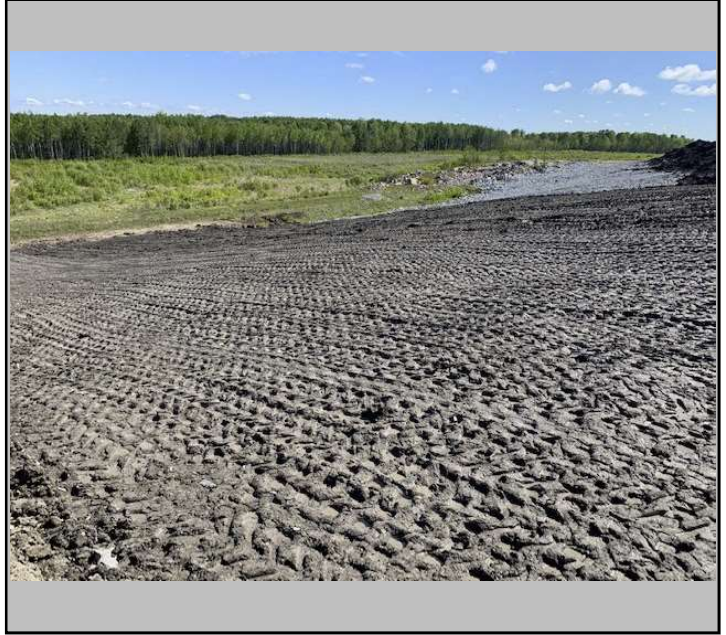
Photo #: 2

Panel 3, CCL Lift 2 this morning.

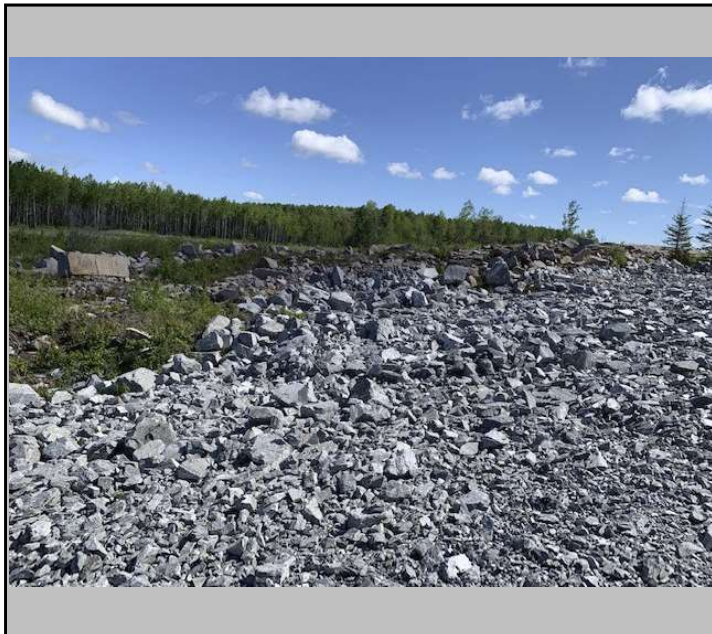
Photo #: 3

EMRS base surface at approximately STA 2+700 that will need to be cleaned up prior to CCL placement

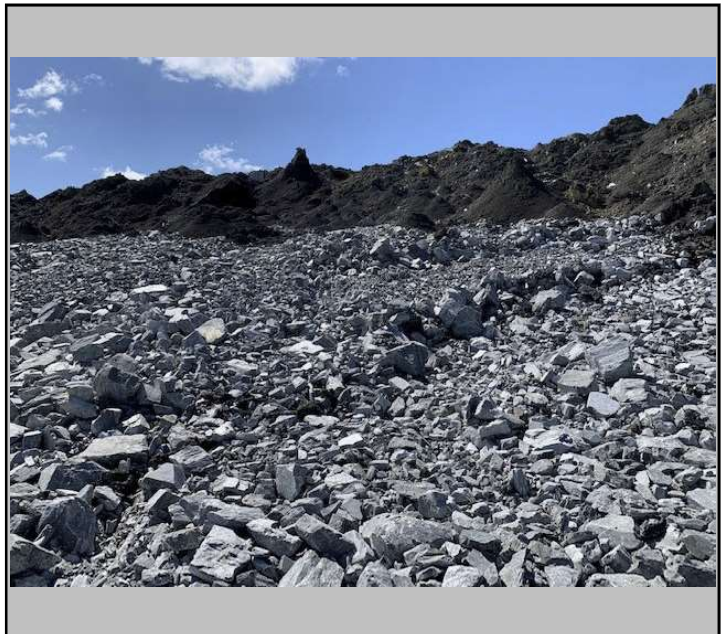
Photo #: 4

EMRS base surface at approximately STA 2+650 that will need to be cleaned up prior to CCL placement

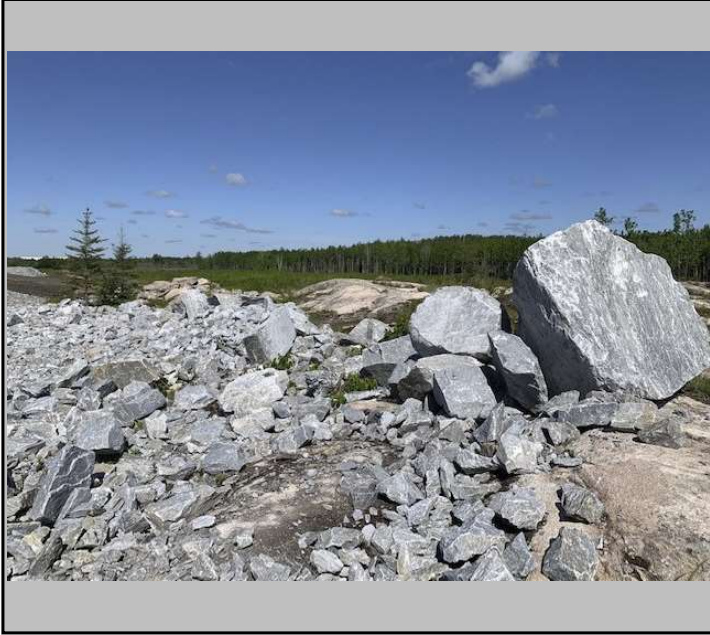
Photo #: 5

EMRS base surface at approximately STA 2+650 that will need to be cleaned up prior to CCL placement

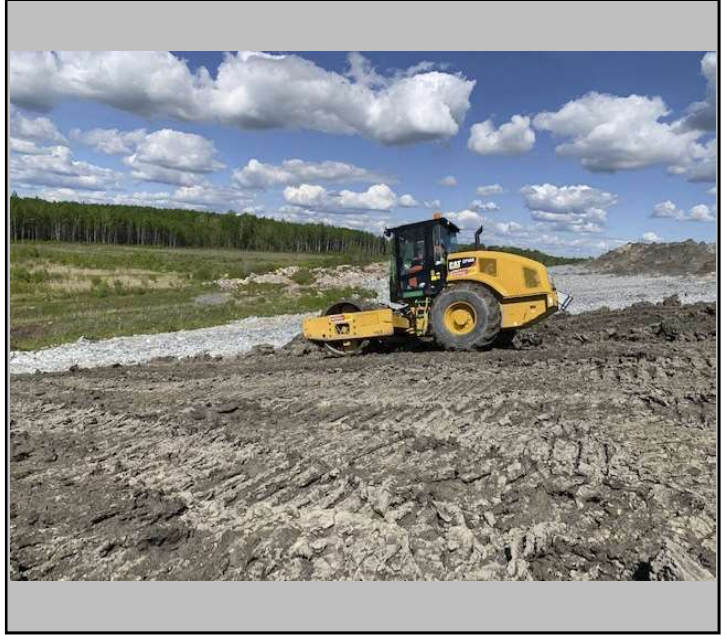
Photo #: 6

Packer attempting to pack CCL Lift 2 on Panel 3 this afternoon.

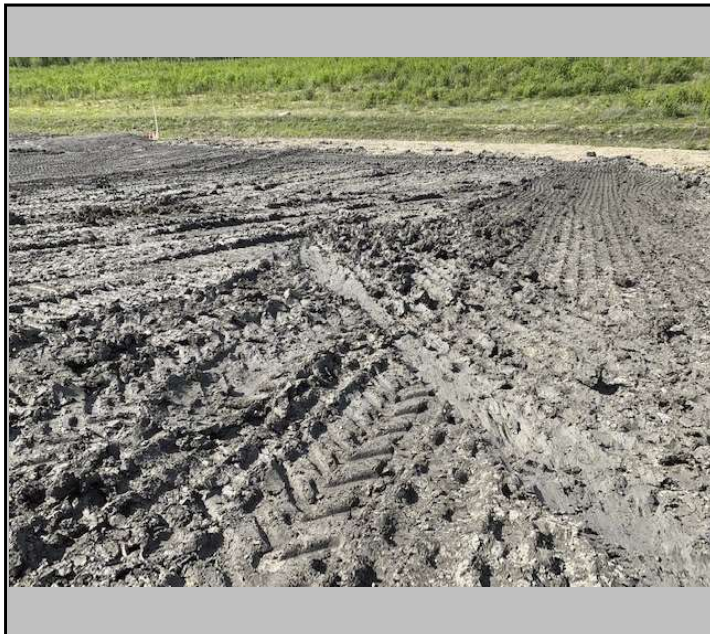
Photo #: 7

Marks from packer spinning while attempting to pack CCL Lift 2 on Panel 3 this afternoon.

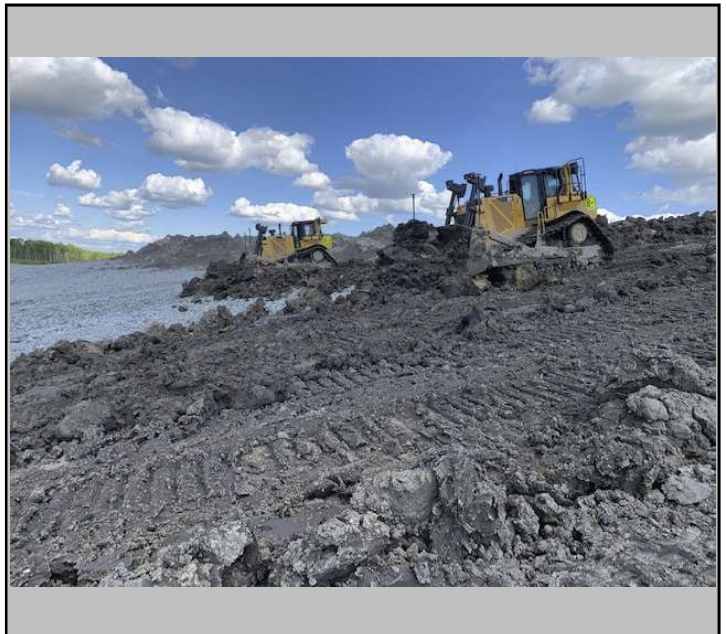
Photo #: 8

D8-1 and D8-1 pushing CCL Lift 1 on Panel 4.

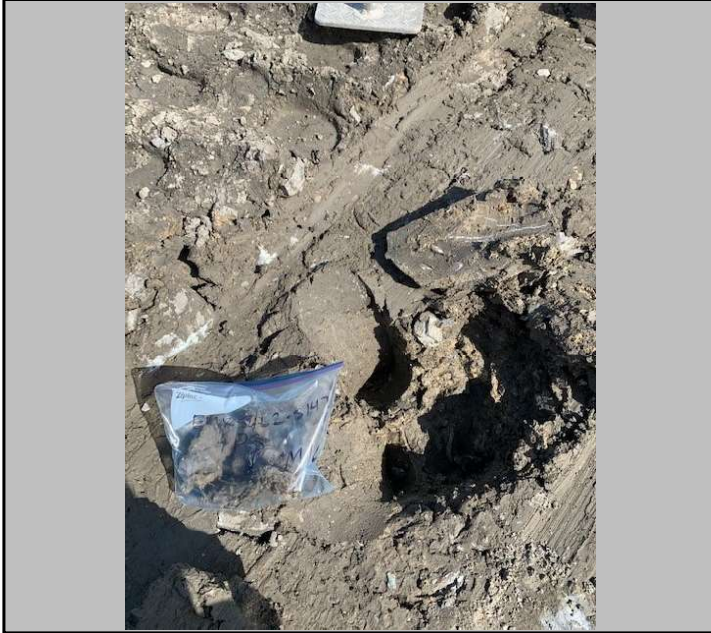
Photo #: 1

Location of Sample EMRS-L2-S147
Moisture Content.

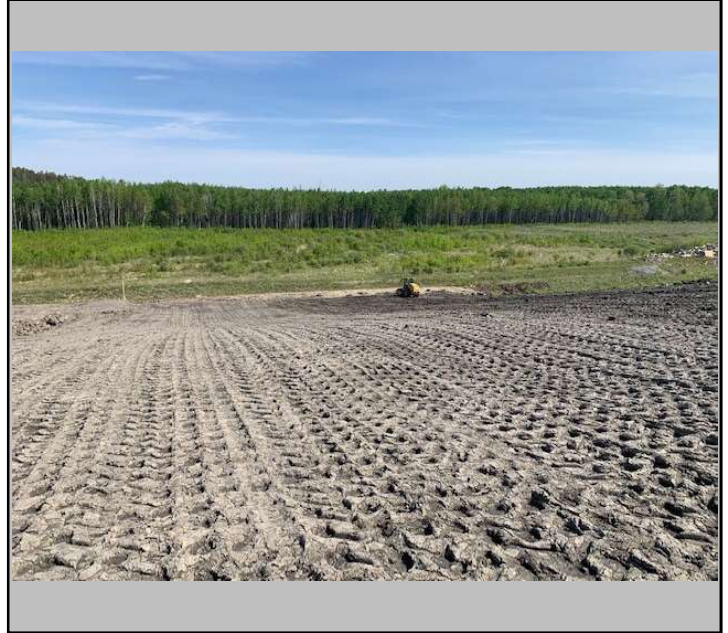
Photo #: 2

Packer packing CCL Lift 2 on Panel 3.

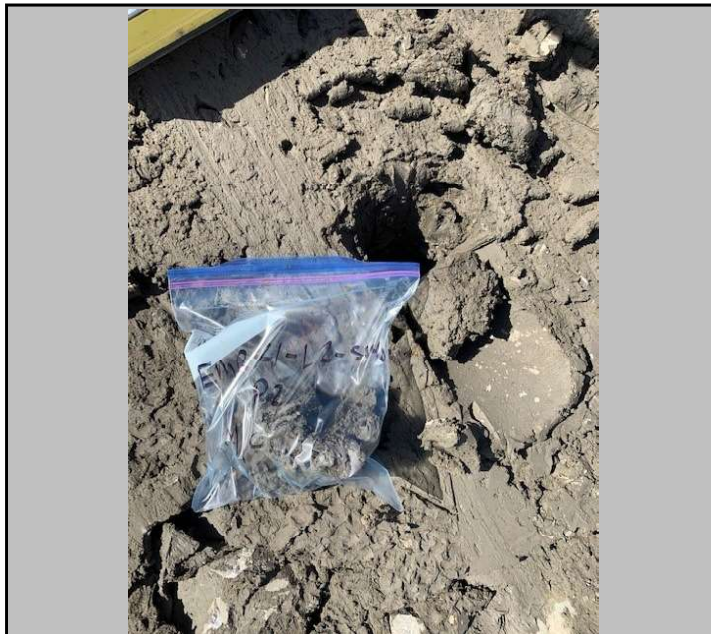
Photo #: 3

Location of Sample EMRS-L2-S148
Moisture Content.

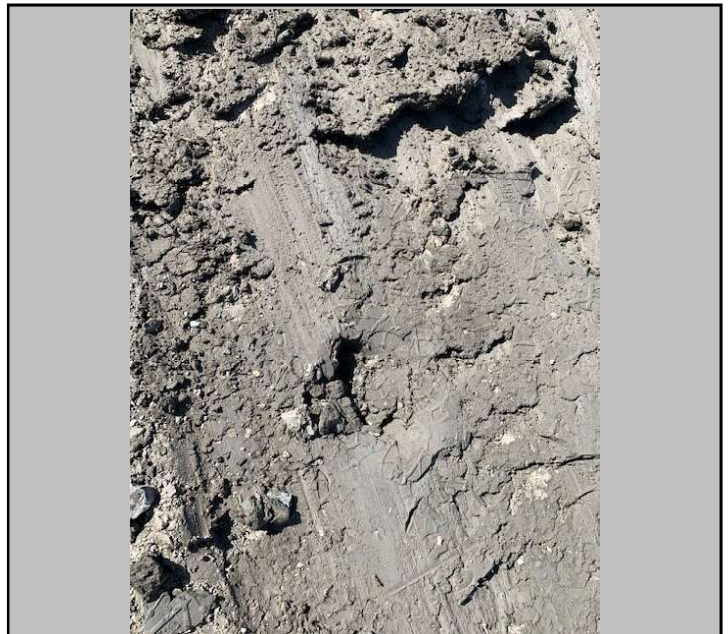
Photo #: 4

Location of Sample EMRS-L2-S149
Moisture Content, Atterberg, Hydrometer.

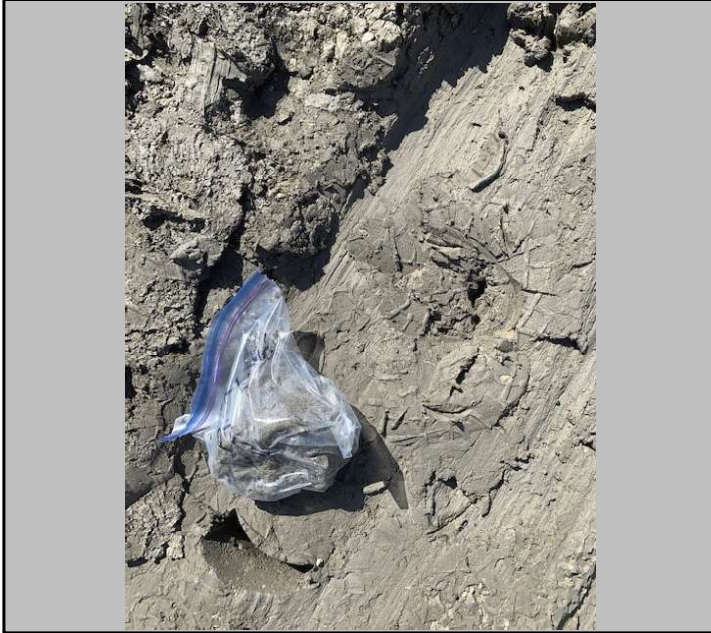
Photo #: 5

Location of Sample EMRS-L2-S150
Moisture Content.

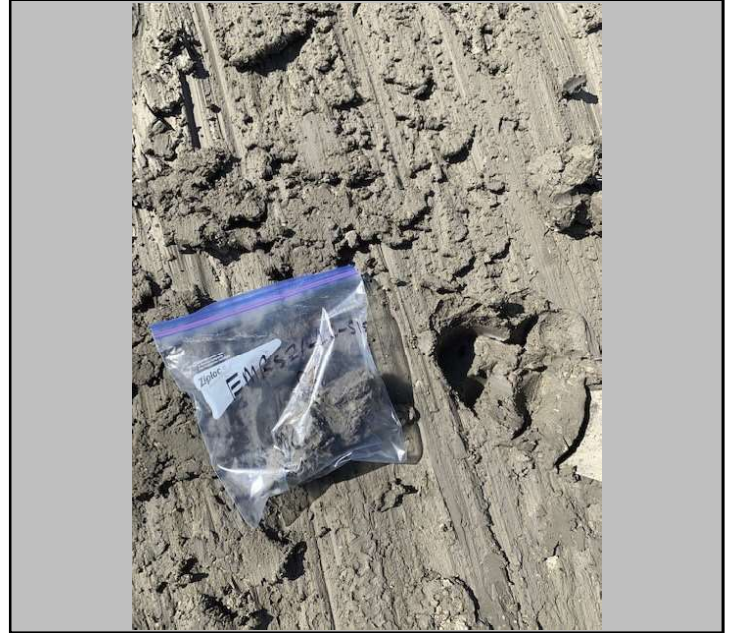
Photo #: 6

Location of Sample EMRS-L2-S151
Moisture Content.

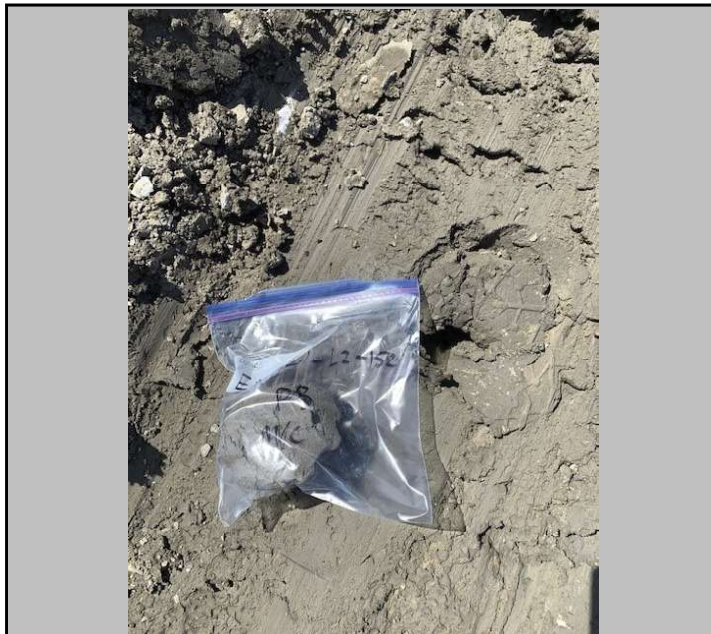
Photo #: 7

Location of Sample EMRS-L2-S152
Moisture Content.

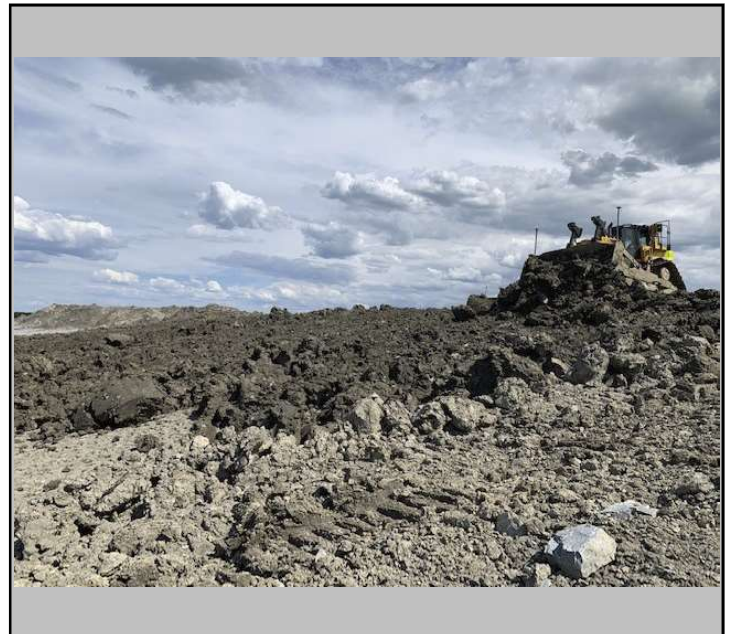
Photo #: 8

D8-1 dozer pushing NCL Lift 3 on Panel 3.
