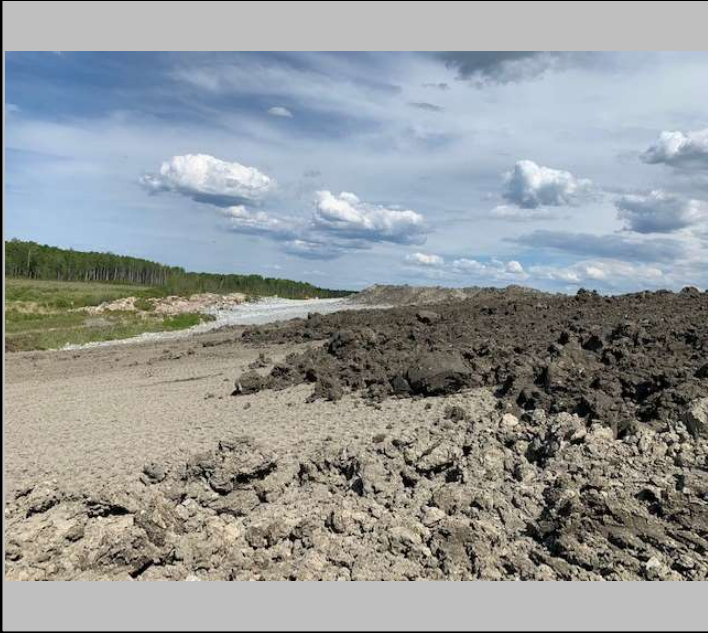
Photo #: 9

NCL Lift 3 material being placed on Panel 3.

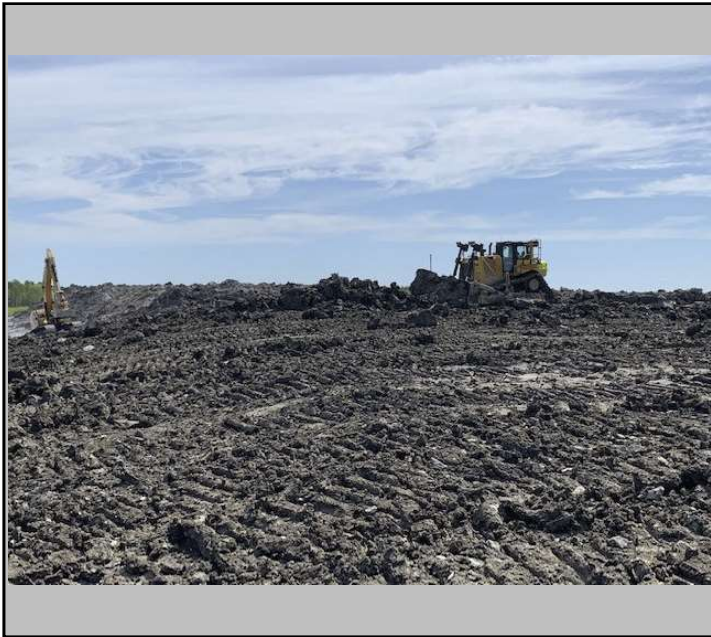
Photo #: 1

D8 dozer pushing NCL Lift 3 on Panel 3.

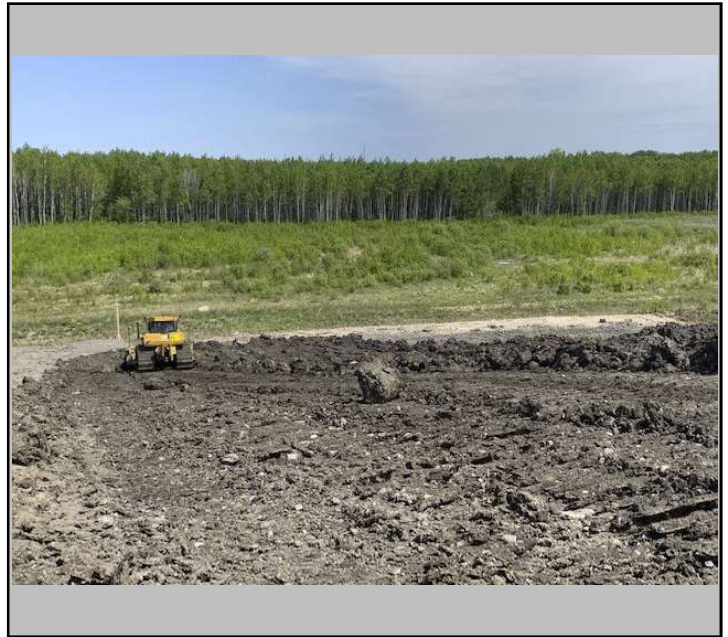
Photo #: 2

D8 dozer pushing NCL Lift 3 on Panel 3.

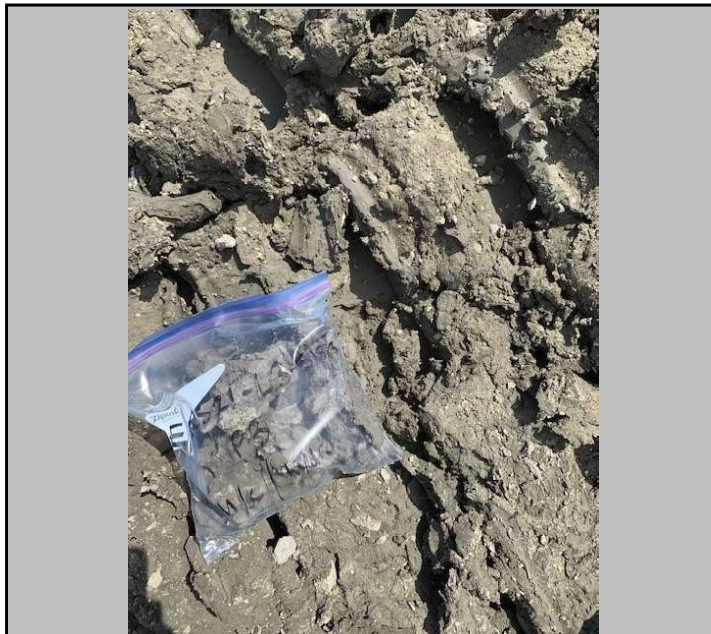
Photo #: 3

Location of sample EMRS21-L3-S153
Moisture and hydrometer

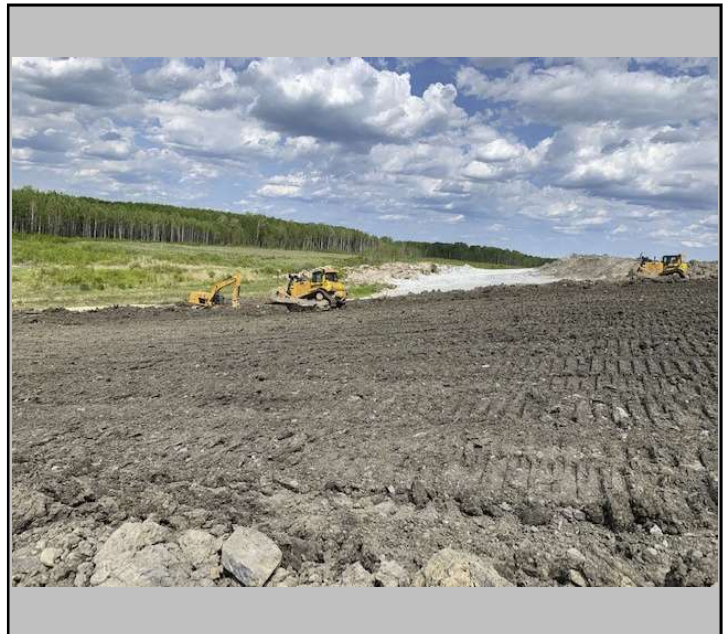
Photo #: 4

D8-1 dozer grading NCL Lift 3 on Panel 3 while
D8-2 dozer starts to grade CCL Lift 1 on Panel 4.

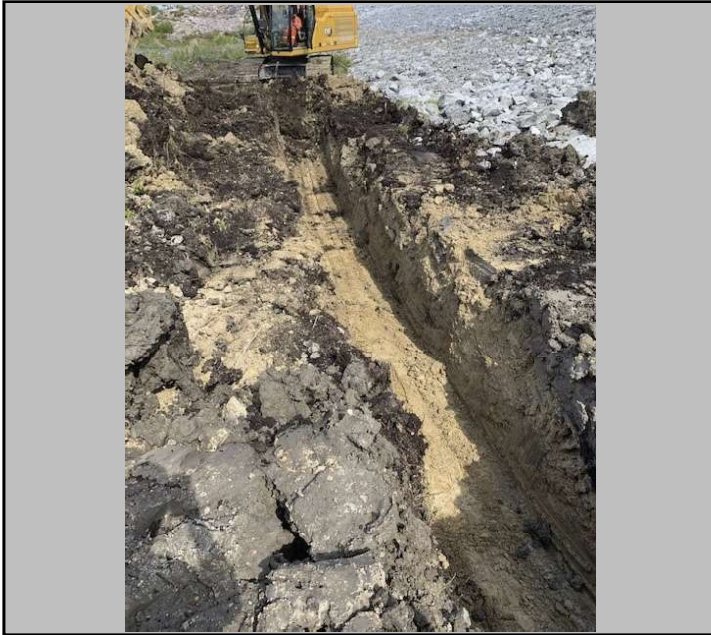
Photo #: 5

CAT 349 excavator excavating key trench for Panel 4 from STA 2+779 to 2+793

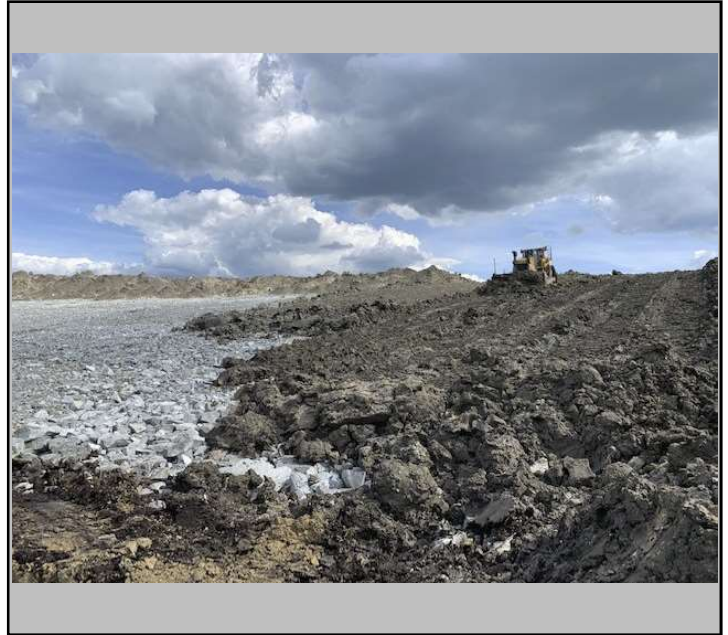
Photo #: 6

D8-2 dozer grading CCL Lift 1 on Panel 4.

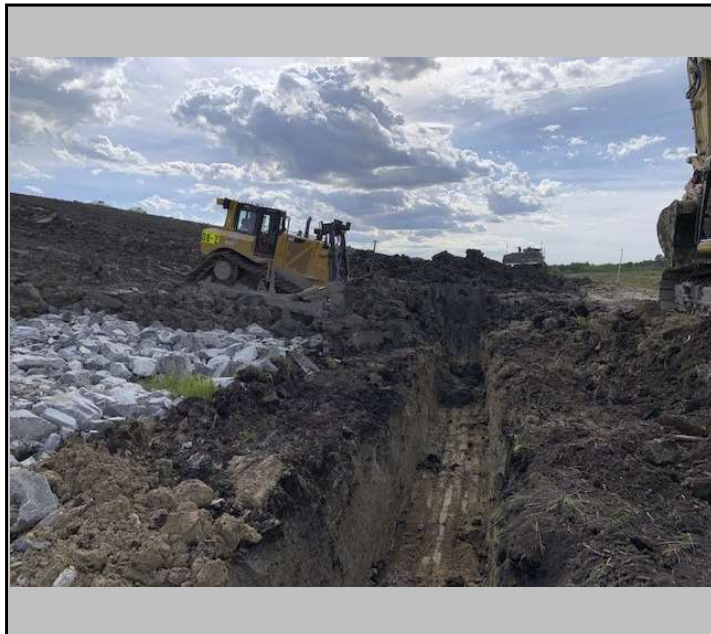
Photo #: 7

D8-2 dozer starting to fill in Key trench for Panel 4 at approximately STA 2+793.

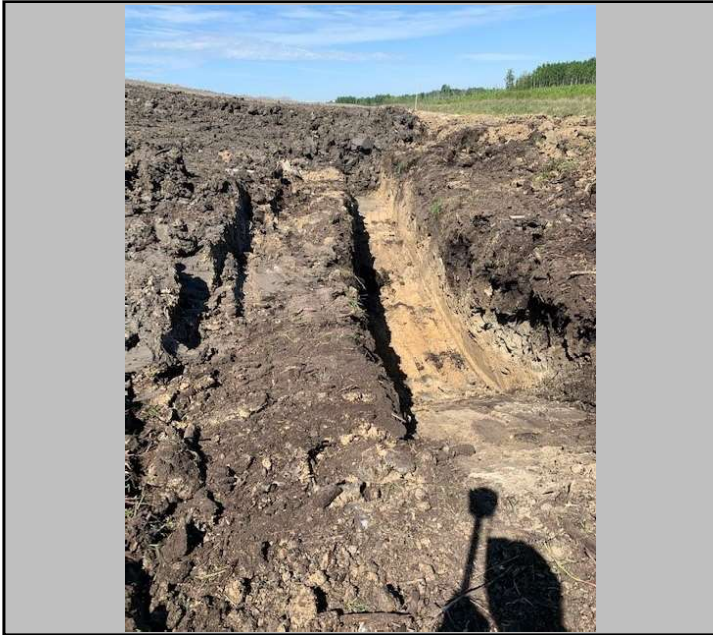
Photo #: 1

Key Trench for Panel 4 from STA 2+766 to 2+779.

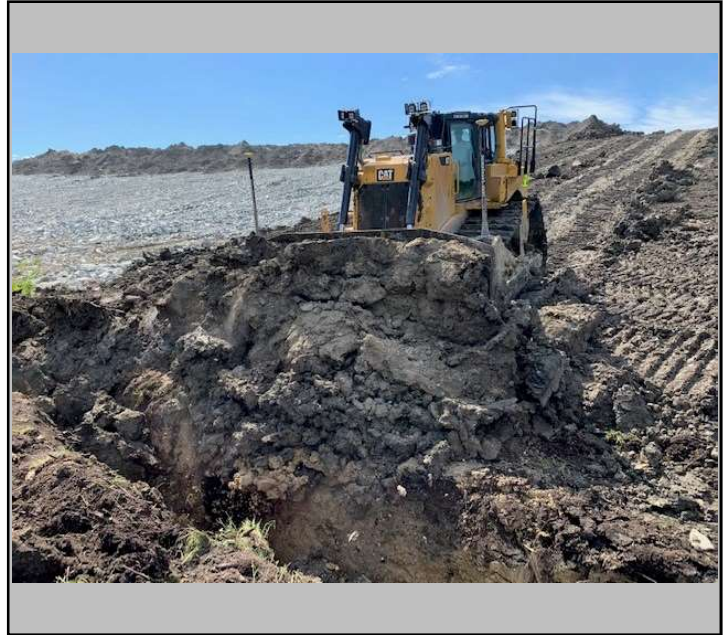
Photo #: 2

D8 dozer filling in Key trench at STA 2+766 to 2+779.

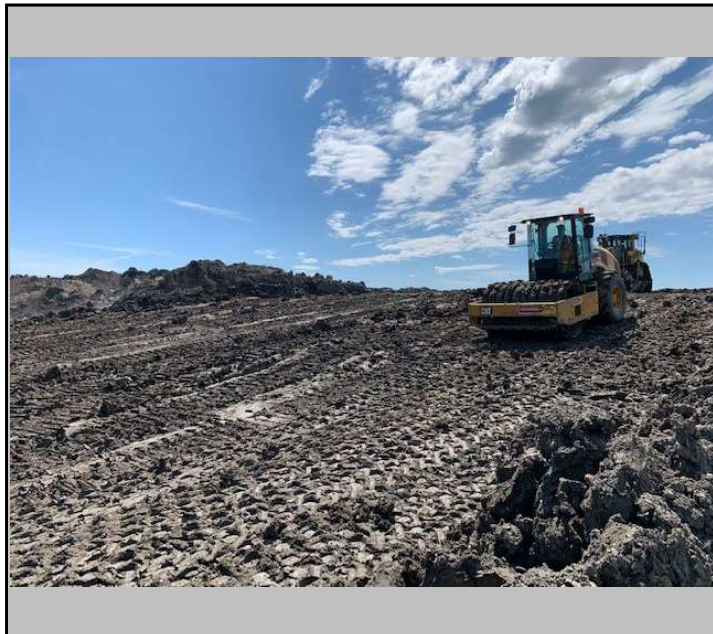
Photo #: 3

Packer packing CCL Lift 1 on Panel 4.

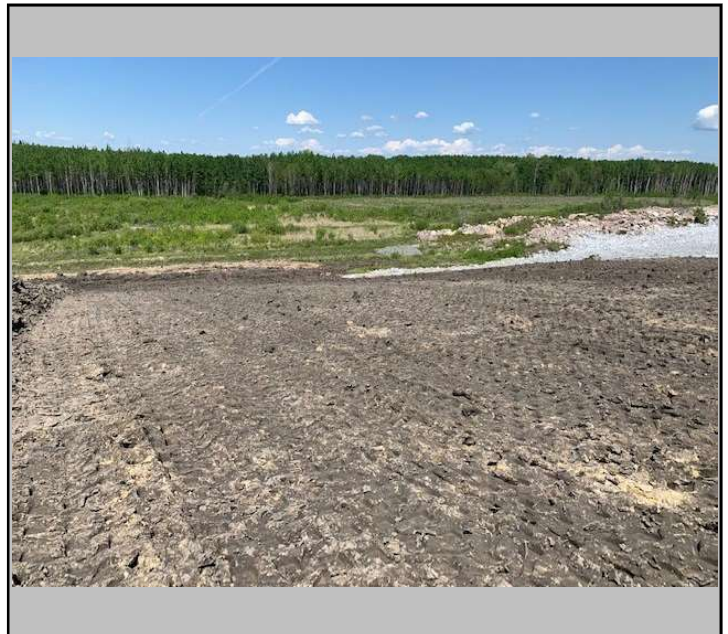
Photo #: 4

Completed CCL Lift 1 on Panel 4.

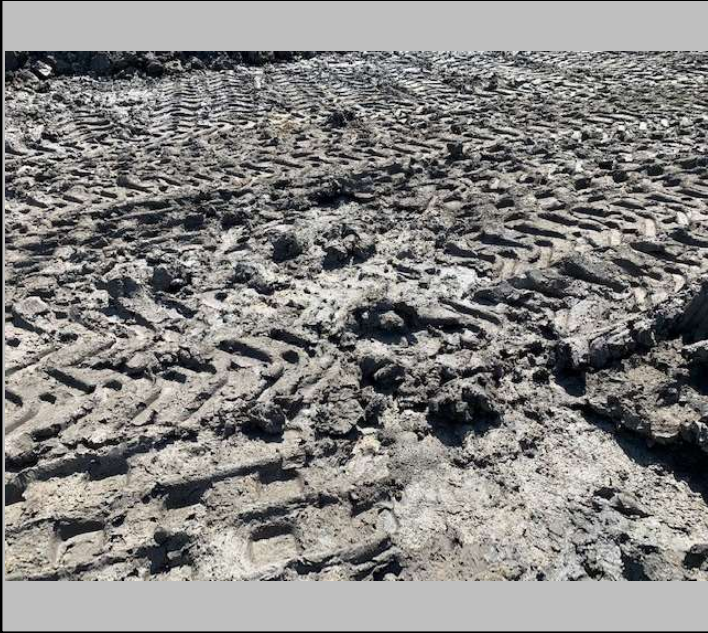
Photo #: 5

In field density tests were giving low compaction results but CQC and CQA felt like this had to do with the material having a higher moisture content.

Wet spot on top of CCL material on Panel 4.

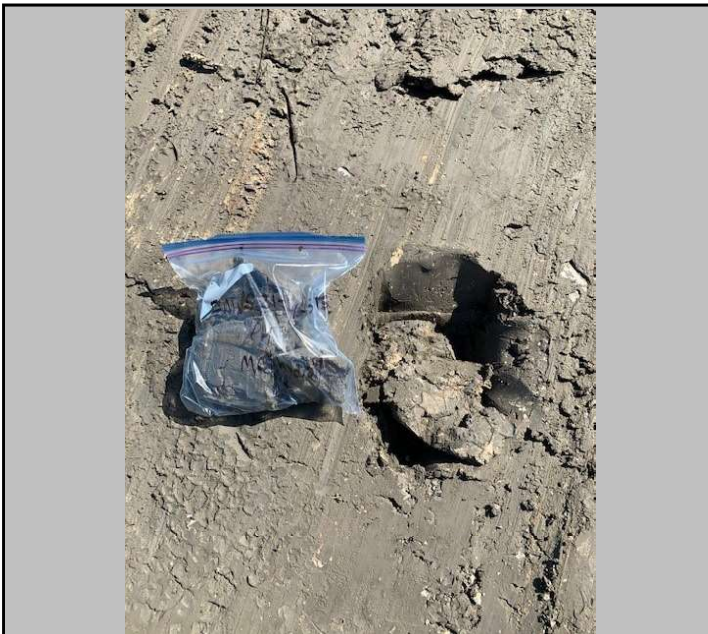
Photo #: 7

Sample EMRS21-L1-S155
Moisture content, Atterberg, and hydrometer.

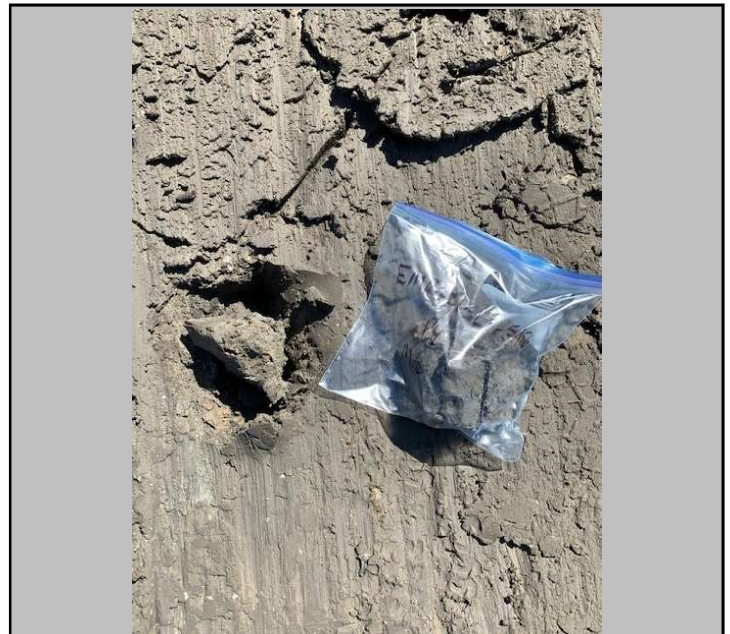
Photo #: 8

Sample EMRS21-L1-S156
Moisture content.

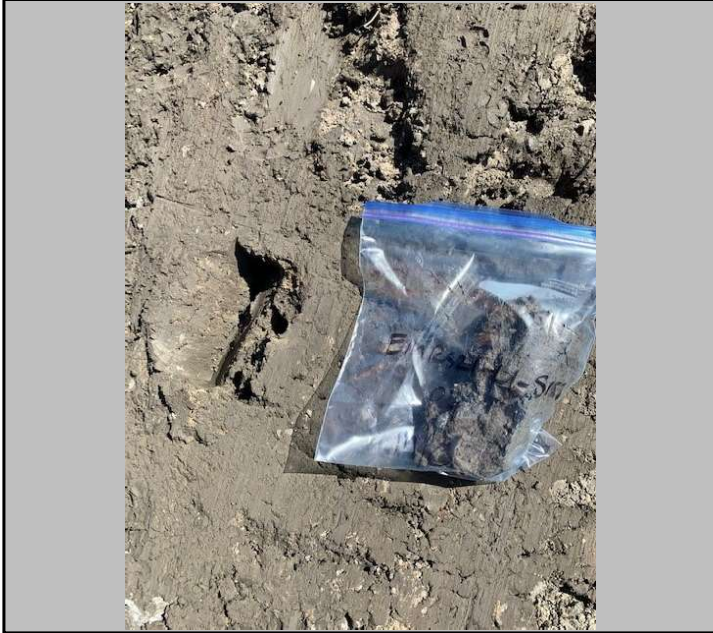
Photo #: 9

Sample EMRS21-L1-S157
Moisture content.

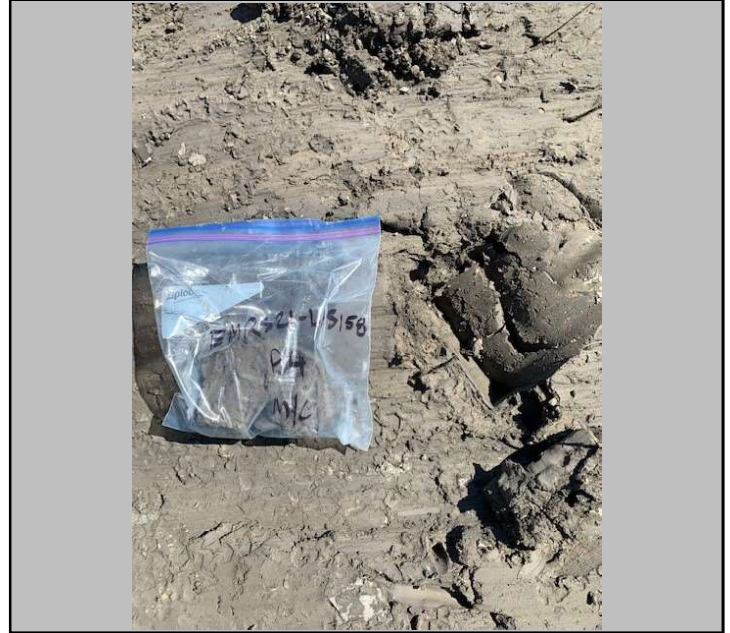
Photo #: 10

Sample EMRS21-L1-S158
Moisture content.

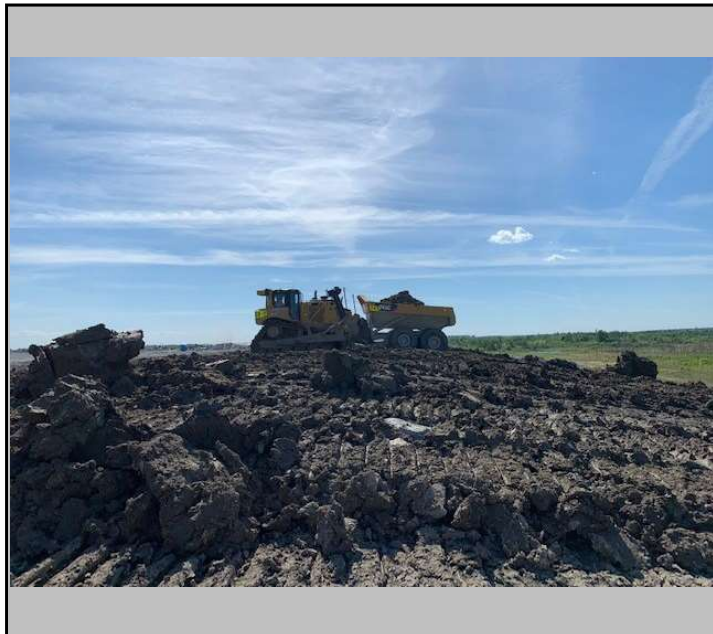
Photo #: 11

NGC wiggle dumping NCL Lift 4 material on slope of Panel 3.

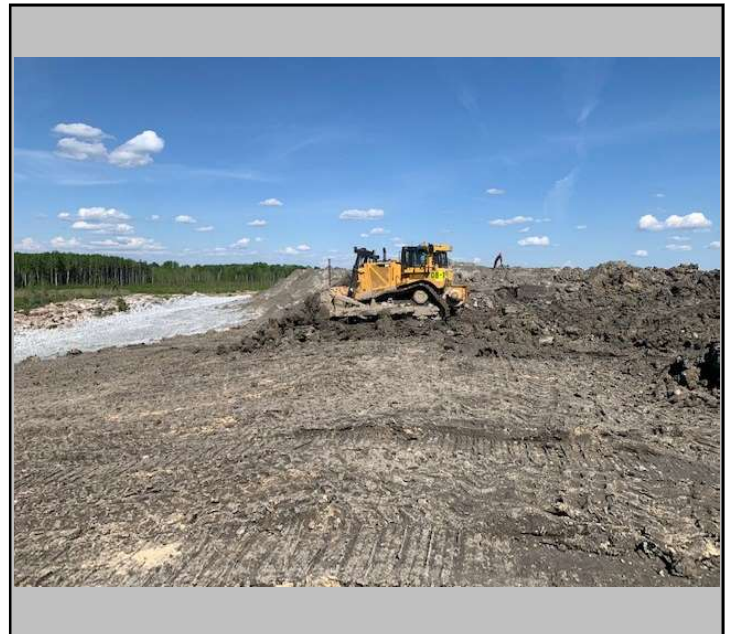
Photo #: 12

D8 dozer pushing CCL Lift 2 on Panel 4.

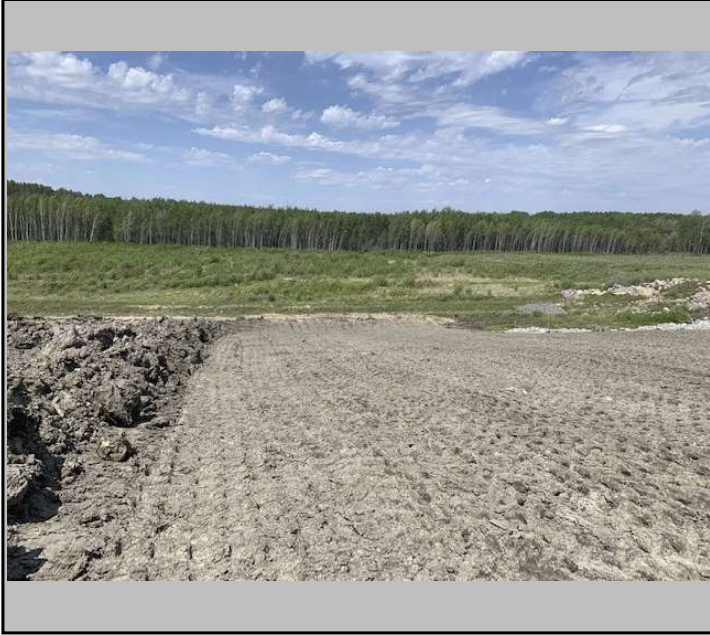
Photo #: 1

CCL Lift 2 on Panel 4.

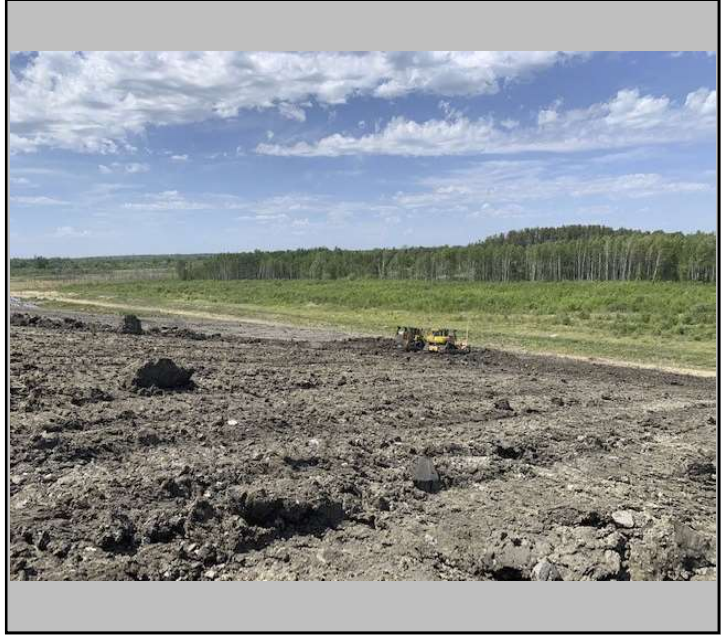
Photo #: 2

D8 dozers pushing and grading NCL Lift 4 on Panel 3.

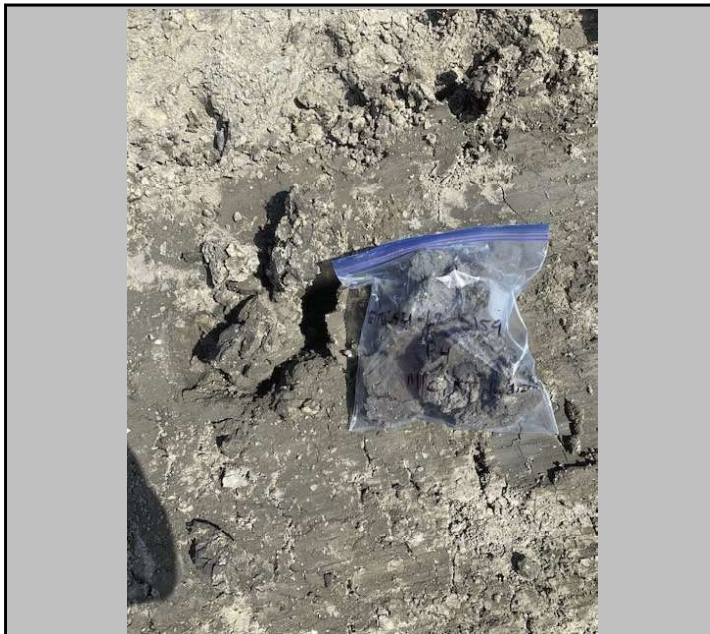
Photo #: 3

Location of sample EMRS21-L2-S159
Moisture content, Atterberg, and Hydrometer.

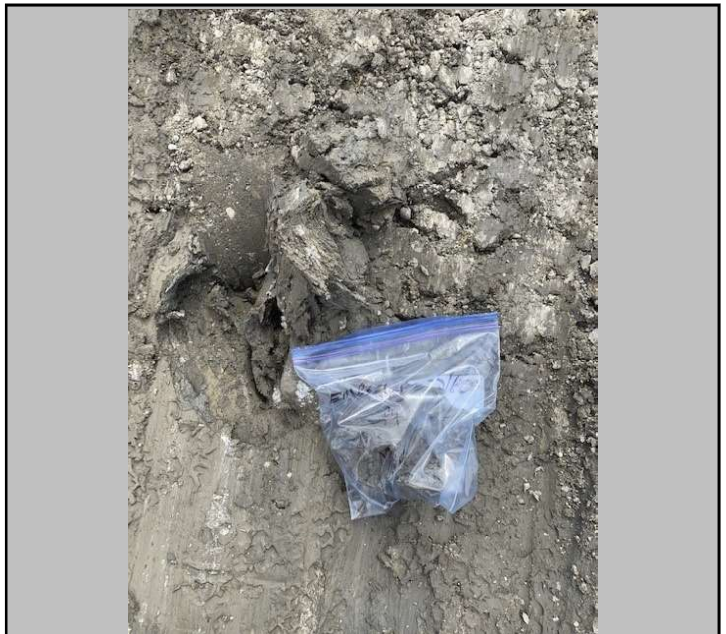
Photo #: 4

Location of sample EMRS21-L2-S160
Moisture content.

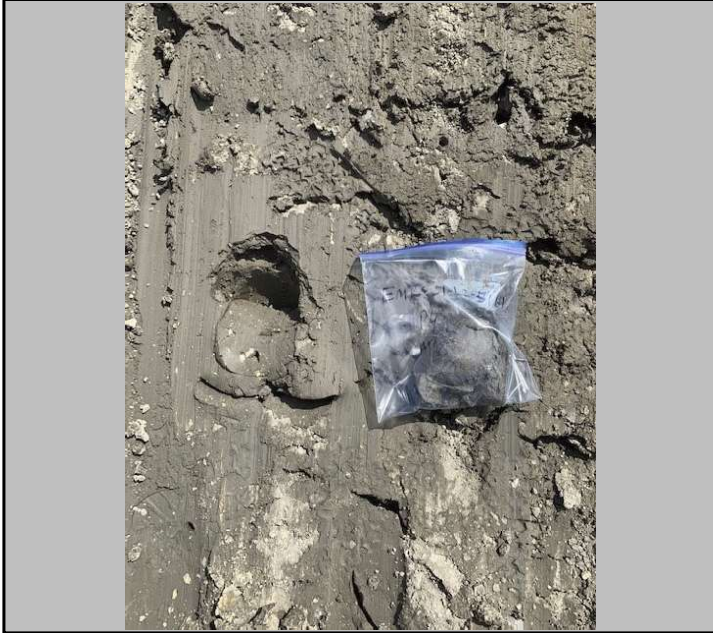
Photo #: 5

Location of sample EMRS21-L2-S161
Moisture content.

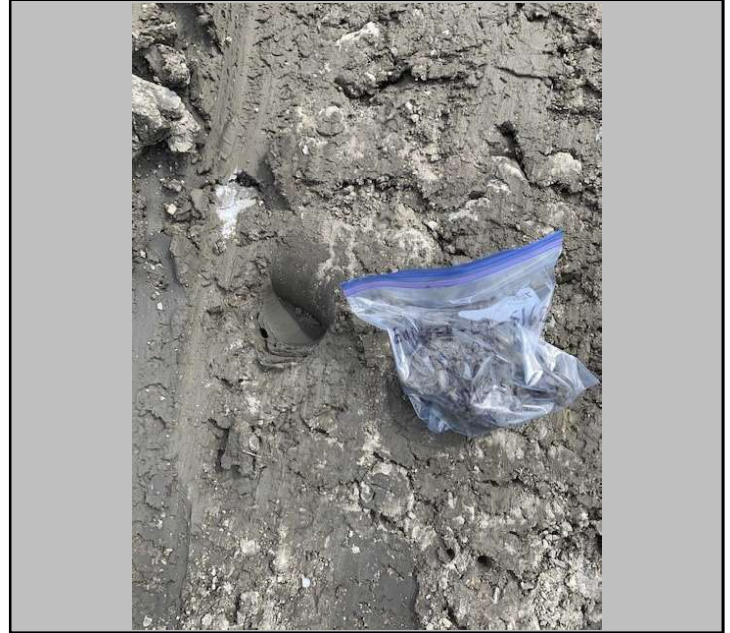
Photo #: 6

Location of sample EMRS21-L2-S162
Moisture content.

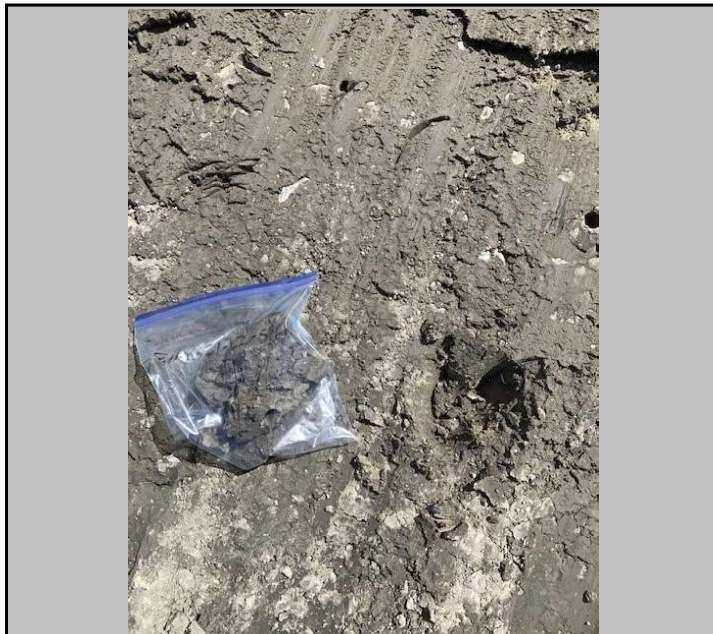
Photo #: 7

Location of sample EMRS21-L2-S163
Moisture content.

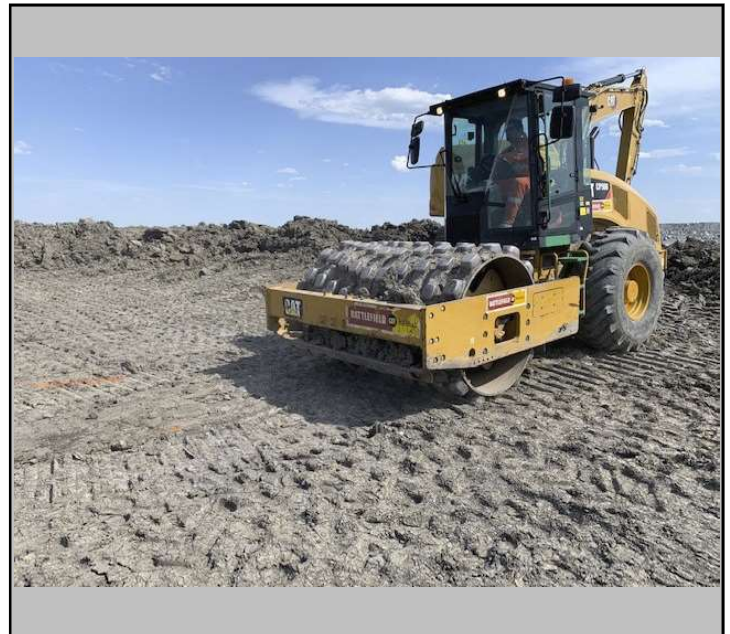
Photo #: 8

Completing a test strip on CCL Lift 2, Panel 4.

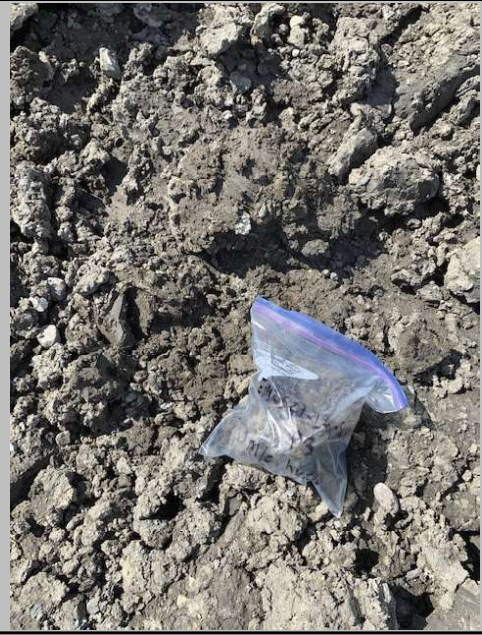
Photo #: 2

Location of sample EMRS21-L4-S164
Moisture content and hydrometer.

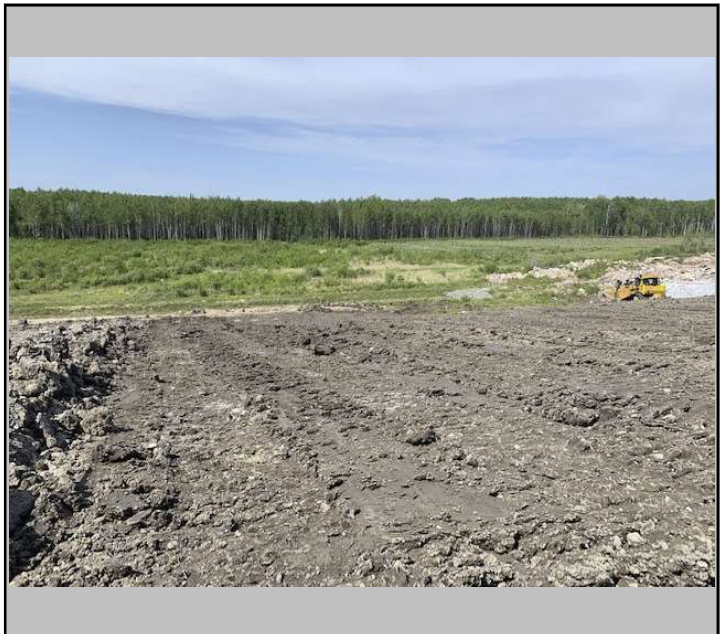
Photo #: 4

Finished Lift 3 on Panel 4.

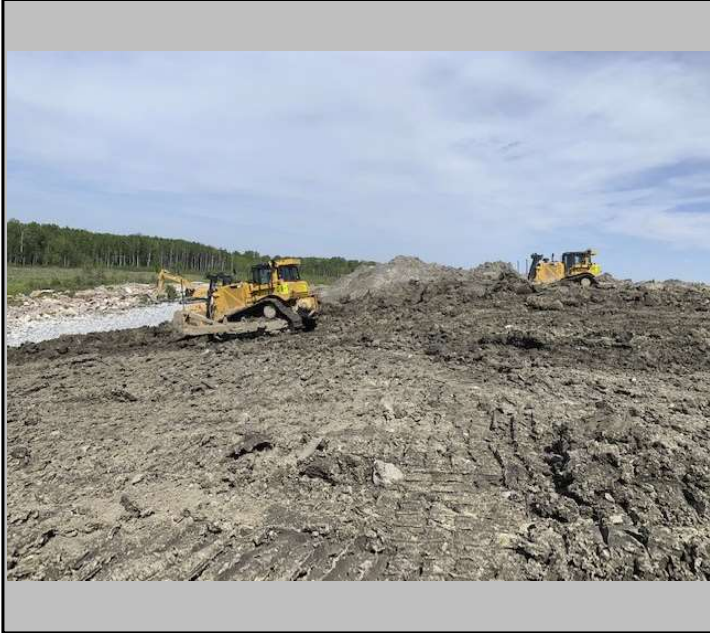
Photo #: 5

No CCL material placed today. CCL material that was bulk placed on Panel 5 was dark brown and seemed like adequate CCL material but visually had a higher moisture content with junks of frozen material mixed in.

D8 dozers bulk placing CCL Lift 1 on Panel 5.

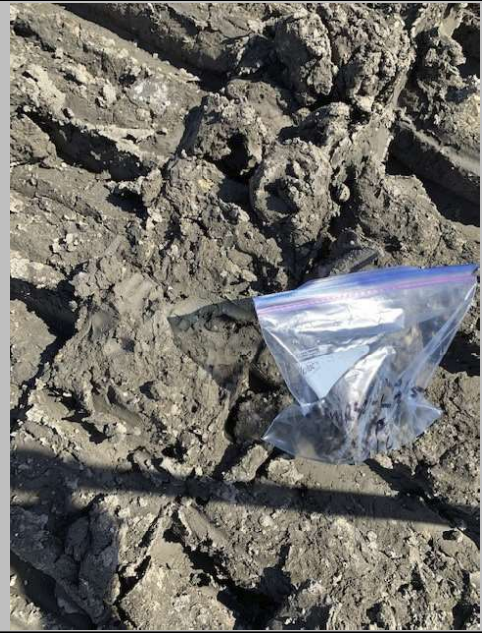
Photo #: 6

Location of sample EMRS21-L3-S165,
Moisture content.

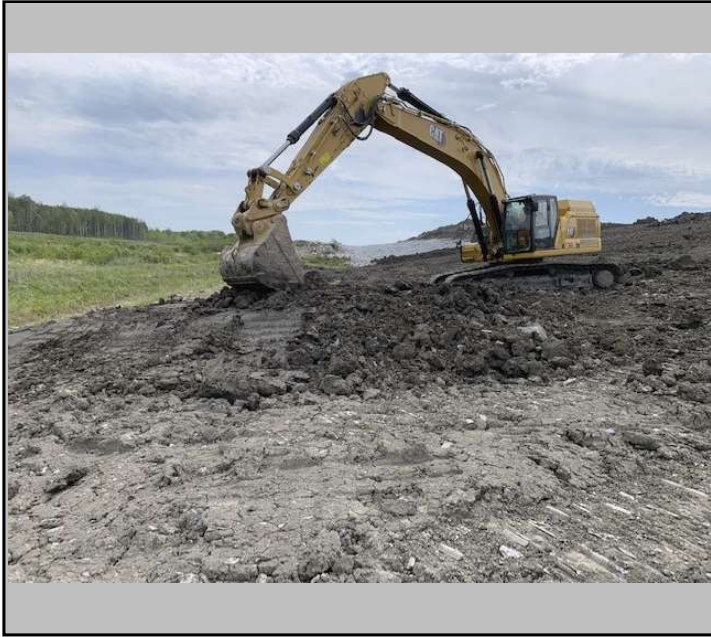
Photo #: 1

NGC CAT349 excavator working to place more cover material on burrito in P3.

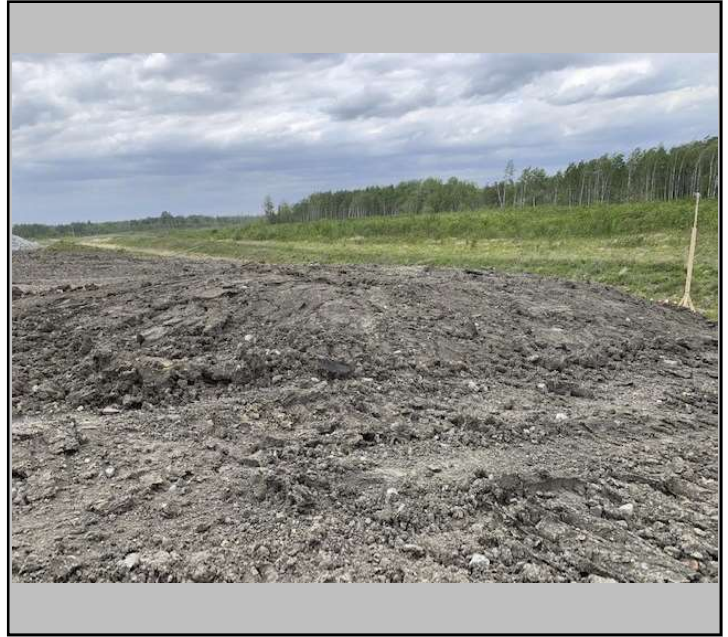
Photo #: 2

Burrito in P3 after more cover material was added and bucket packed.

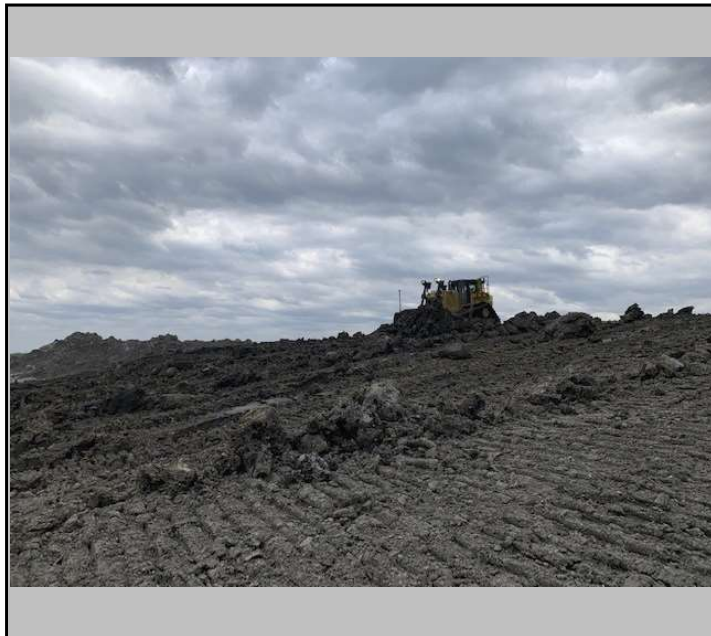
Photo #: 3

D8 dozer pushing NCL Lift 4 material on Panel 4.

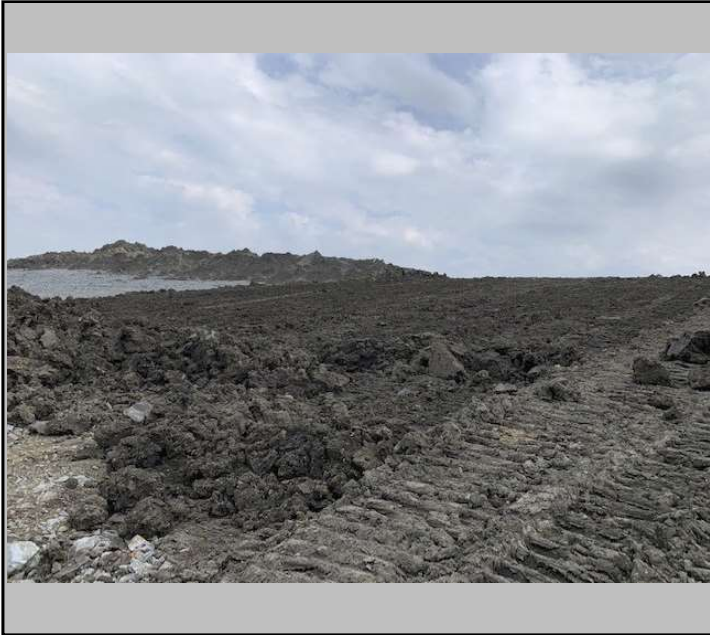
Photo #: 5

CCL material was dark brown with light brown spots mixed in. Material was pliable and could be rolled out to form a ribbon in your hands. Visually the material seemed to have a low abundance of large rocks mixed in. Even though material was bulk placed yesterday to dry out it still visually had a high moisture content today.

CCL Lift 1 material on placed on Panel 5.

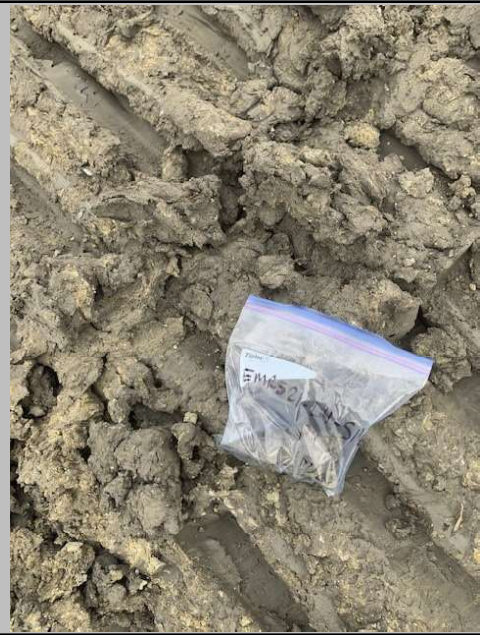
Photo #: 6

Location of sample EMRS21-L4-S165,
moisture content.

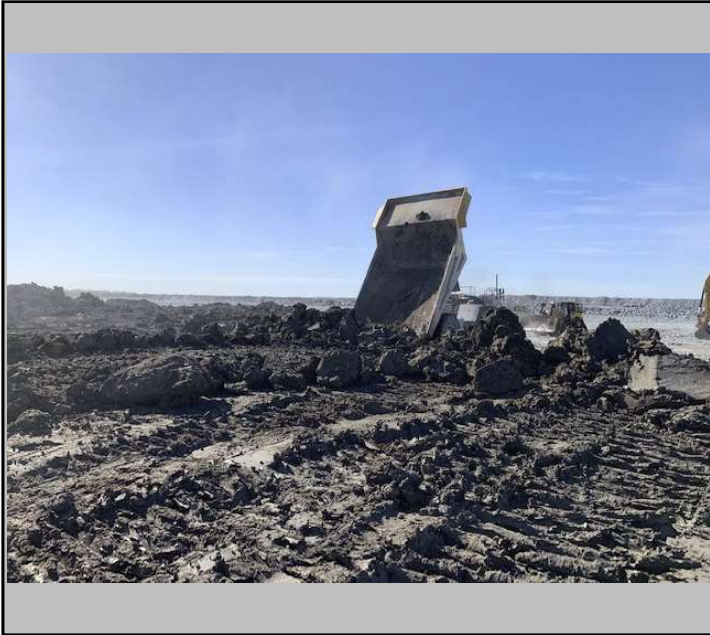
Photo #: 1

NGC 100 ton truck delivering material.

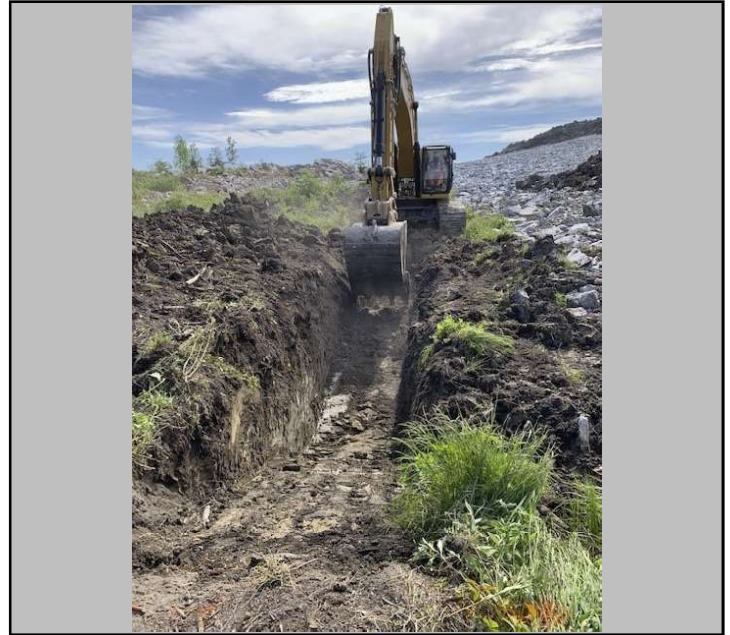
Photo #: 2

CAT349 excavator excavating key trench for Panel 5.

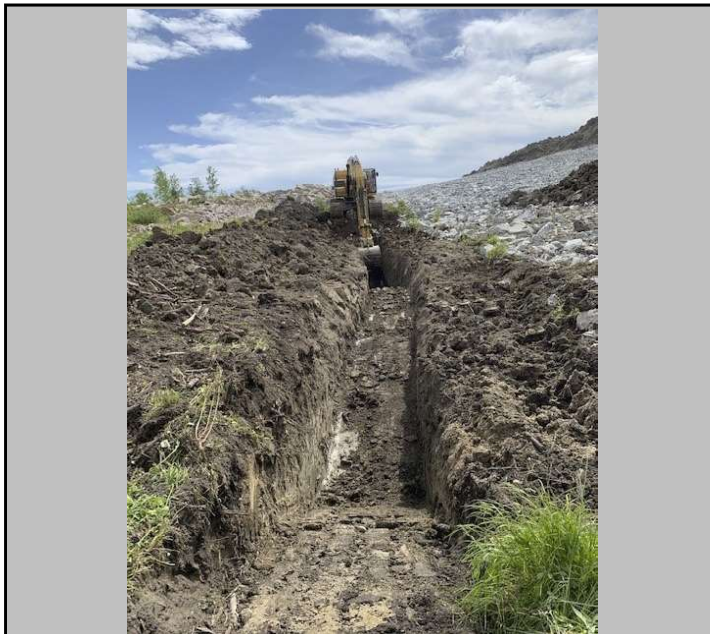
Photo #: 3

Key trench excavated from

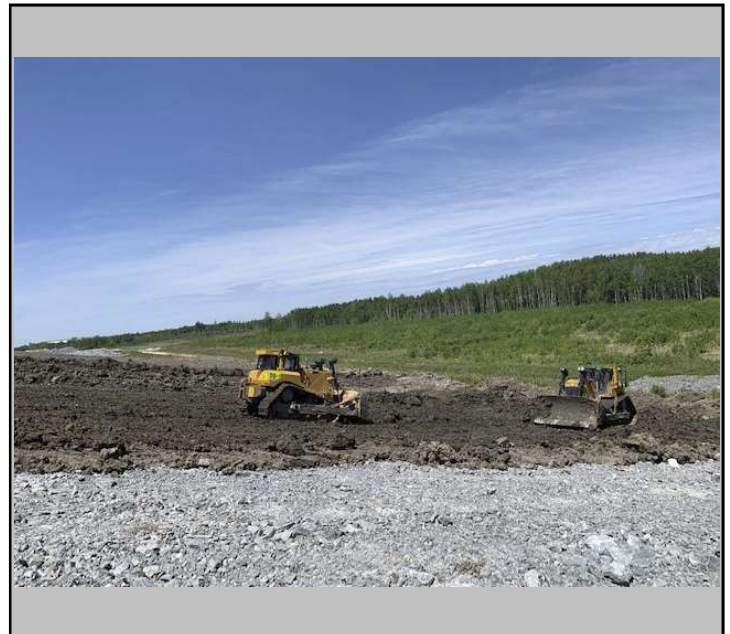
Photo #: 4

D8 dozers grading NCL Lift 4 on Panel 4.

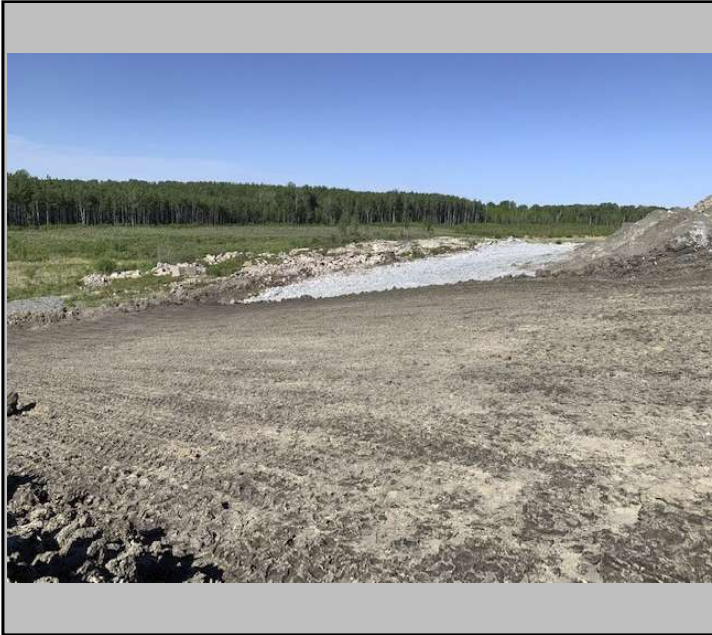
Photo #: 5

CCL material was dark brown with light brown spots mixed in. Material was pliable and could be rolled out to form a ribbon in your hands. Visually the material seemed to have a low abundance of large rocks mixed in. Material visually had a higher moisture content but will have time to dry out more over night.

Finished CCL Lift 1 on Panel 5 ready for approval.

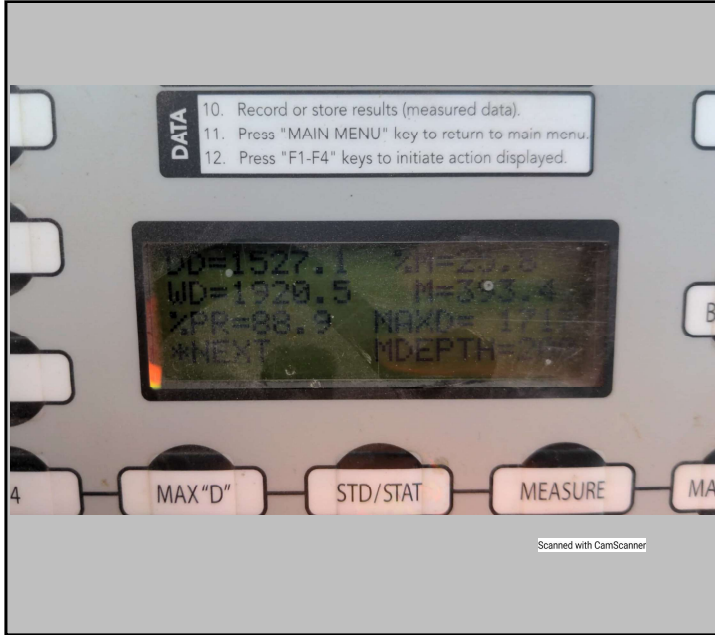
Photo #: 1

EMRS21-L1-D56.

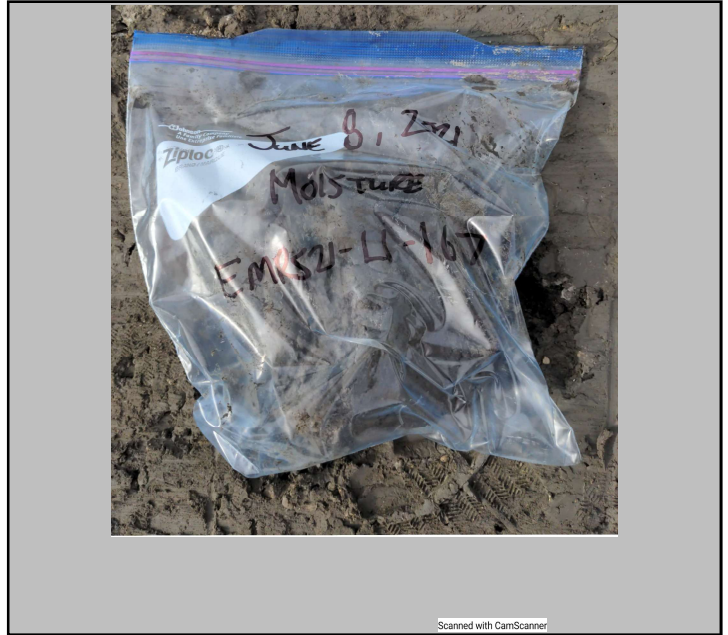
Photo #: 2

EMRS21-L1-S167.

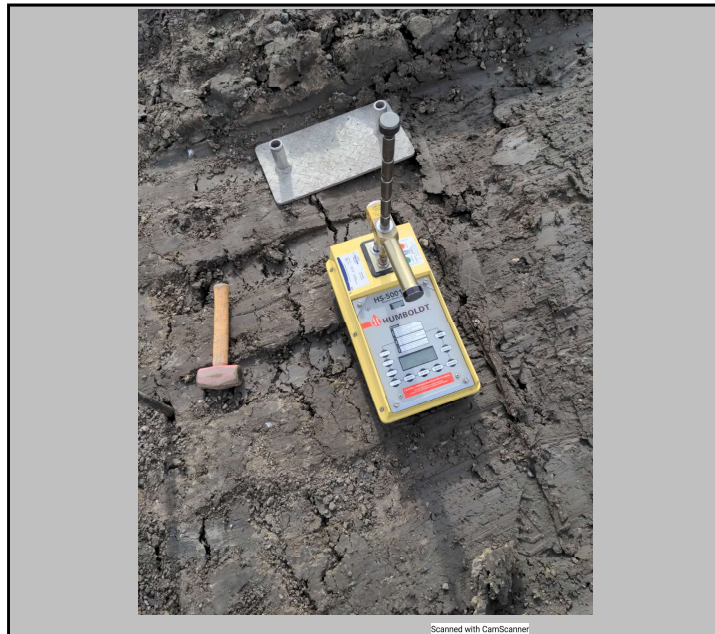
Photo #: 3

EMRS21-L1-D57.

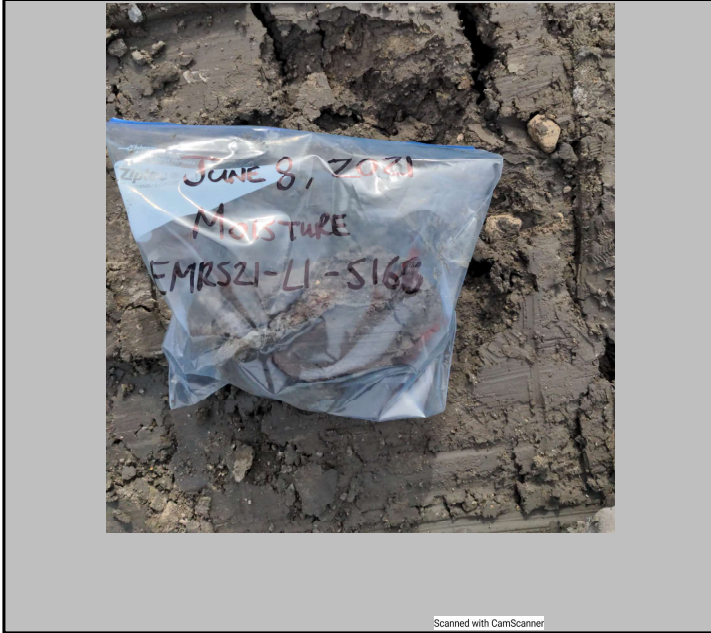
Photo #: 5

EMRS21-L1-S168.

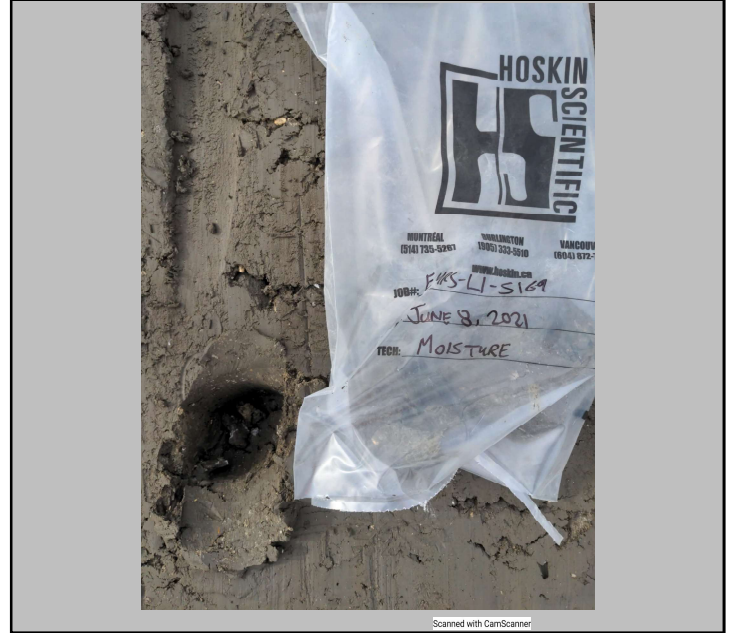
Photo #: 6

EMRS21-L1-S169.

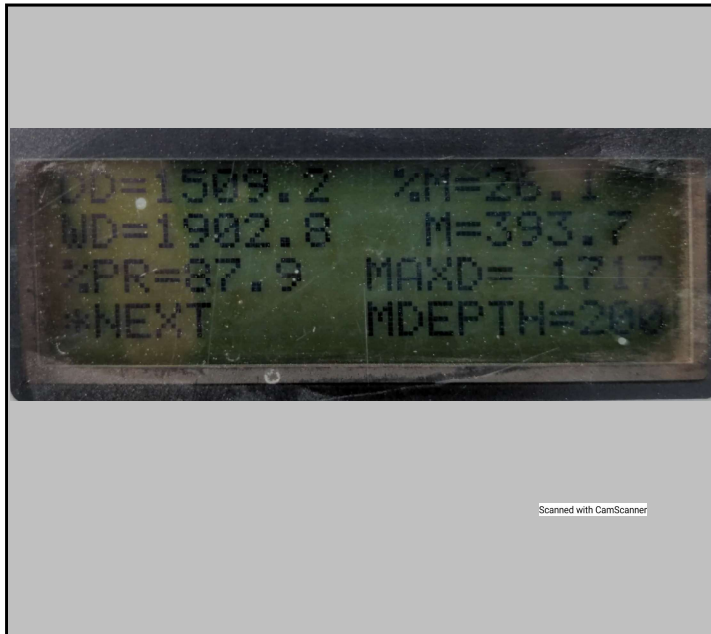
Photo #: 7

EMRS21-L1-D59.

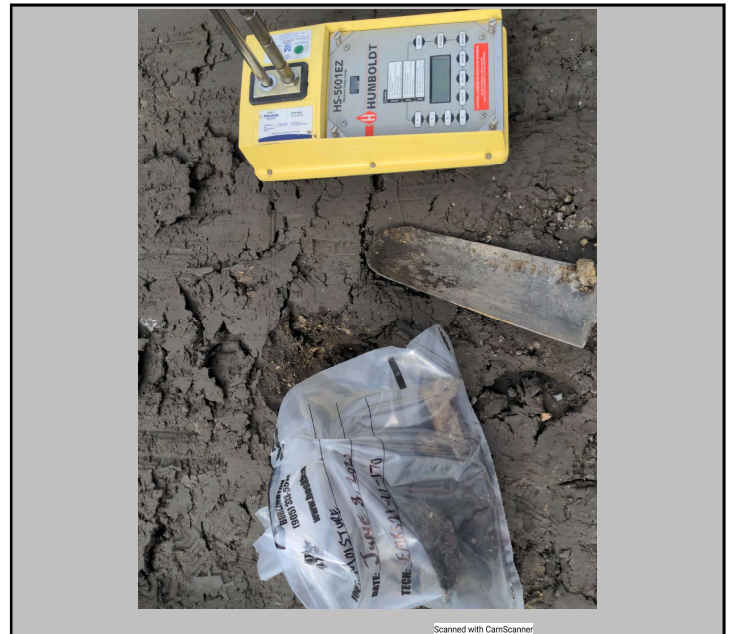
Photo #: 8

EMRS21-L1-S170.

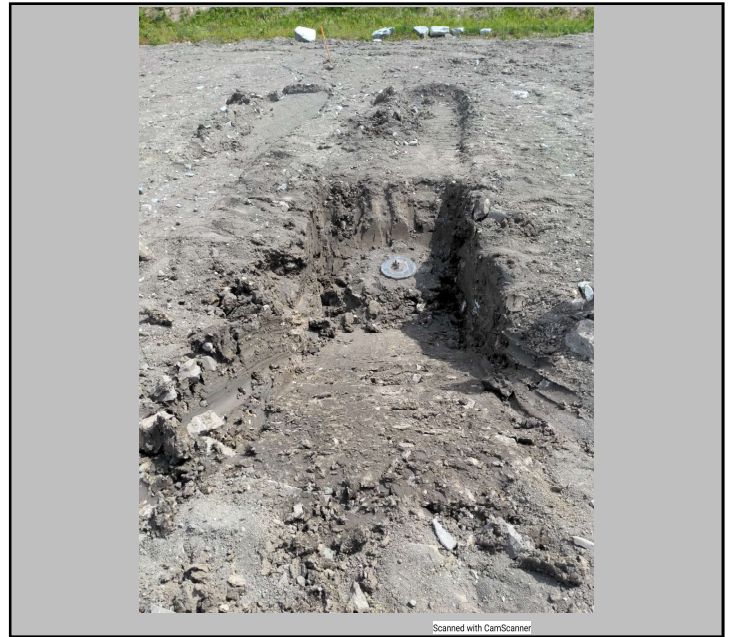
Photo #: 10

Okane test pit.
