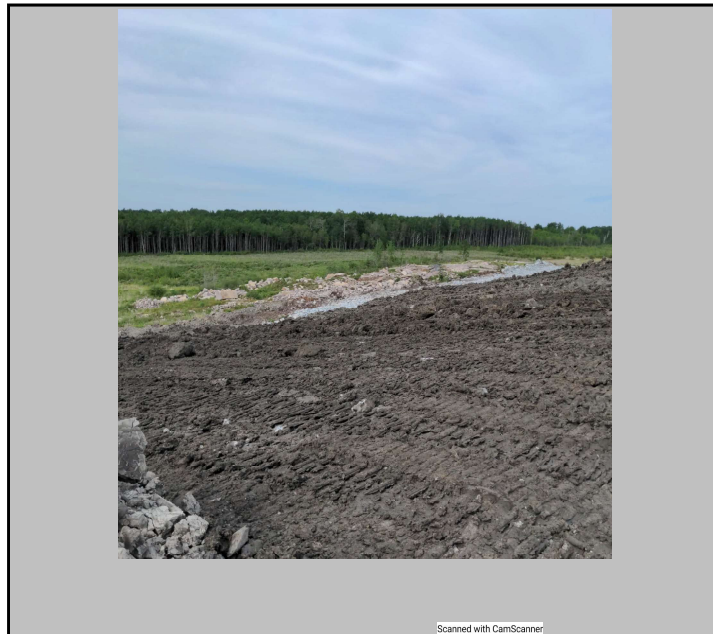
Photo #: 11

Panel 5 CCL Lift 2 and Panel 6 CCL Lift 1.

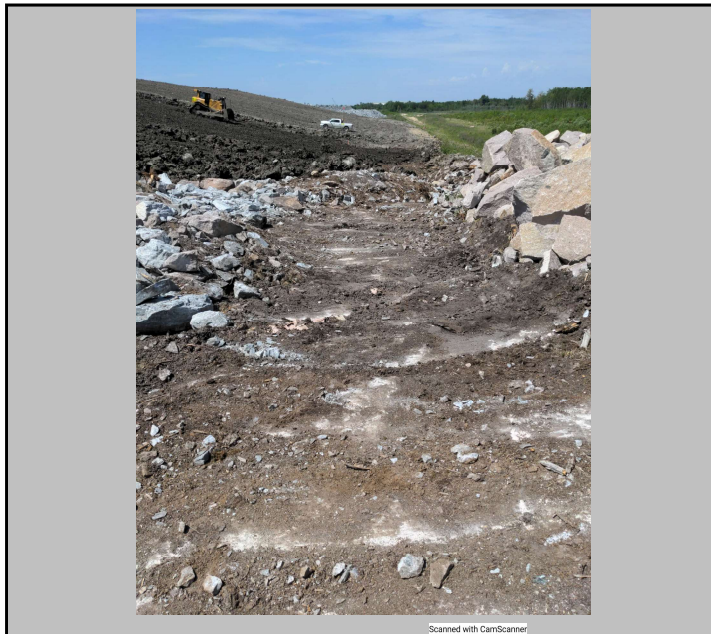
Photo #: 3

Key Trench 2+723 to 2+622

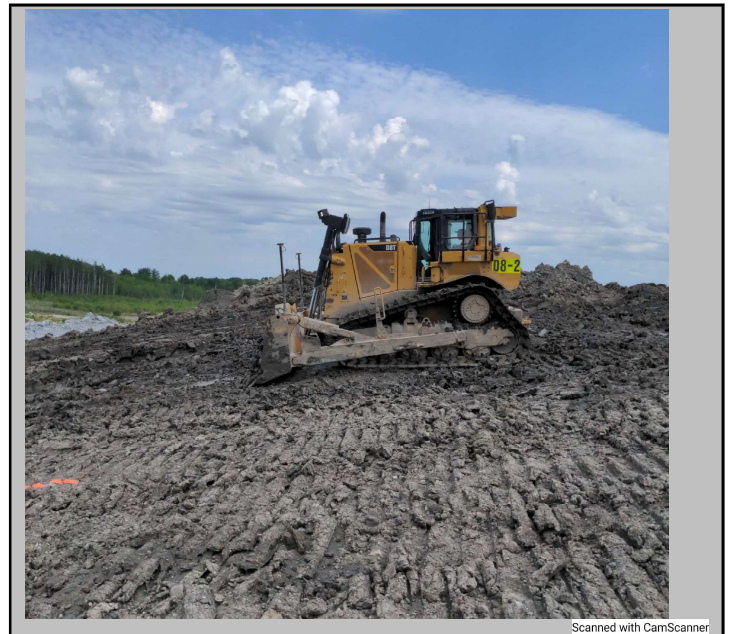
Photo #: 4

D8-2 placing and grading Panel 6 CCL Lift 1.

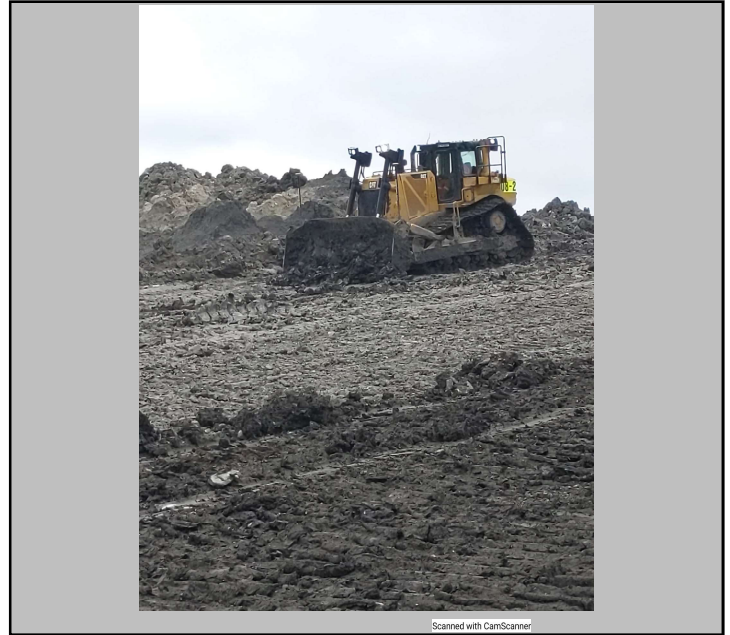
Photo #: 2

Grading Panel 6 CCL Lift 1.

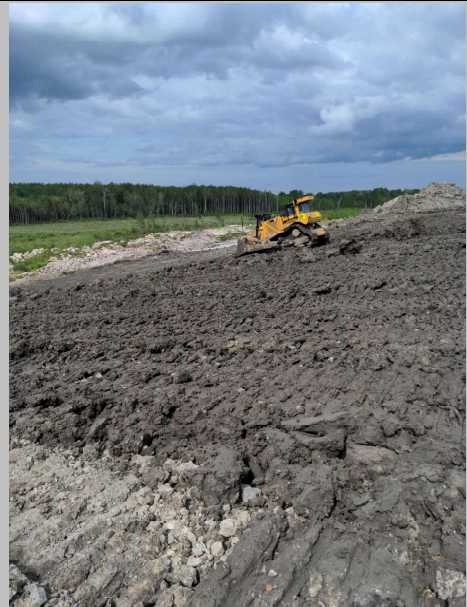
Photo #: 10

Grading Panel 6 CCL Lift 1.

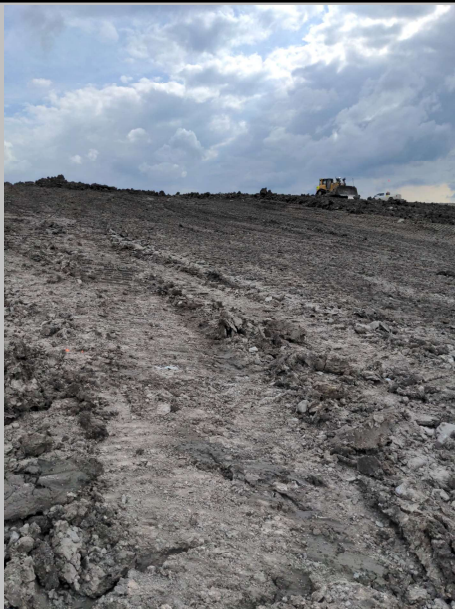
Photo #: 11

Panel 6 CCL Lift 1.

CCL material was dark grey with dark and light brown spots mixed in. Material was pliable and could be rolled out to form a ribbon in your hands. High moisture results required the lift to be re-worked, grade and packed prior to approval.

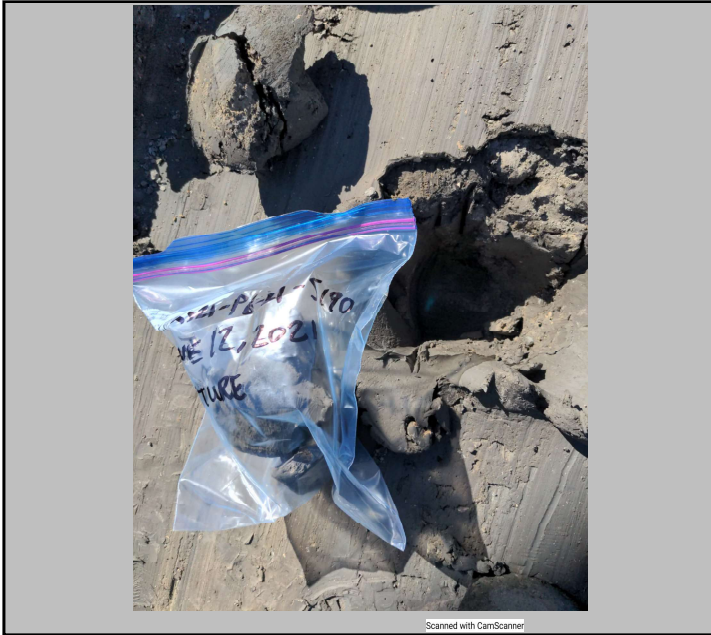
Photo #: 9

EMRS21-P6-L1-S190.

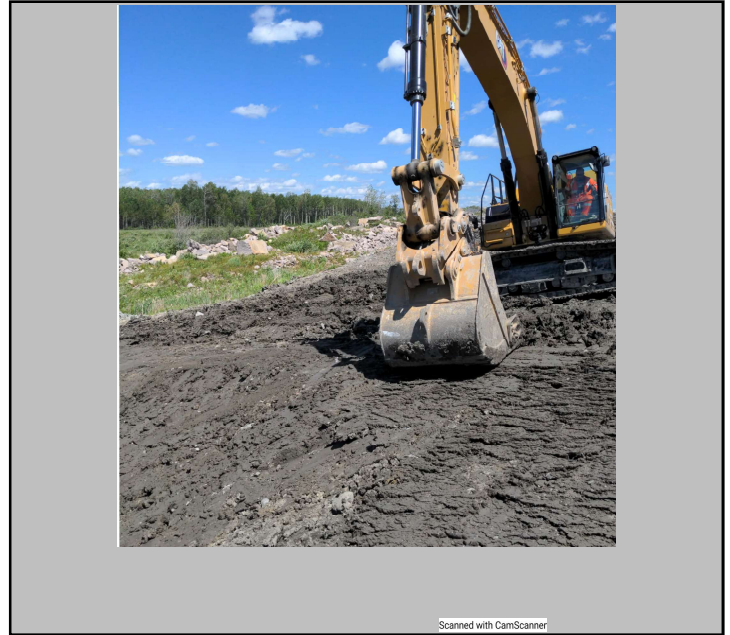
Photo #: 10

Trench Drain Panel 5.

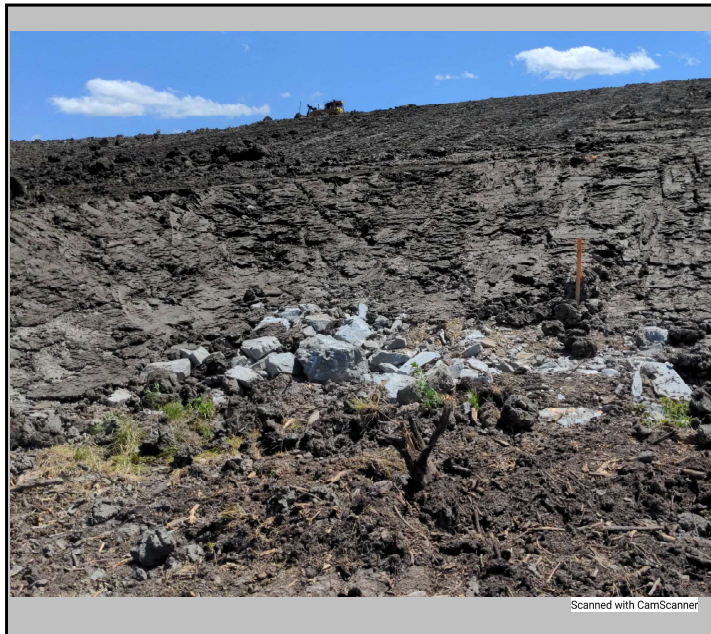
Photo #: 11

Trench Drain Panel 5.

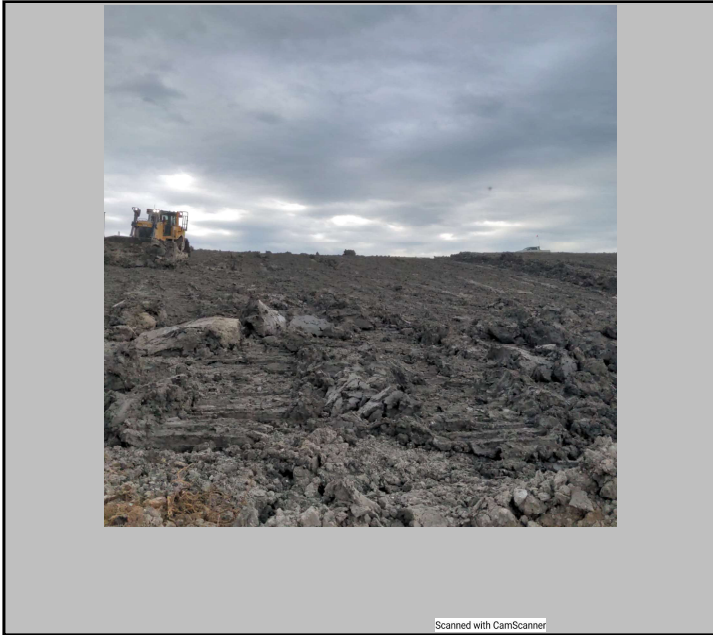
Photo #: 1

Panel 6 CCL Lift 2 placement and grading.

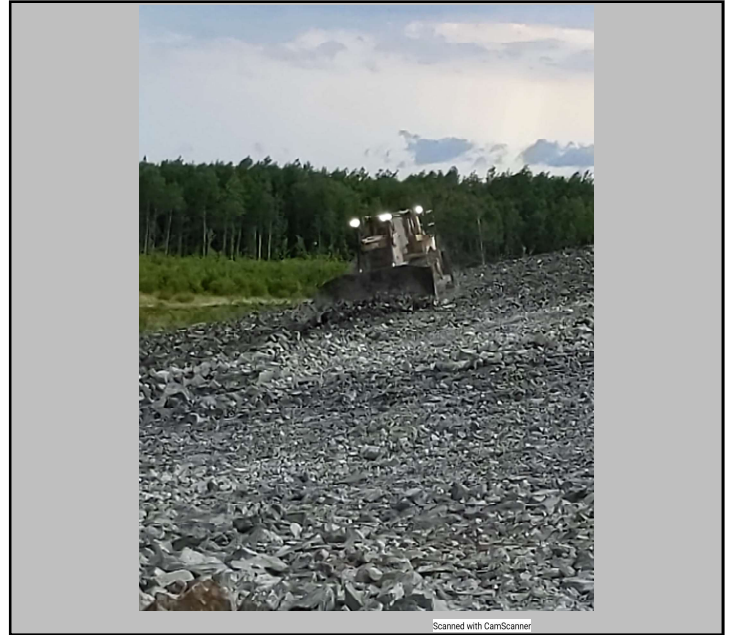
Photo #: 2

EMRS Slope Base re-grade.

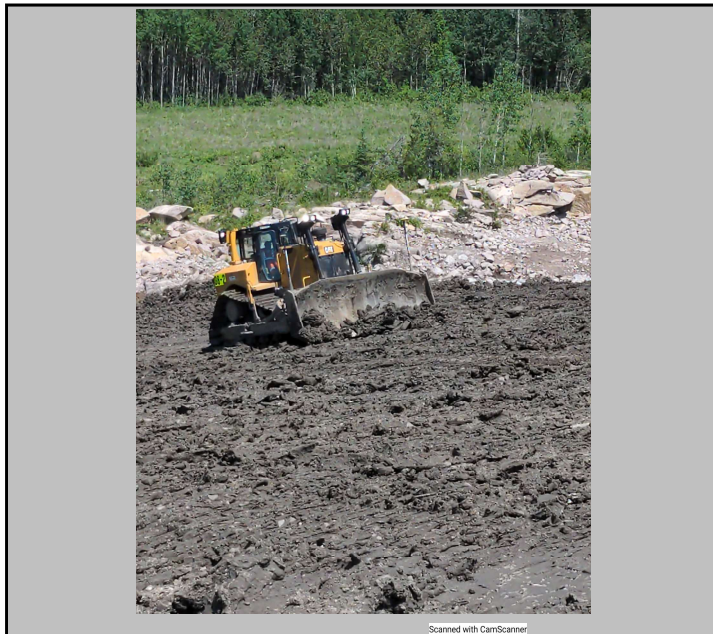
Photo #: 3

Panel 6 CCL Lift 2 grading.

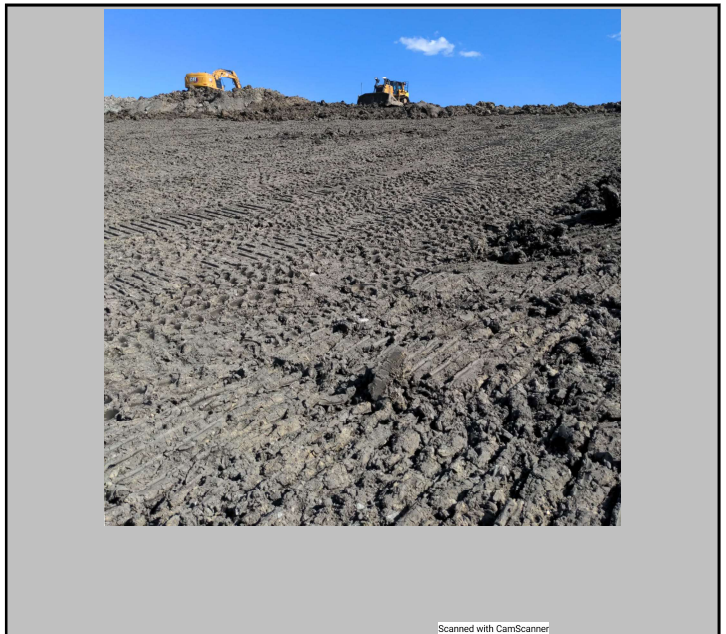
Photo #: 12

Panel 6 CCL Lift 2 and NCL Lift 3 placement.

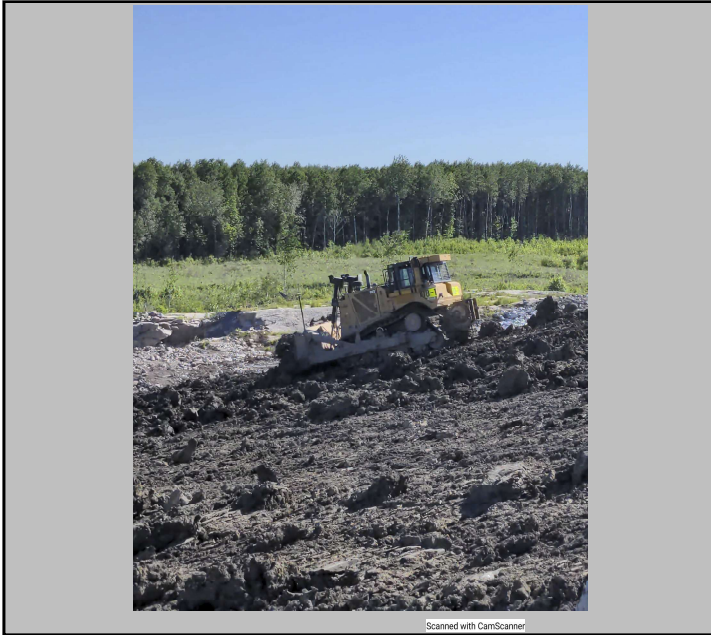
Photo #: 1

Panel 6 NCL Lift 3 placement and grading.

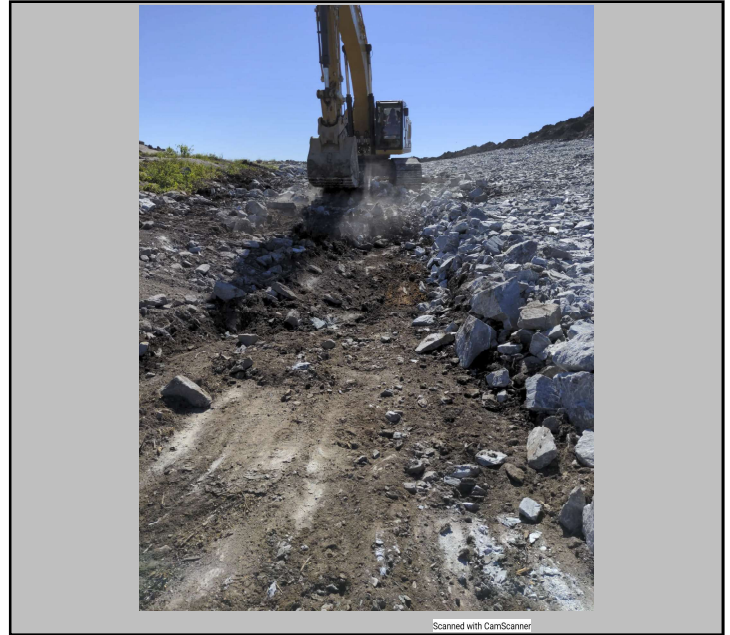
Photo #: 2

Key Trench 2+682 to 2+632.

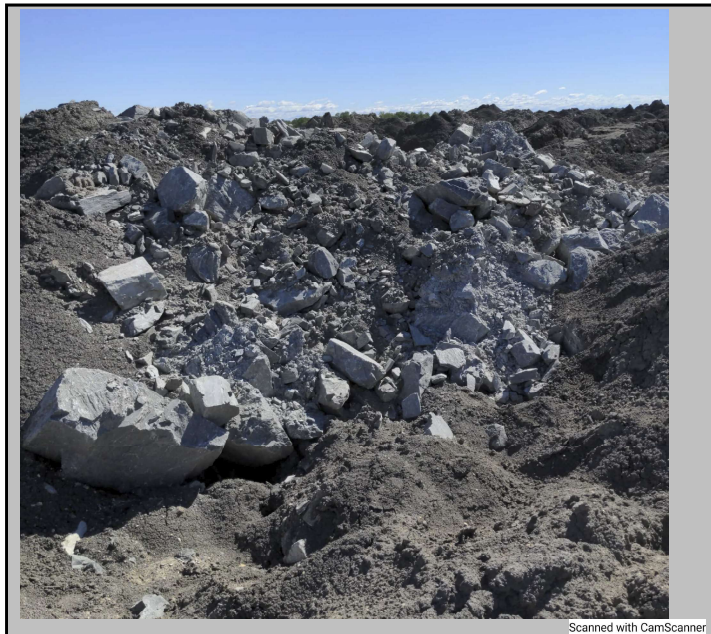
Photo #: 3

Waste rock removed from stockpiles.

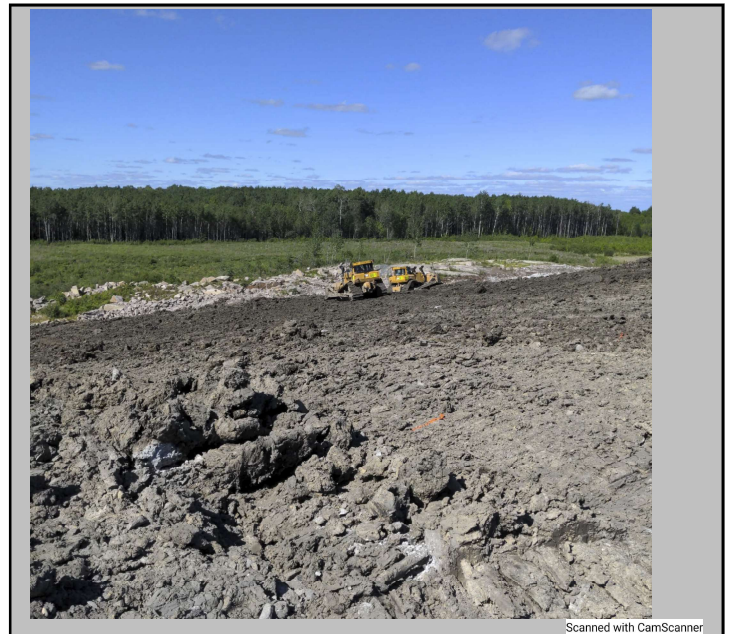
Photo #: 4

Panel 6 NCL Lift 3 grading.

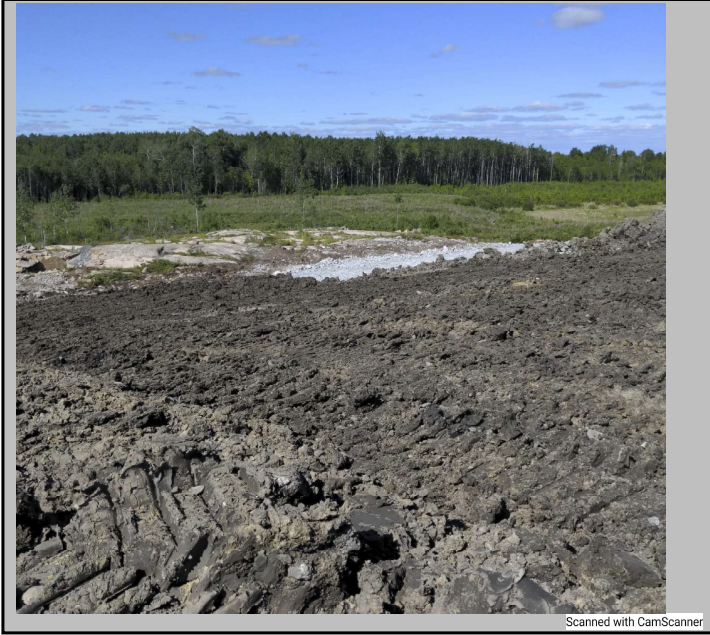
Photo #: 5

Panel 7 CCL Lift 1 placement and grading.

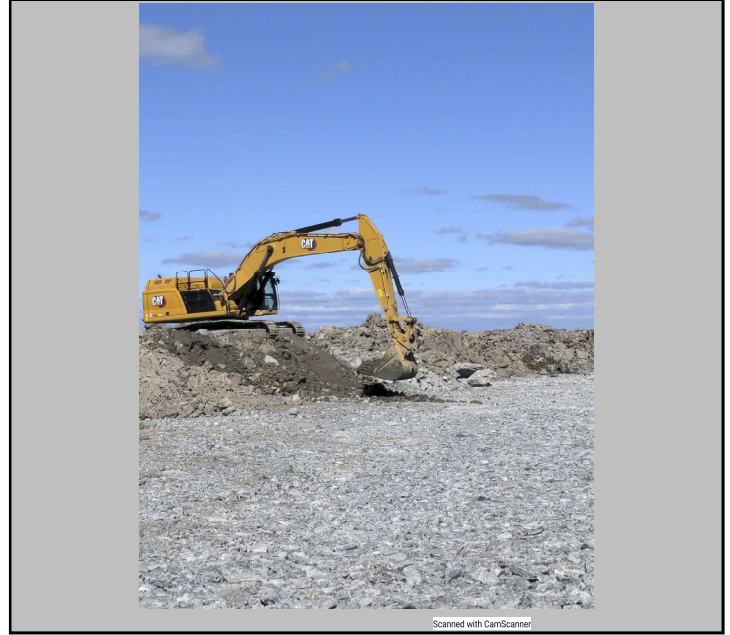
Photo #: 6

Waste rock removal from stockpiles.

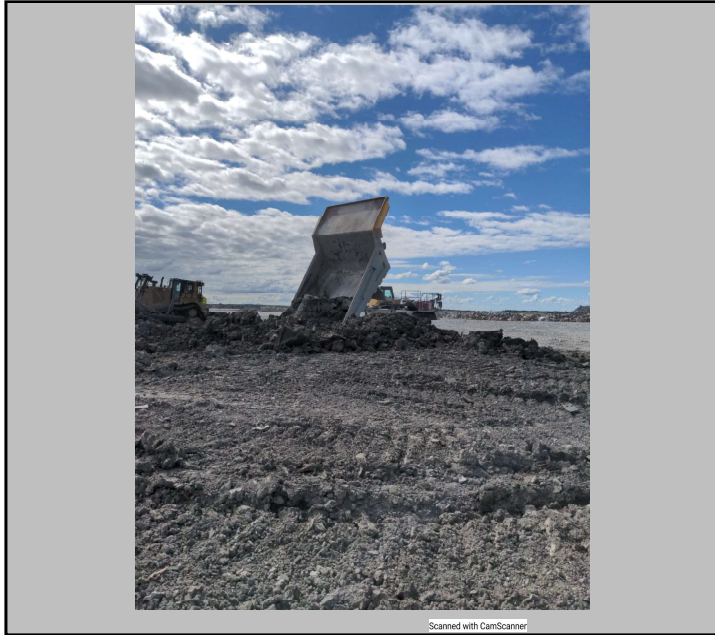
Photo #: 1

Trucks dumping clay material for Panel 6 NCL Lift 4.

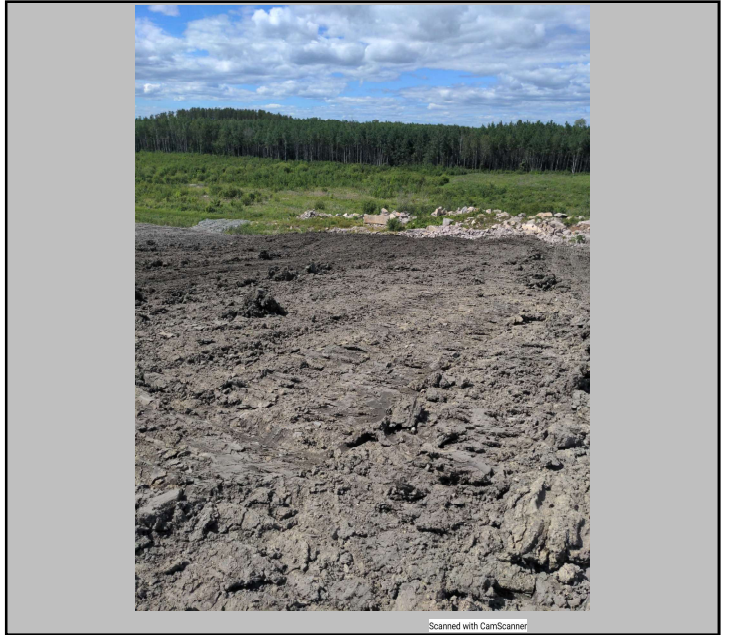
Photo #: 2

Panel 6 NCL Lift 3.

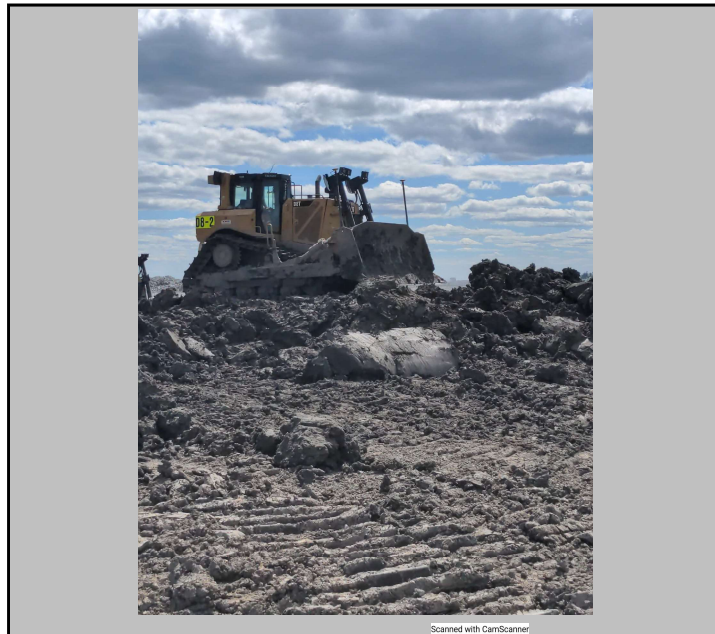
Photo #: 3

Dozers placing Panel 6 NCL Lift 4.

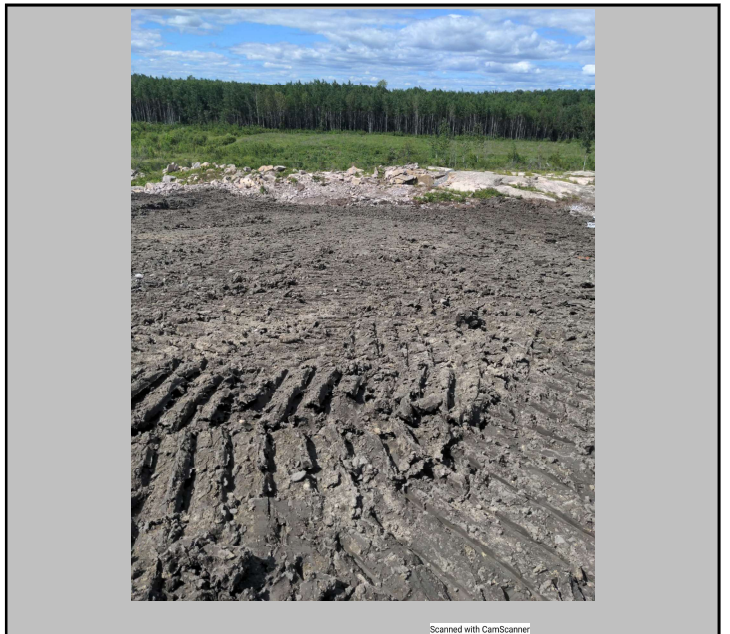
Photo #: 4

Panel 7 CCL Lift 1 prior to packing.

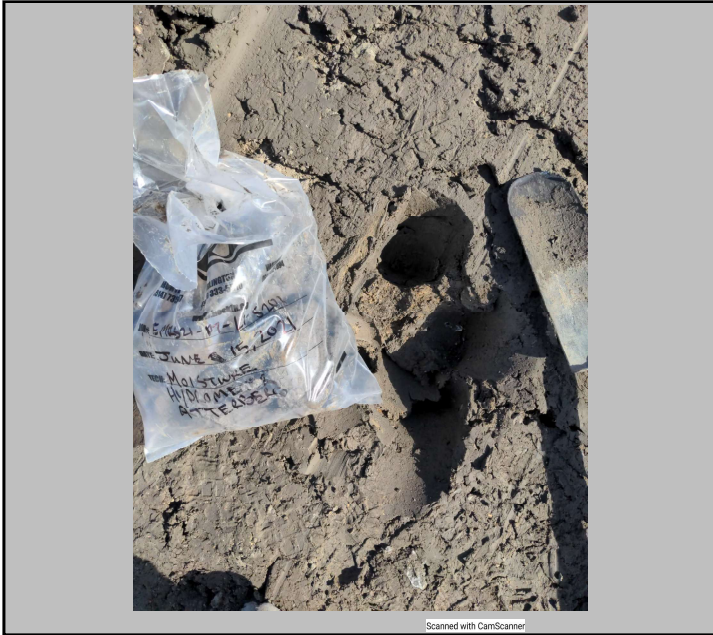
Photo #:

EMRS21-P7-L1-203.

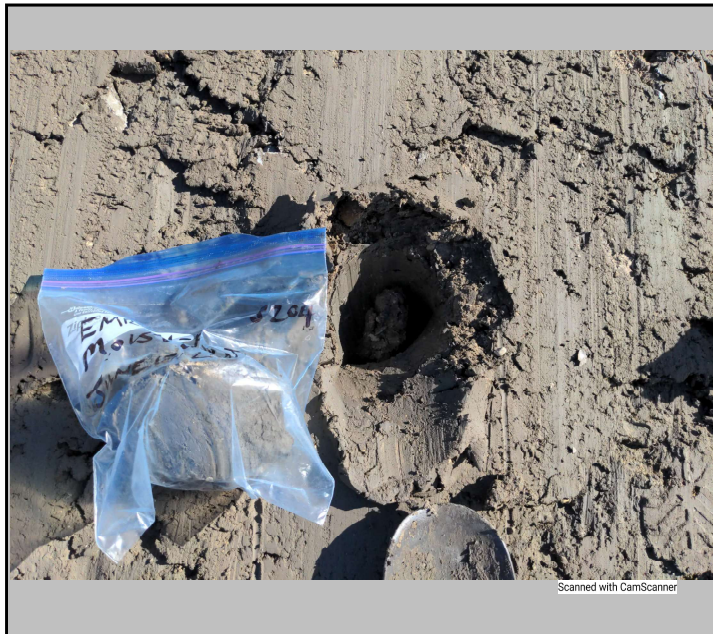
Photo #:

EMRS21-P7-L1-204.

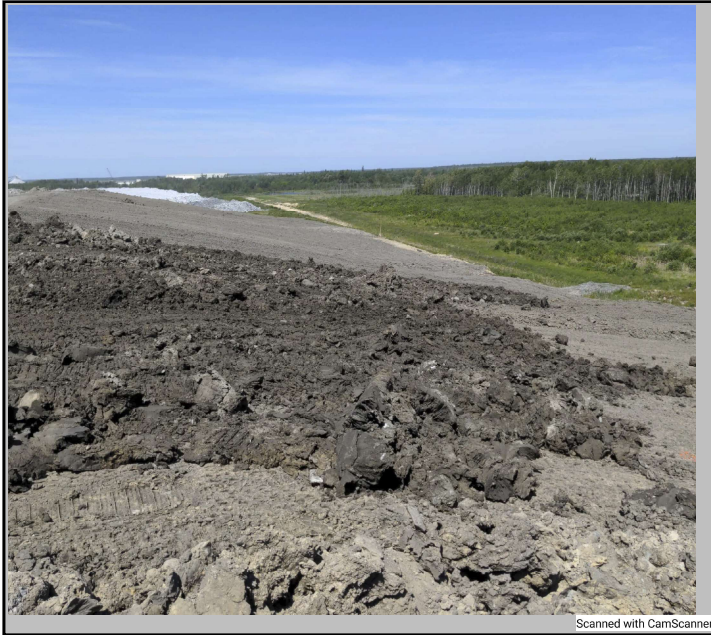
Photo #: 1

Panel 7 CCL Lift 2 placement.

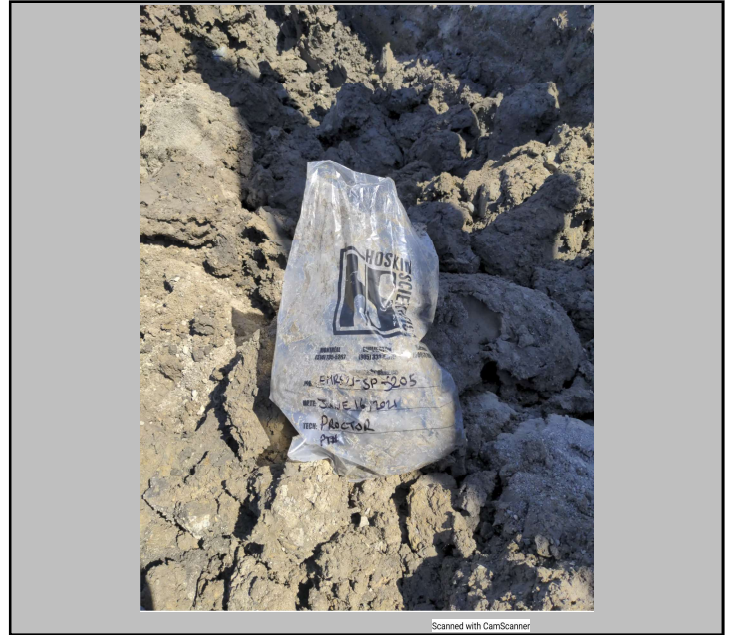
Photo #: 2

EMRS21-SP-S205.

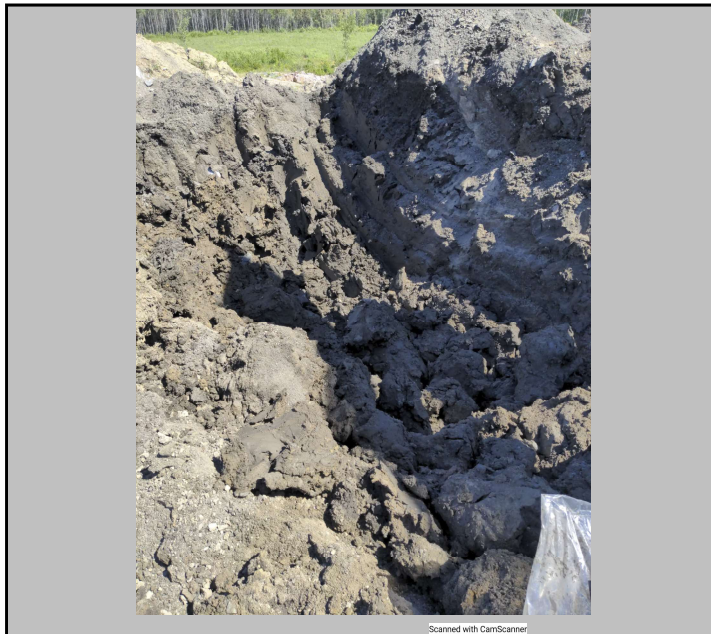
Photo #: 3

Test pit for Sample 205.

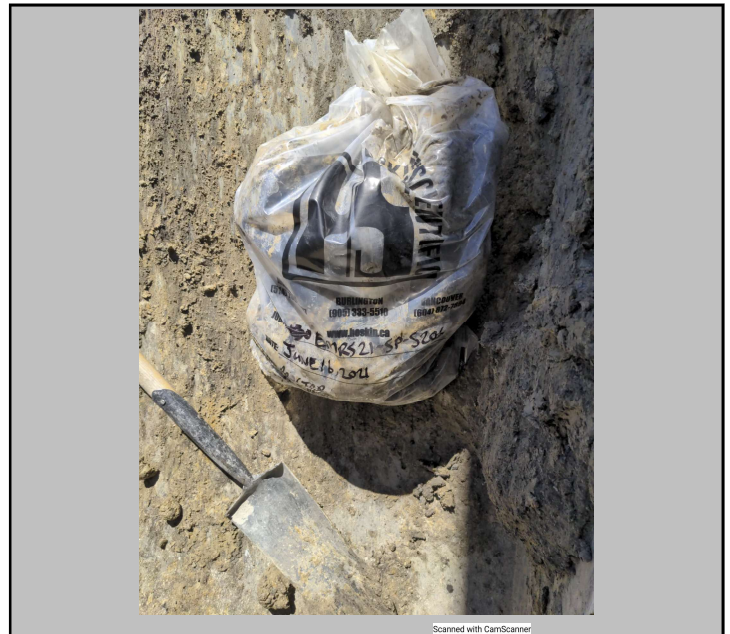
Photo #: 4

EMRS21-SP-S206.

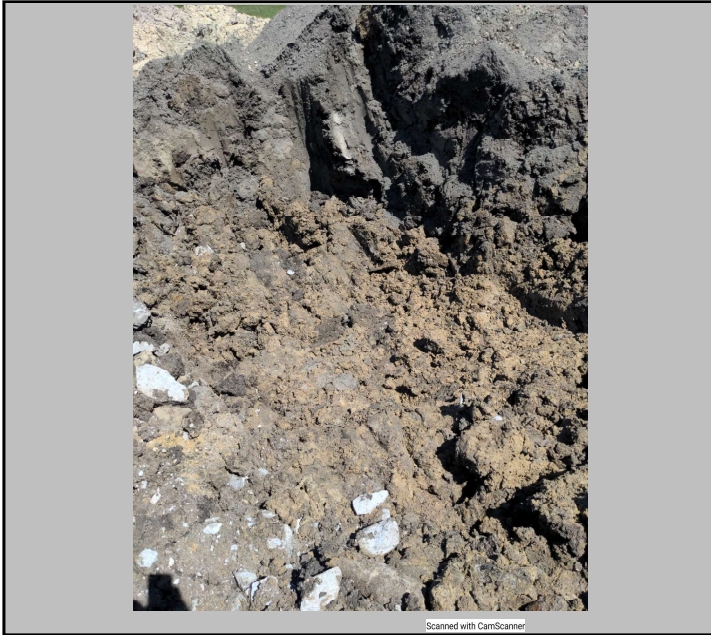
Photo #: 5

Test pit for Sample 206.

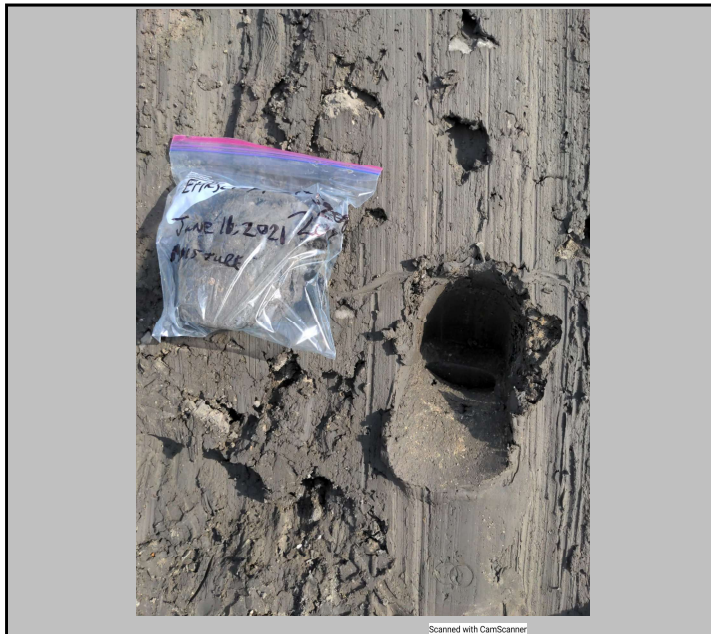
Photo #: 7

EMRS21-P7-L2-S207

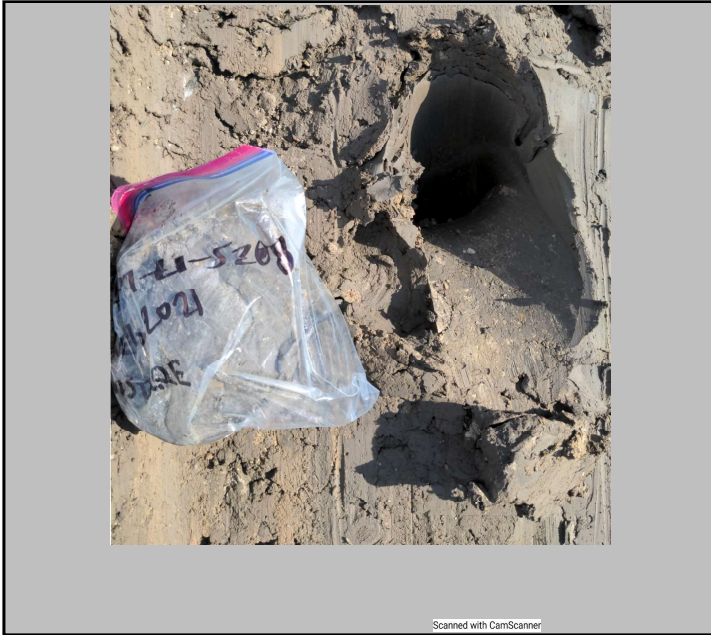
Photo #: 9

EMRS21-P7-L2-S208

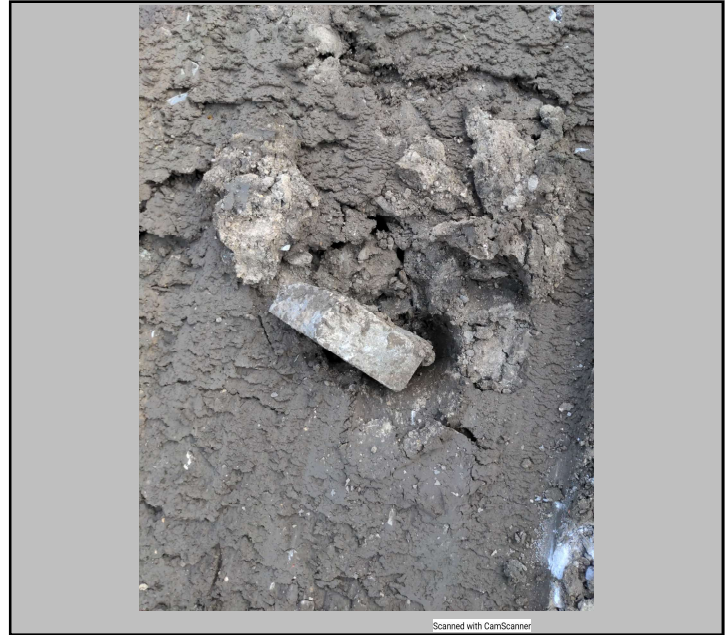
Photo #: 10

EMRS21-P7-L2-D104 test rock discovered.

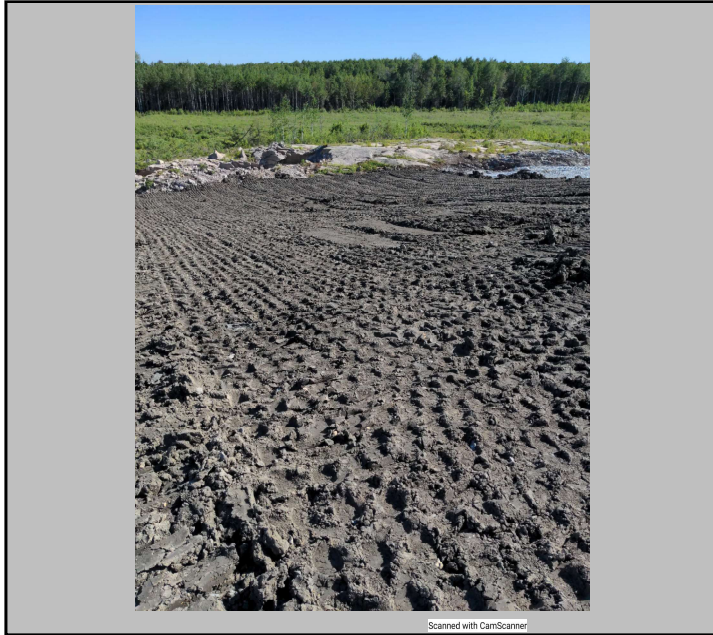
Photo #: 1

Panel 7 CCL Lift 2.

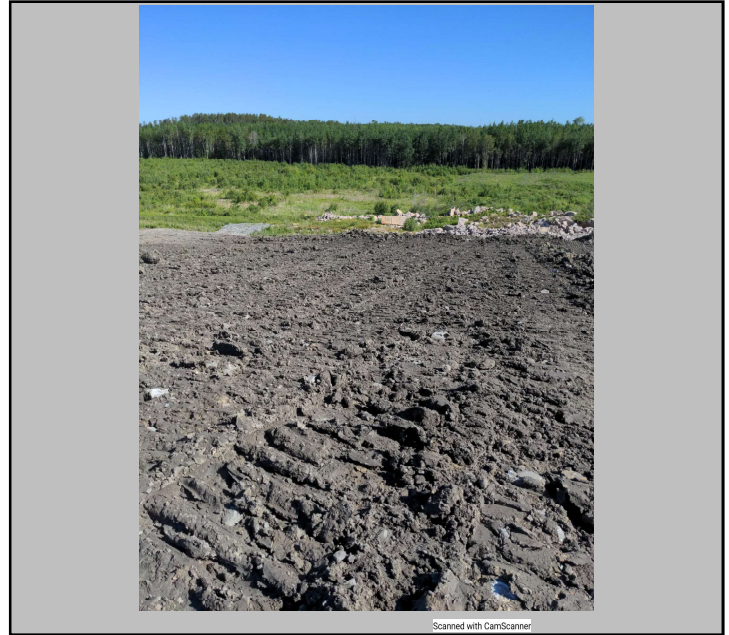
Photo #: 2

Panel 6 NCL Lift 4.

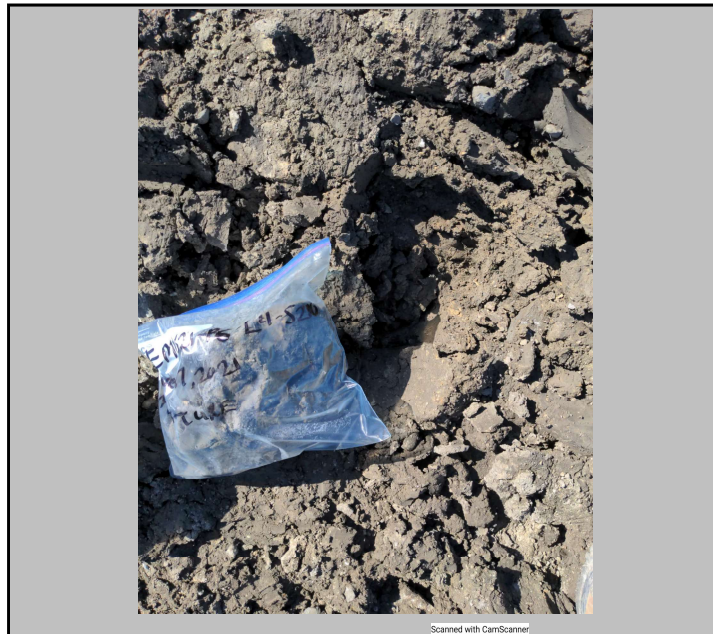
Photo #: 3

EMRS21-P6-L4-S210.

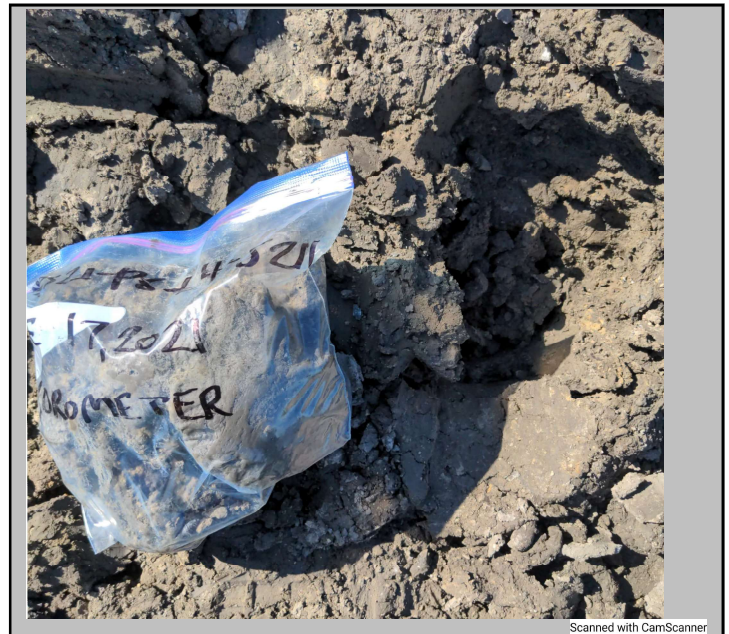
Photo #: 4

EMRS21-P6-L4-S211.
