PHOTOGRAPHS

Date:	June 19, 2021	Owner/Client:	New Gold Inc.
Day:	Saturday	OKC Project #:	1003-19
Prepared by:	Martin Moore	Project Location:	Rainy River - Ontario

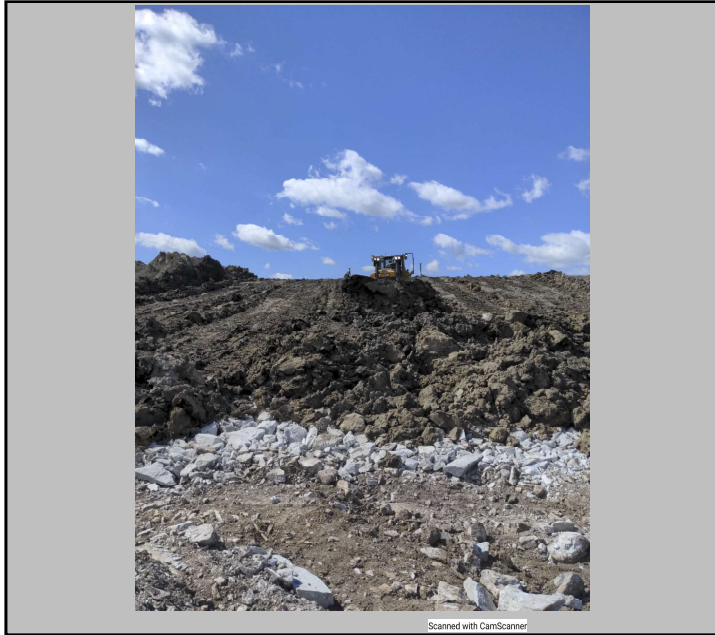
Photo #: 1

Panel 8 CCL Lift 1.

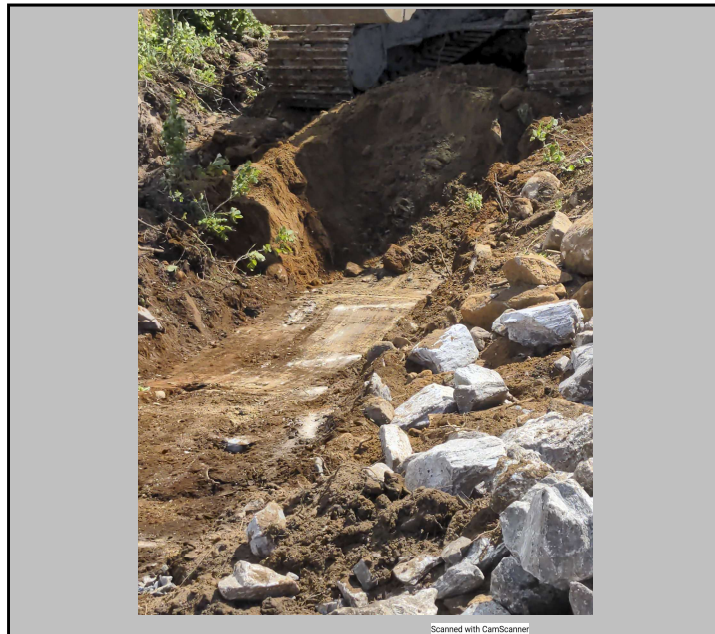
Photo #: 3

Key Trench.

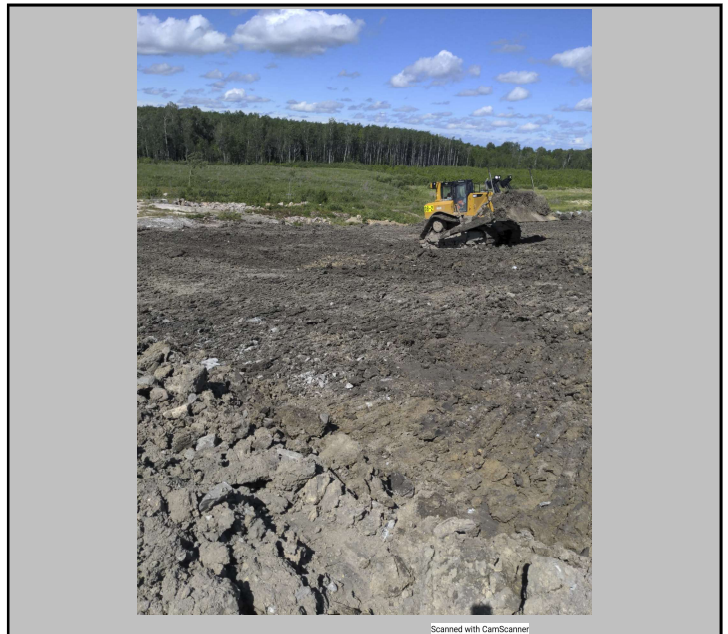
Photo #: 4

Panel 8 CCL Lift 1.

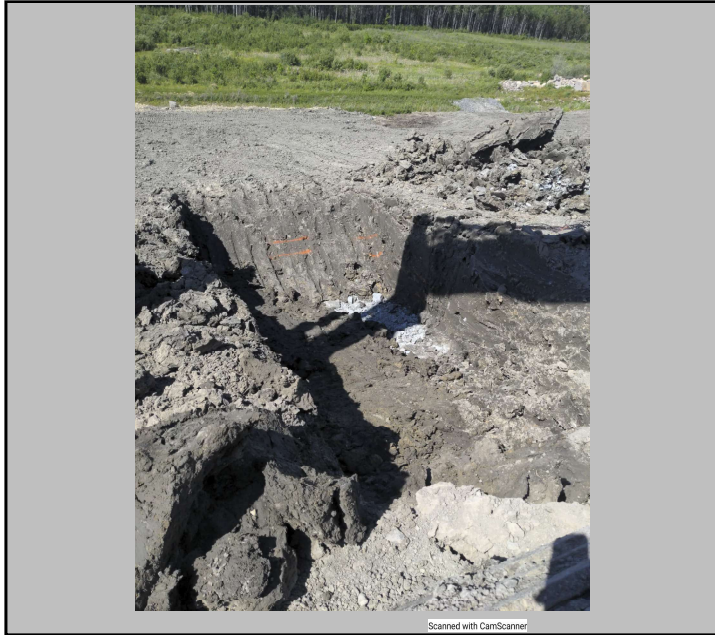
Photo #: 5

Okane Test Pit for instruments.

CAT 349 excavated test pit for Okane to install instrumentation. Excavator replaced material at proper lift thicknesses and used packer to complete two passes for two first lifts.

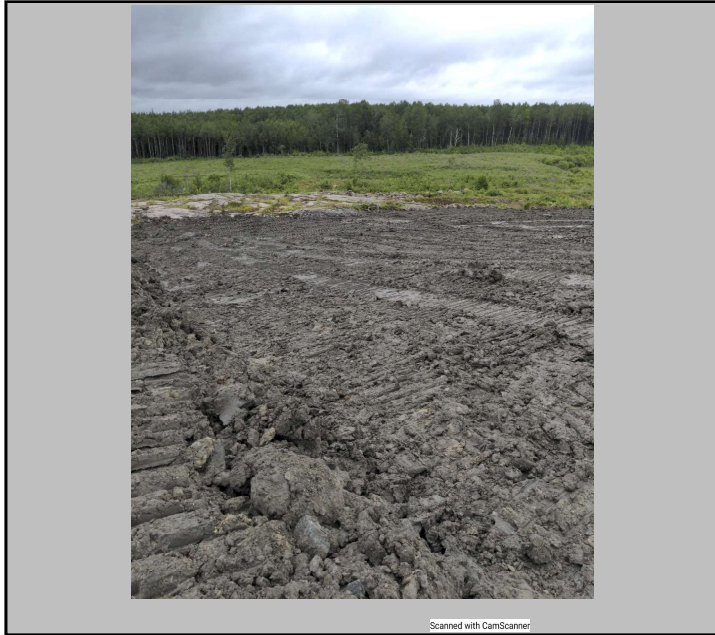
Photo #: 1

CT 349 removing oversize boulders from Panel 8 CCL Lift 2 that were not removed during placement prior to packing. Rain at EMRS caused Panel 8 CCL Lift 2 too wet to begin packing.

Panel 8 CCL Lift 2 slope after rain.

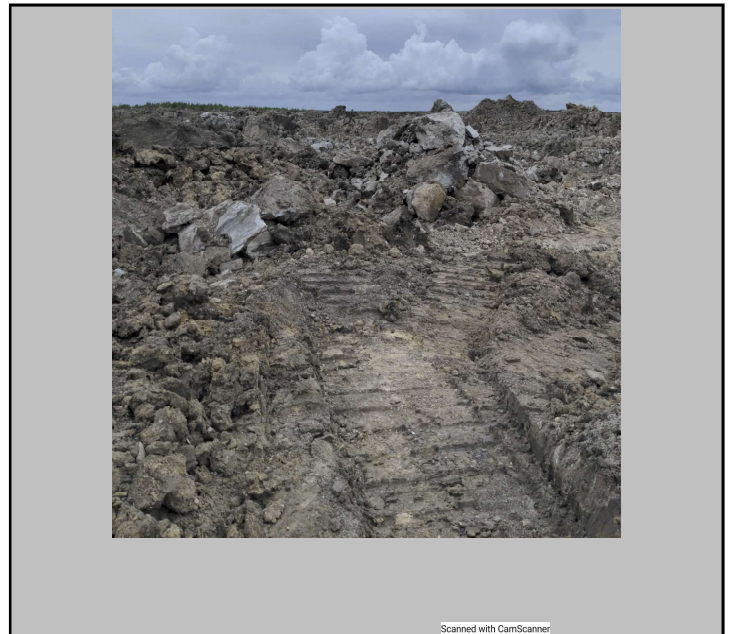
Photo #: 4

Rocks being removed from stockpiles.

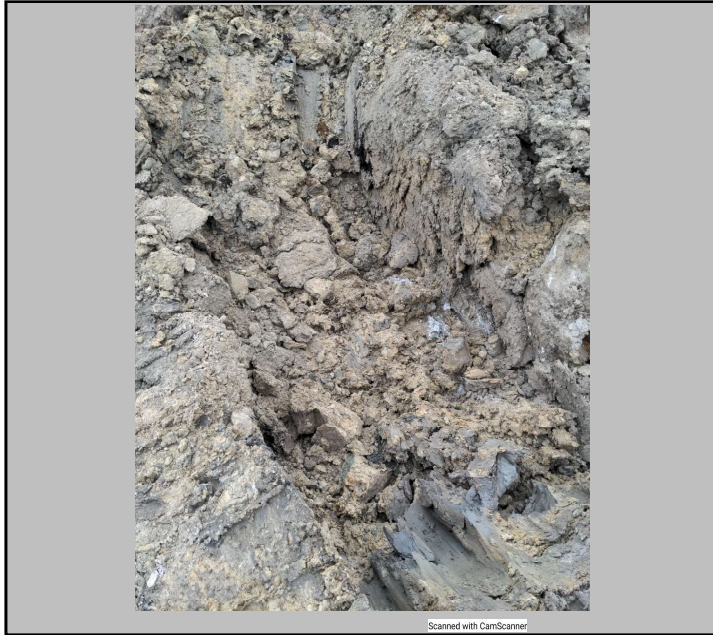
Photo #: 5

EMRS21-SP-S218 test pit location.

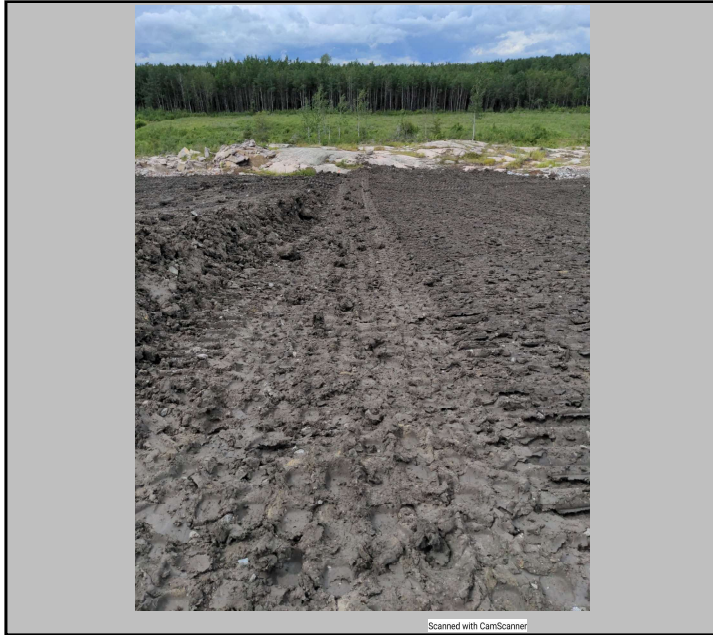
Photo #: 9

Panel 8 CCL Lift 2 roller pickup.

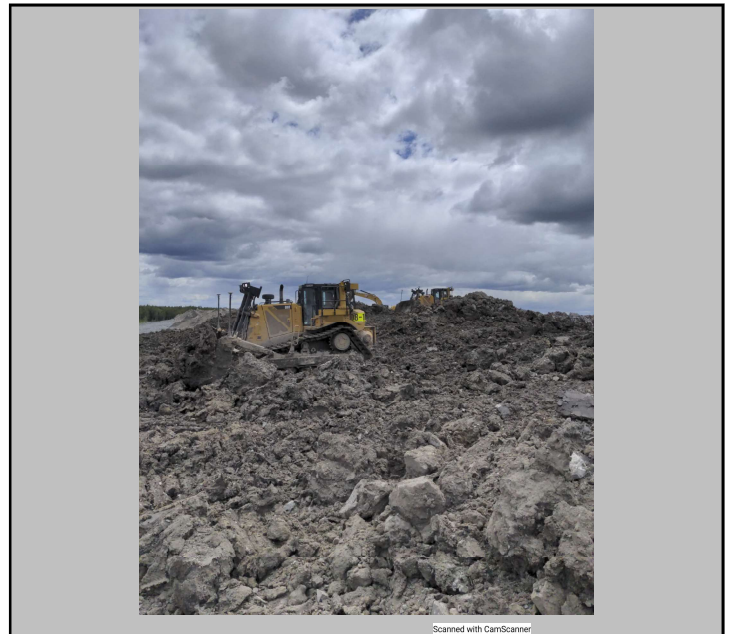
Photo #: 8

Panel 8 NCL Lift 3 placement.

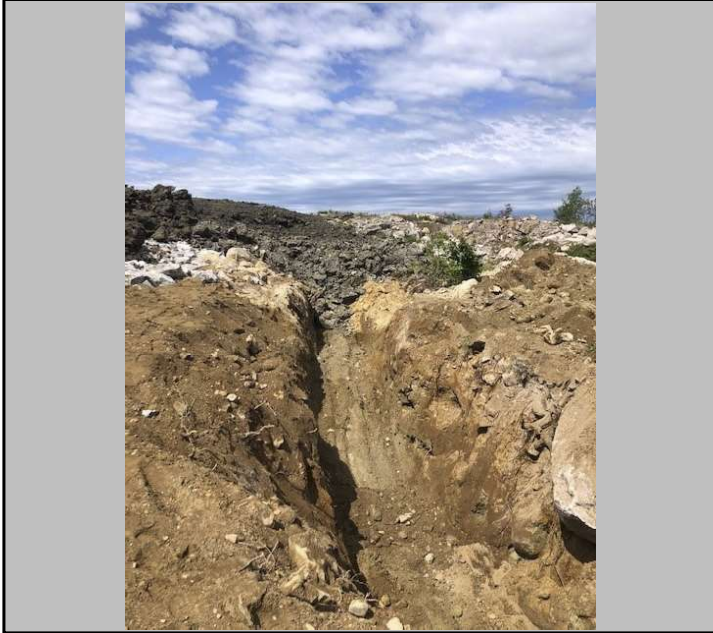
Photo #:

Panel 9 2+570-2+610 Key Trench

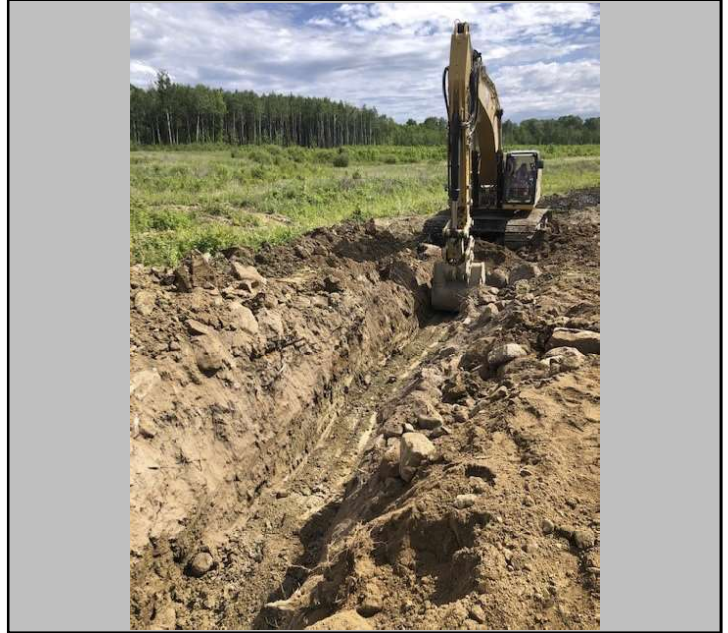
Photo #:

Panel 9 2+570-2+610 Key Trench

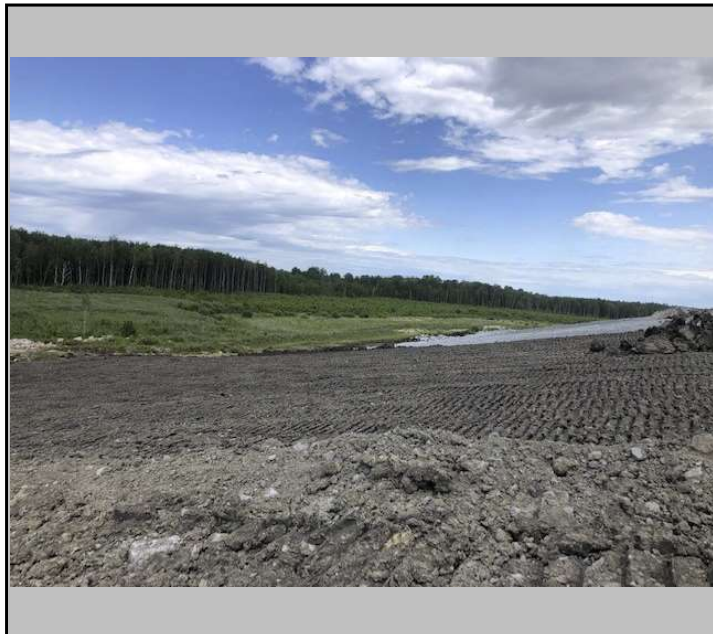
Photo #:

Panel 9 CCL Lift 1 Before packing

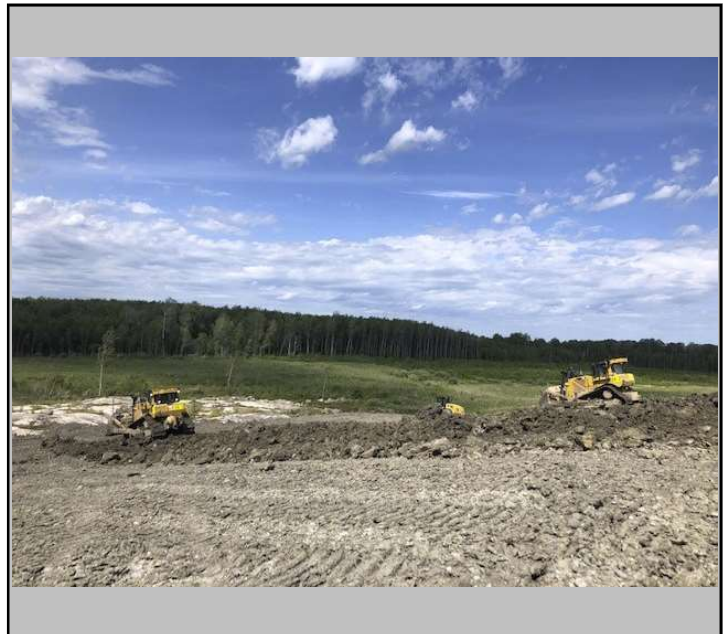
Photo #:

Dozers placing Panel 8 NCL Lift 4

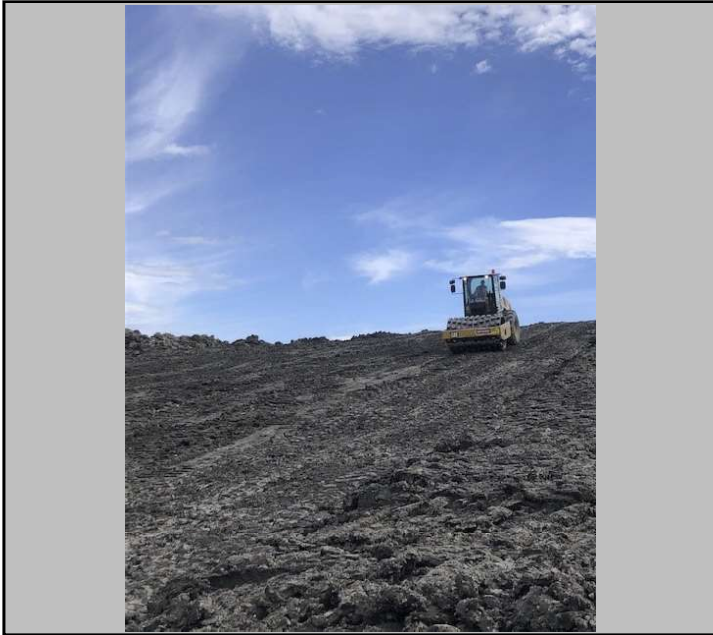
Photo #:

Packer on Panel 9 CCL Lift 1

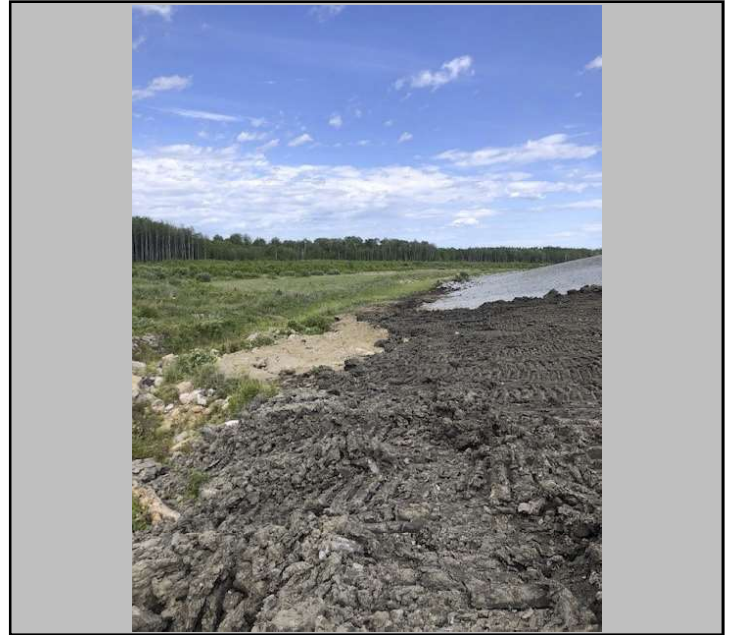
Photo #:

Covered Panel 9 2+570-2+610 Key Trench

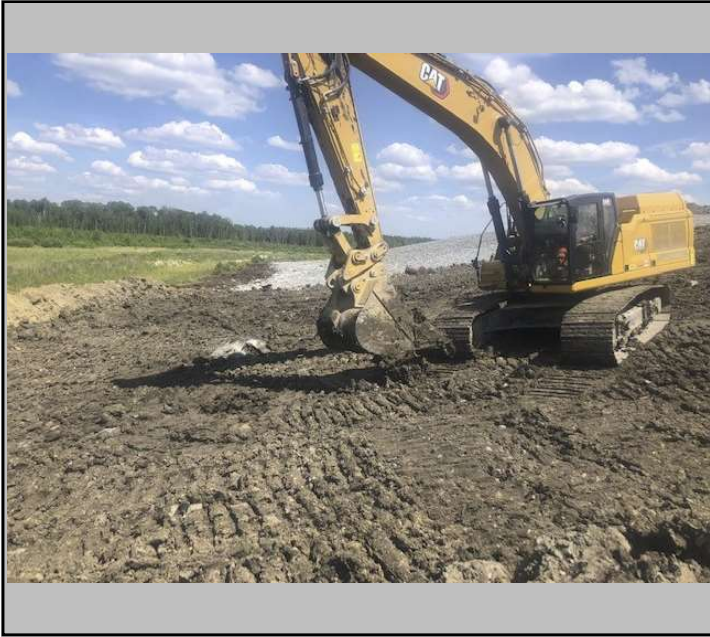
Photo #: 6

Cat 349 Excavator removing boulders prior to compaction CCL L1 P10

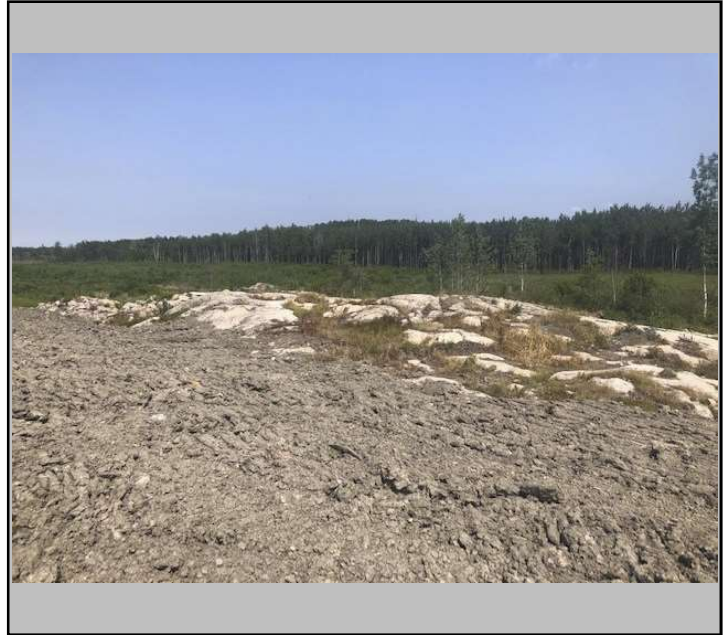
Photo #: 6

Panel 8 bedrock at toe

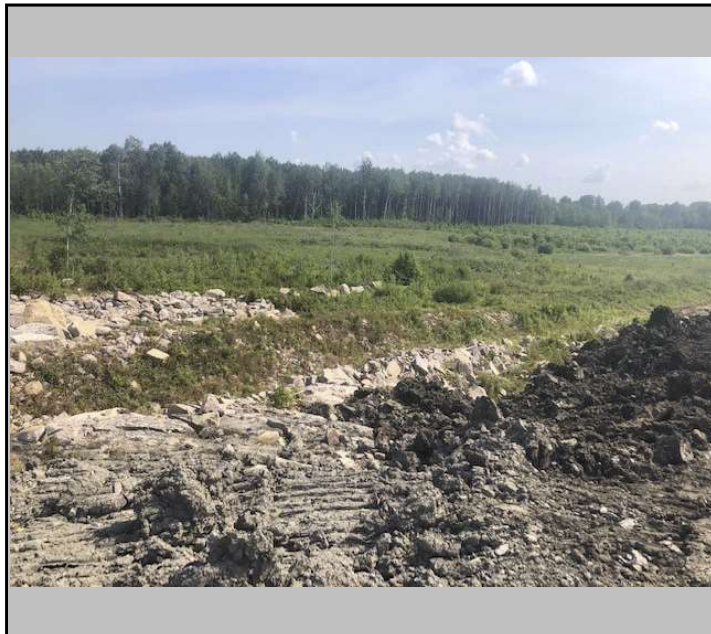
Photo #: 7

Tulloch met with New Gold supervisor to discuss in field conditions at toe of Panel 8/9 which would cause future pooling water. In conclusion, it was decided to add material at the toe of Panel 8 to make a drainage break making water flow into appropriate ditches. It was also decided to bring in freshly hauled clay for Panel 11 as stockpiled material appeared too dry to meet specification.

Panel 8/9 toe without proper drainage (in progress)

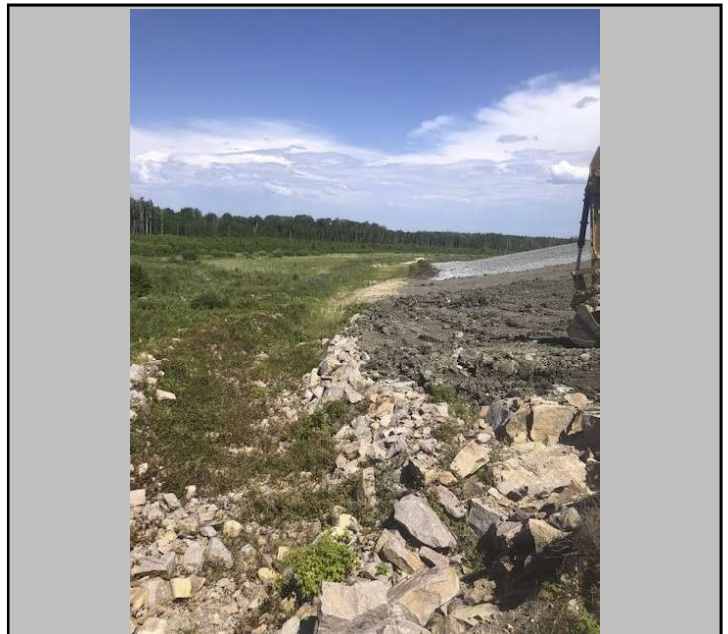
Photo #: 8

Panel 8/9 toe after extra material added to maintain proper drainage into ditch

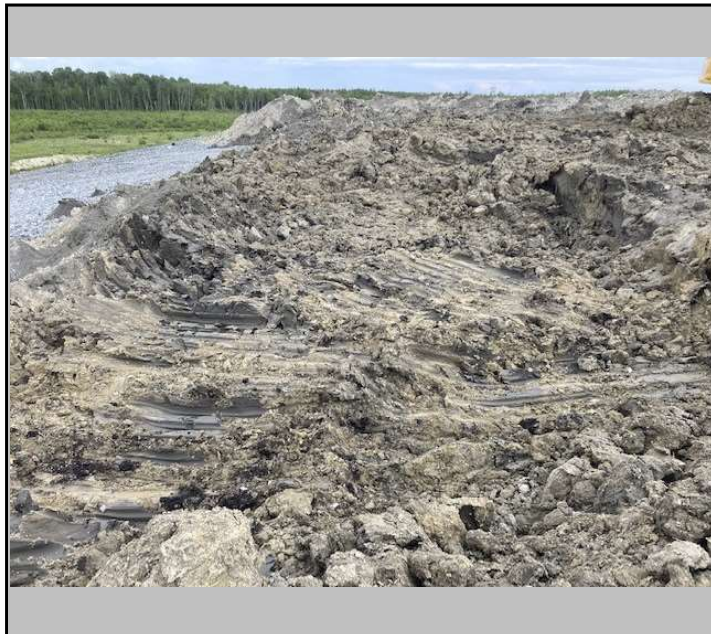
Photo #: 3

Stockpiled CCL material for Panel 11 to be mixed with freshly hauled CCL

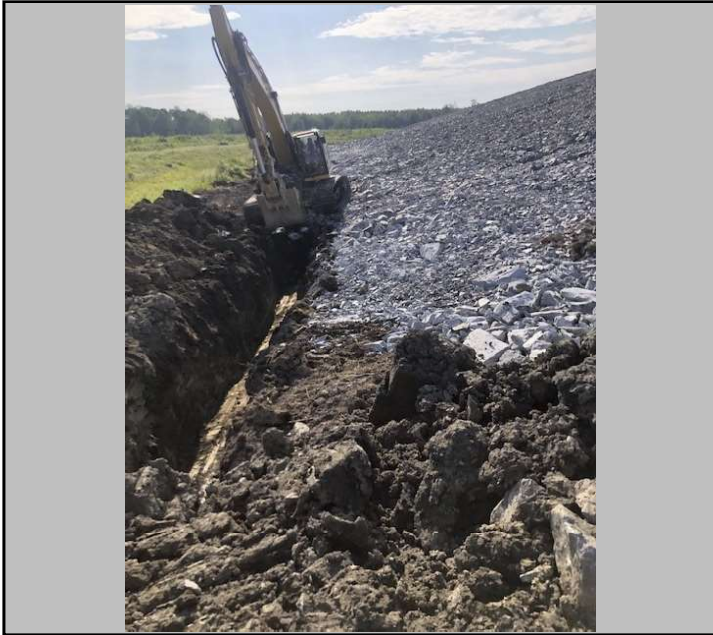
Photo #: 1

Panel 11 Key Trench 3m deep

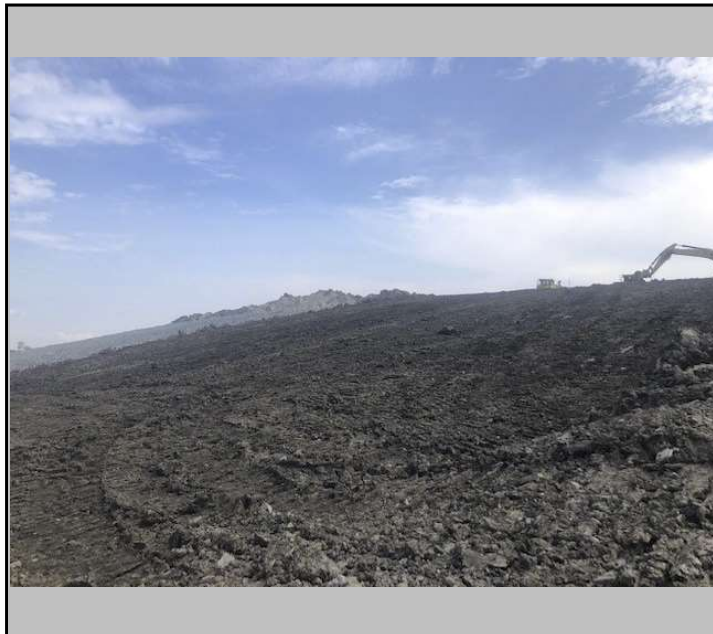
Photo #: 3

NCL Panel 11 Lift 1

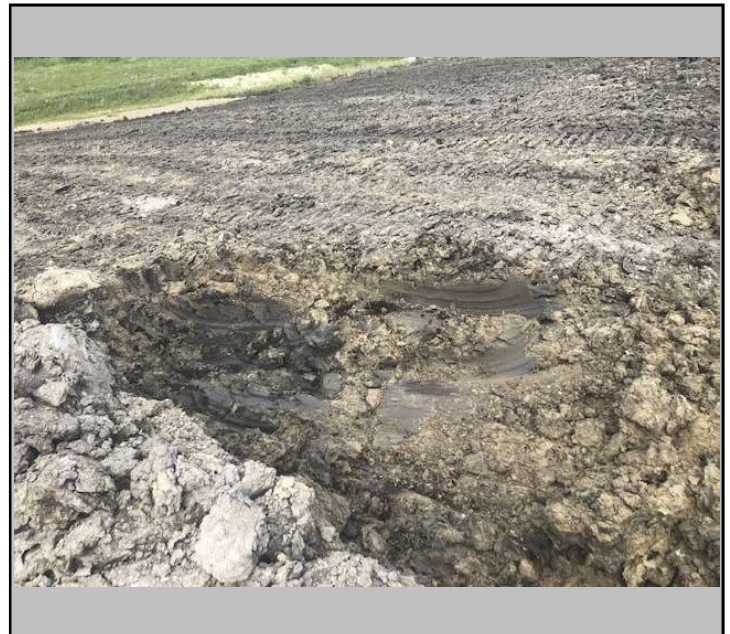
Photo #: 4

Removing Brenna material near top of bench
Panel 11

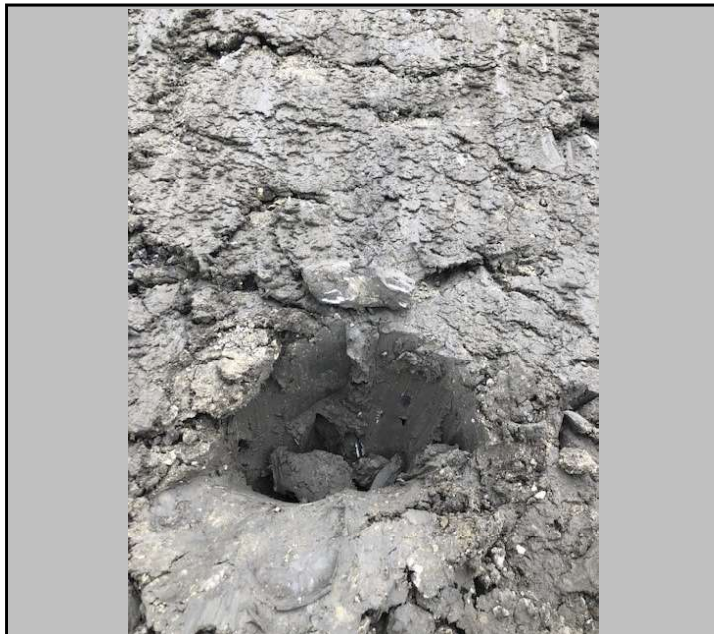
Photo #: 3

CCL Panel 11 Lift 2 material appeared to be dark grey/brown with areas of light brown mixed in. Material could be compressed into a ball and but would experience some crumbling when rolled into a string. Large abundance of small rocks found in material creating difficulties while testing and sampling.

Rock under nuke probe Density test 155

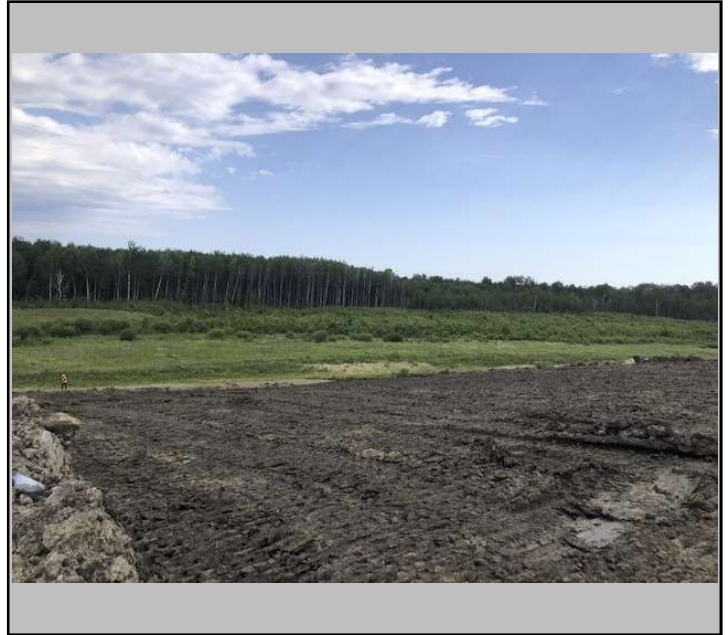
Photo #: 6

CCL Panel 11 Lift 1 approved by Okane inspector after completion of sampling and testing. Nuclear gage results portrayed that vibratory rolling helped pack and spread moisture for material that was visually dryer than previous panels. Specified lift thickness for CCL Panel 11 Lift 1 confirmed by Tulloch survey.

Approved CCL Panel 11 Lift 1 before placement of Lift 2

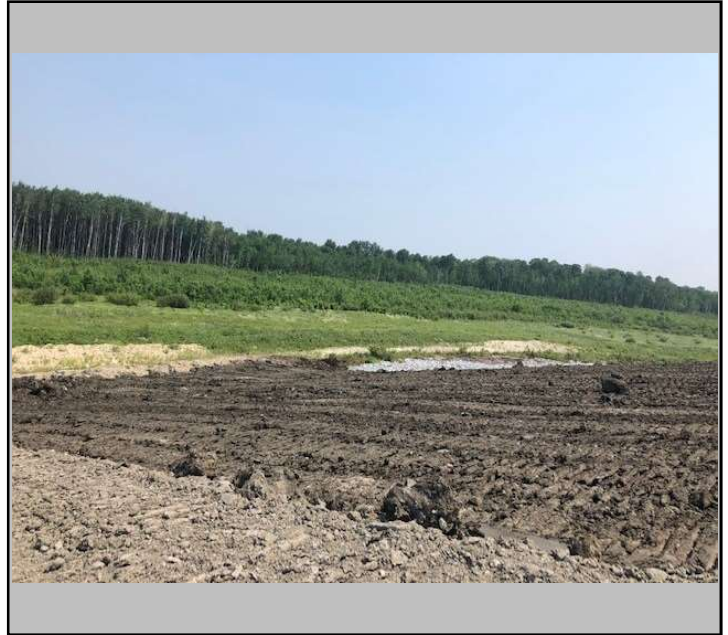
Photo #: 2

CCL material appeared dark grey/brown with no areas of light brown. Material contained lots of moisture as well a sufficient amount of small rocks. CCL was pliable and could easily be rolled into a string without crumbling.

CCL Panel 12 Lift 2 before compaction

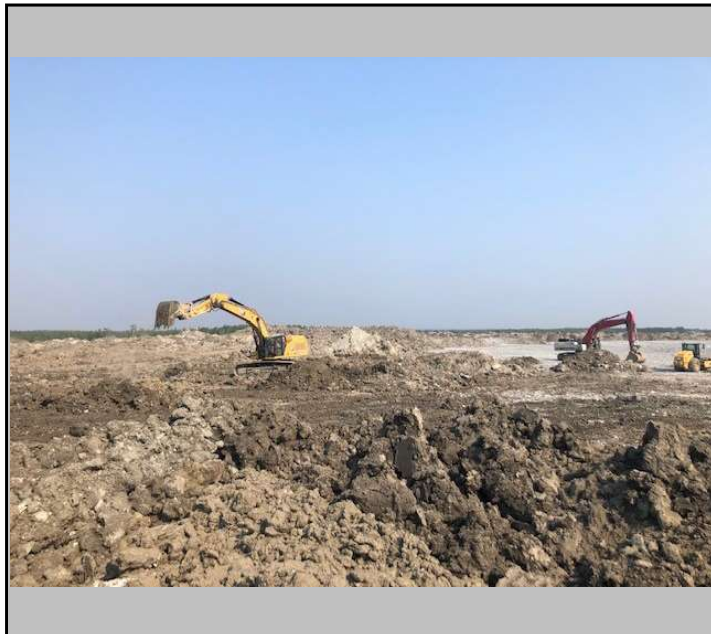
Photo #: 11

Excavator 349 sorting material and removing large rocks

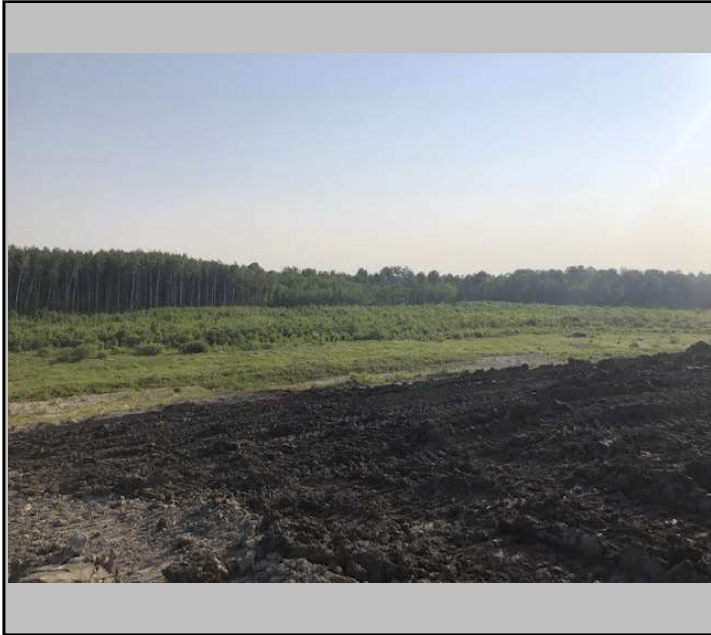
Photo #: 1

- Night shift placed NCL material for lift 3 can be view in picture 3
- Completed placement of lift 3 and thickness confirmed by Tulloch survey
- Contaminated section from oil spill removed and replaced with suitable material
- Replaced section compacted

NCL Panel 12 Lift 3 after night shift placement
(not to grade)

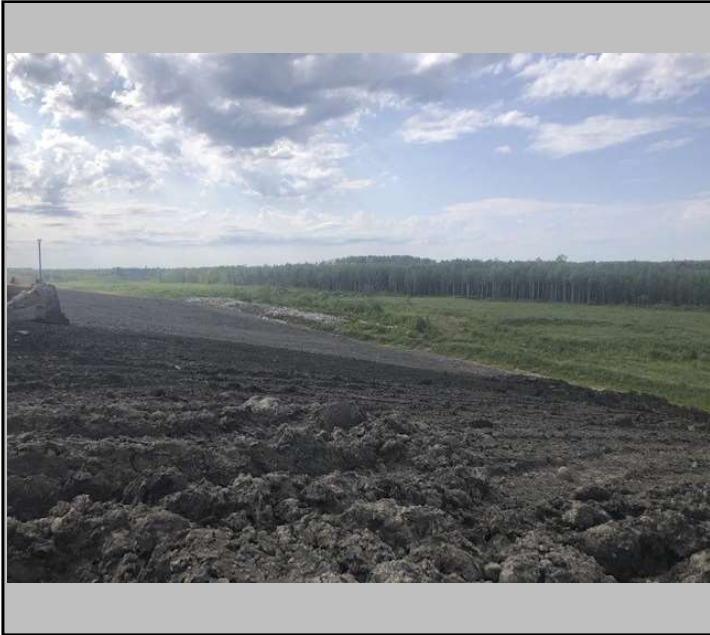
Photo #: 5

NCL Panel 11 Lift 4 (in progress)

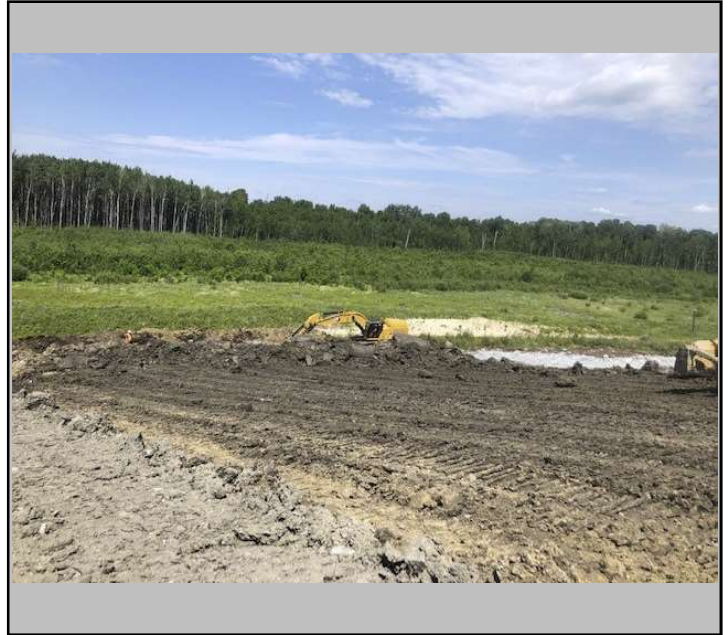
Photo #: 6

CCL Panel 13 Lift 1

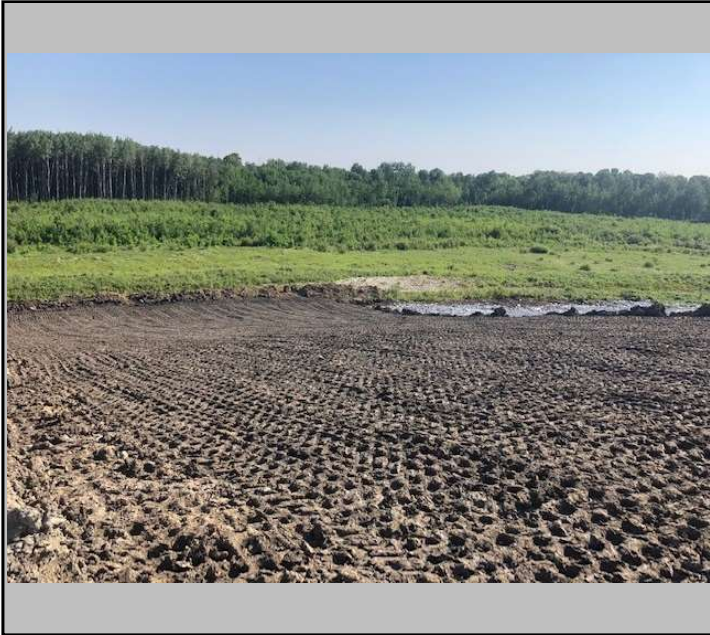
Photo #: 1

CCL Panel 13 Lift 1

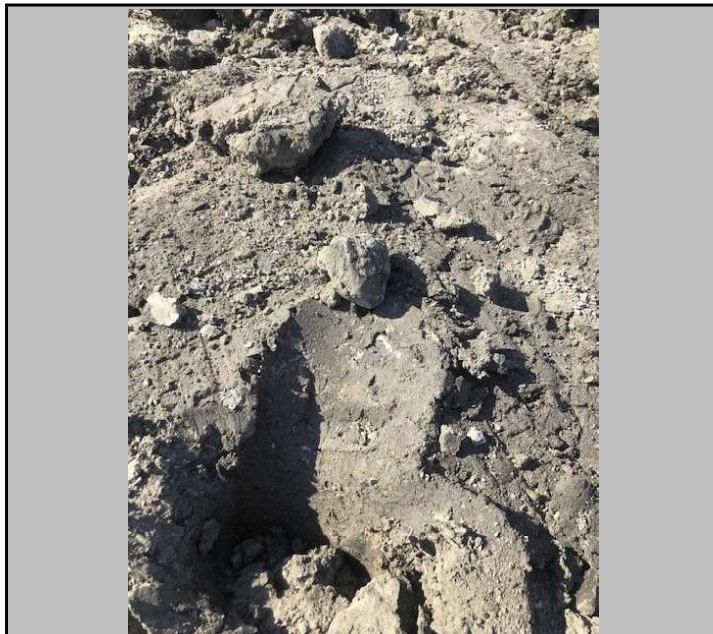
Photo #: 7

D186 Rock under probe

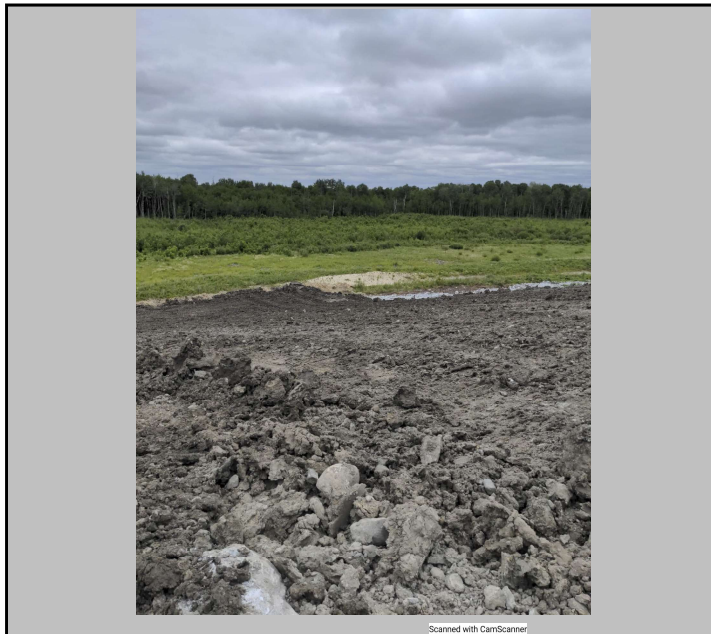
Photo #: 3

Panel 13 NCL Lift 3 completed.

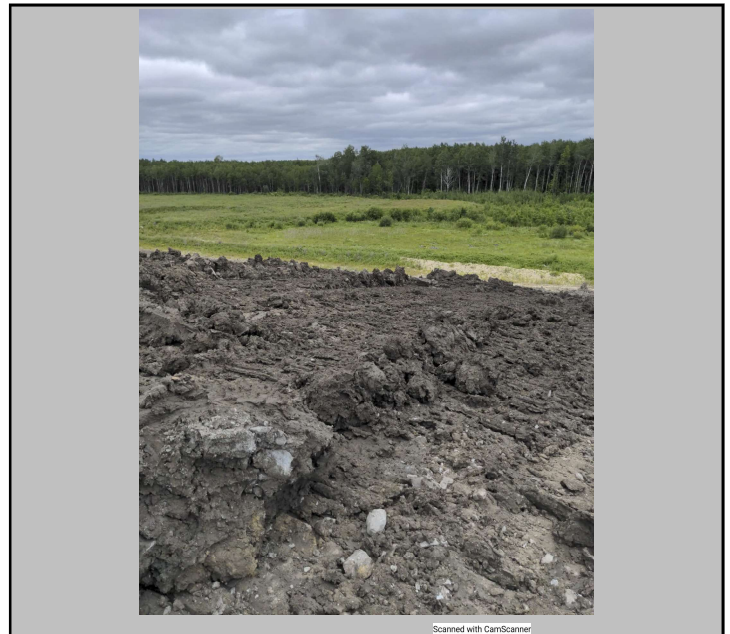
Photo #: 4

Panel 12 NCL Lift 4 placement.

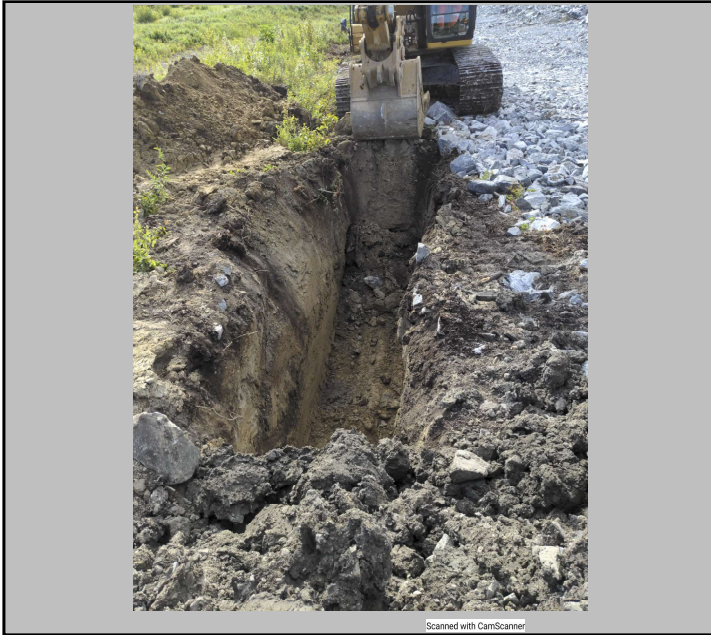
Photo #: 1

Key Trench 2+403 to 2+360.

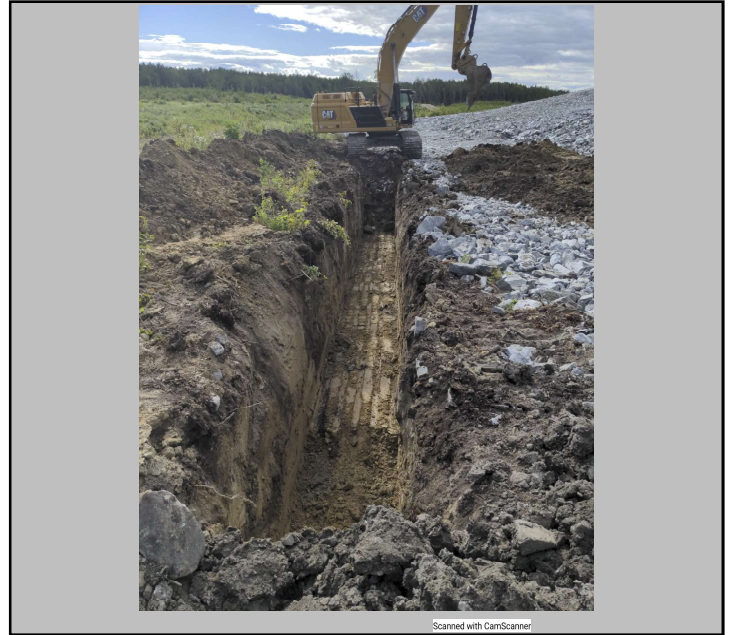
Photo #: 2

Key Trench 2+403 to 2+360.

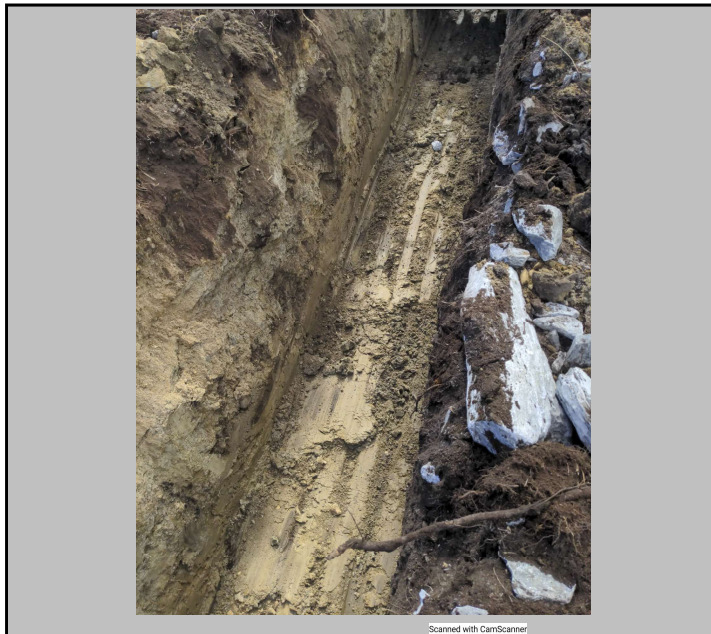
Photo #: 3

Key Trench 2+403 to 2+360.

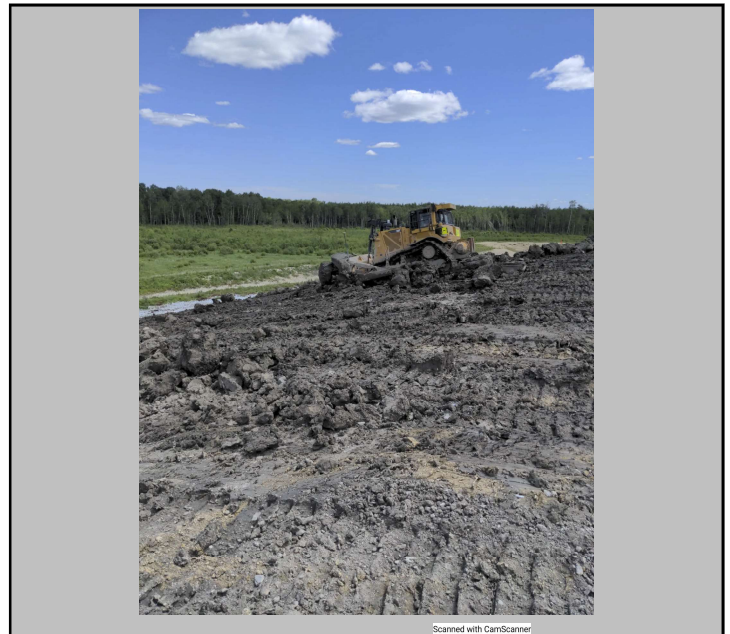
Photo #: 4

D8-1 placing Panel 14 CCL Lift 1.

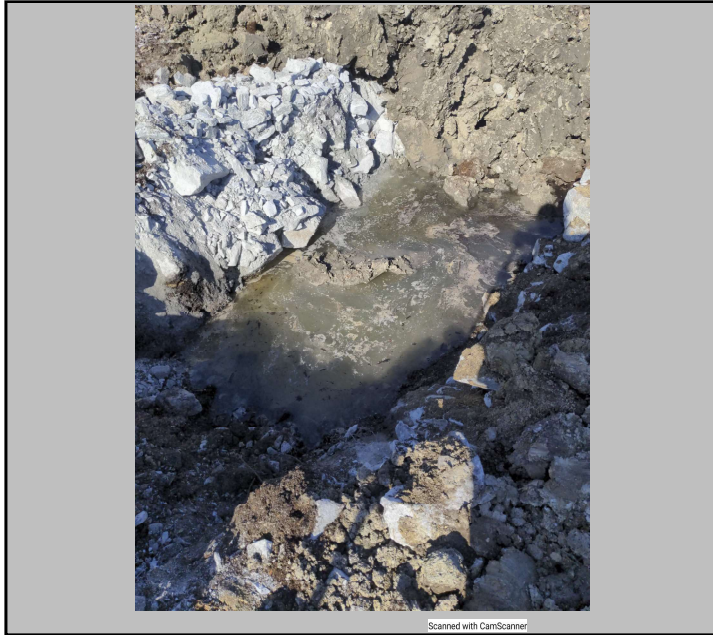
Photo #: 1

Key Trench built to 2+357 filled with water over night.

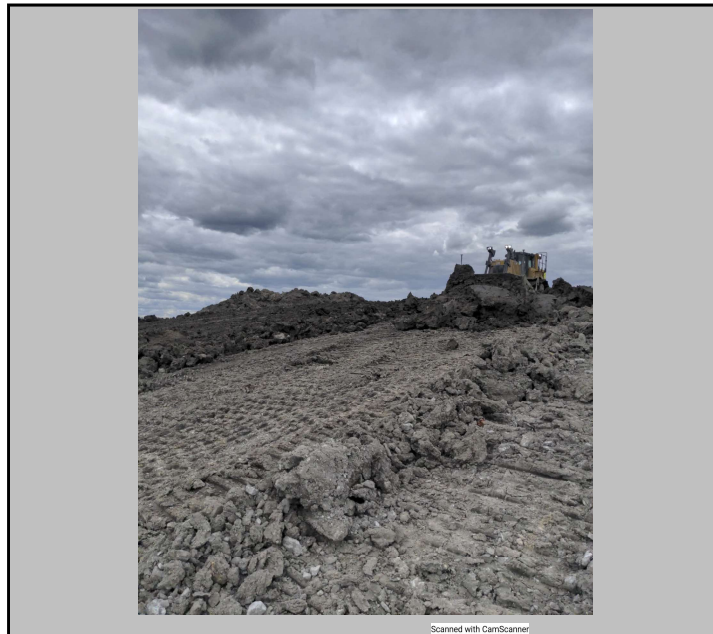
Photo #: 3

Panel 14 CCL Lift 2 placement.

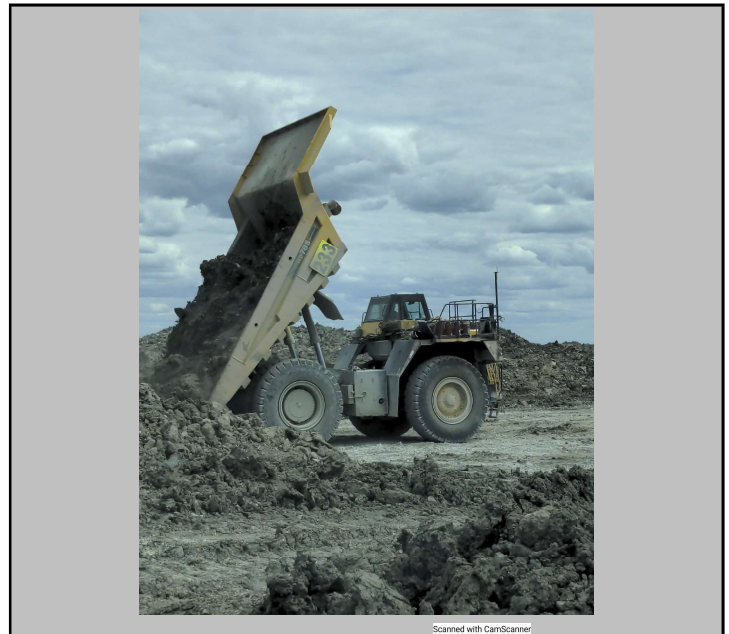
Photo #: 4

Dumping material for Panel 13 NCL Lift 4.

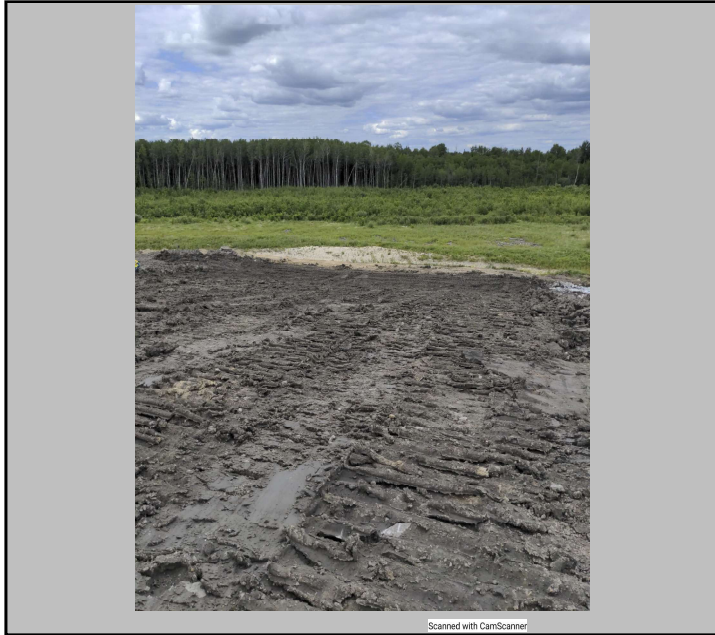
Photo #: 5

Panel 14 CCL Lift 2 prior to packing.

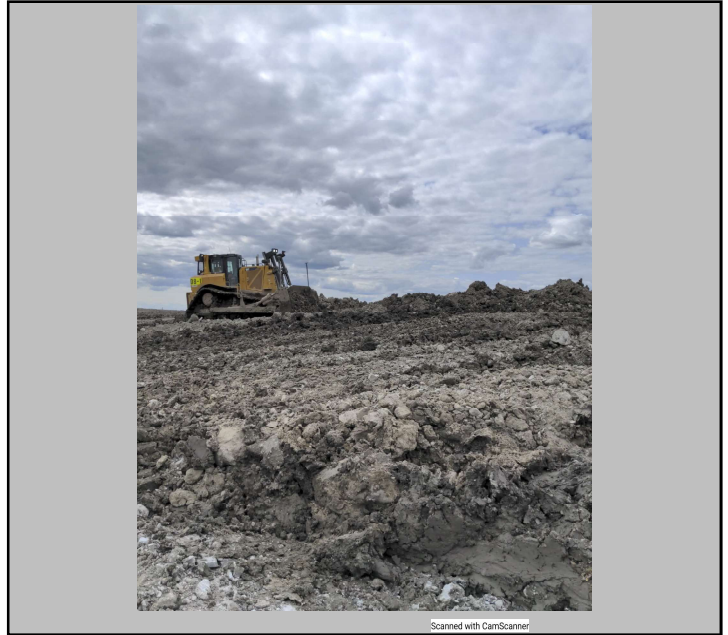
Photo #: 6

Placing Panel 13 NCL Lift 4.

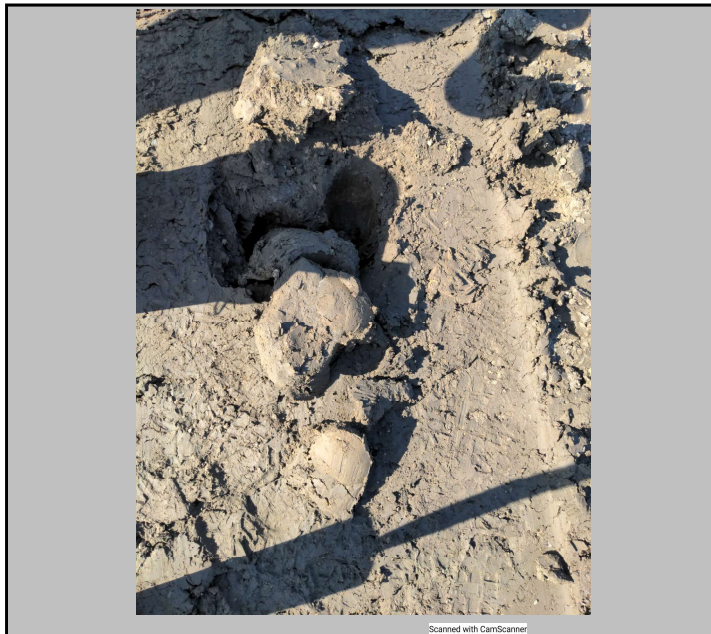
Photo #: 3

Test D212 Rock in probe hole.

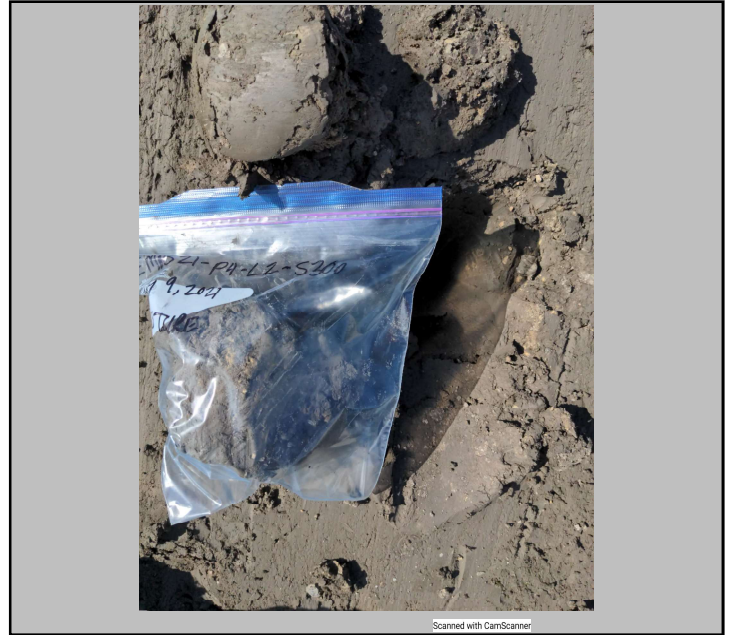
Photo #: 5

EMRS21-P14-L2-S299.

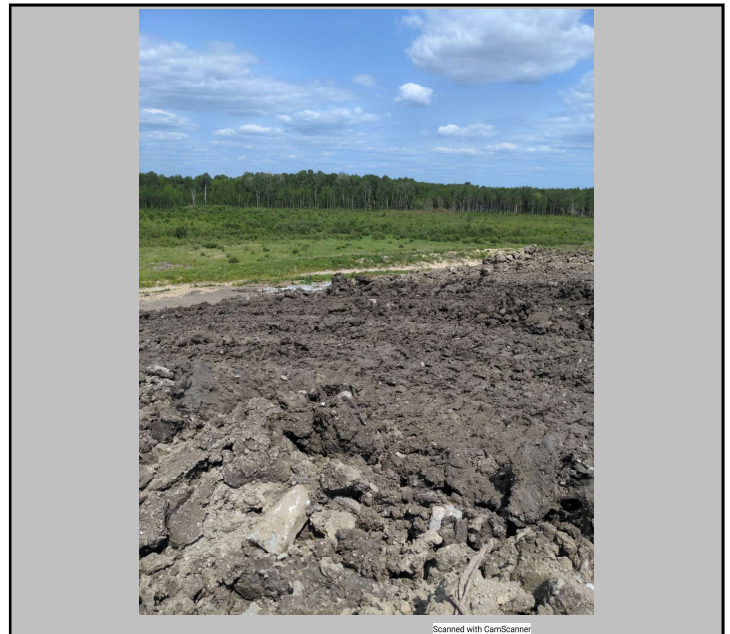
Photo #: 7

Panel 14 CCL Lift 2 complete.

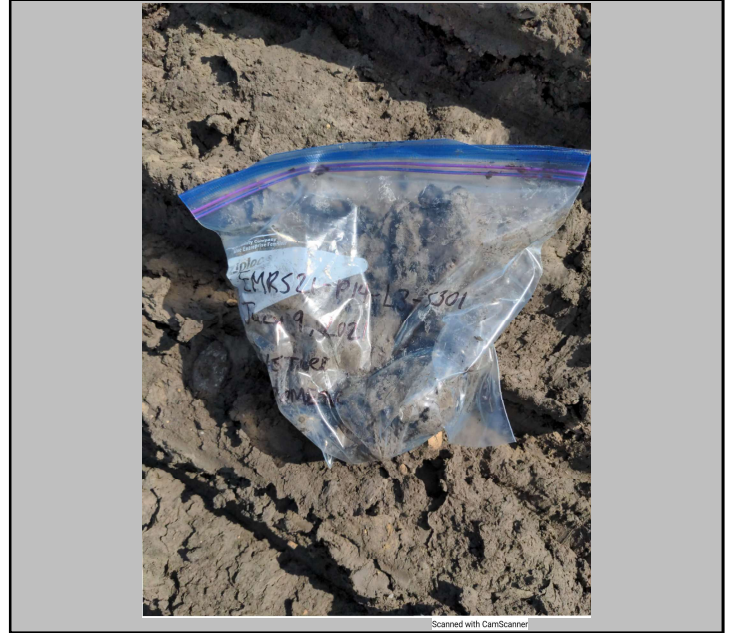
Photo #: 9

Panel 14 NCL Lift 3 placement.

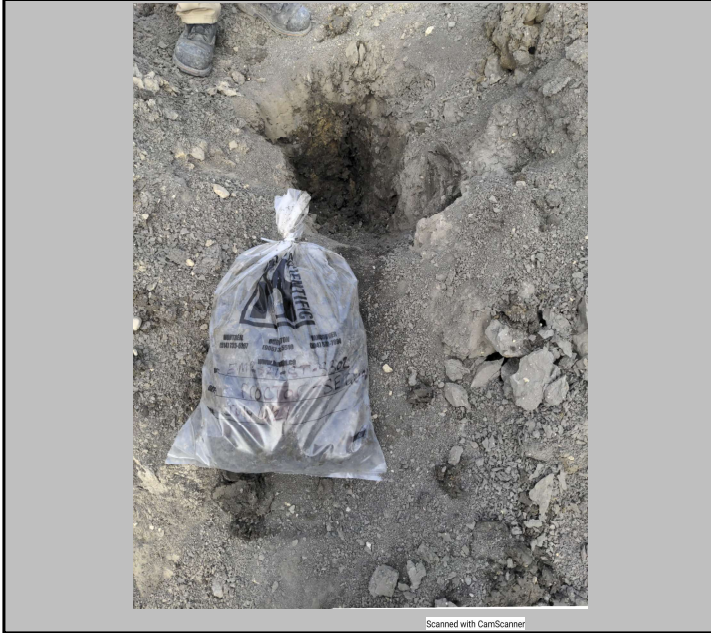
Photo #: 1

EMRS South East Quadrant Stockpile Proctor Sample. EMRS21-ST-S302.
