PHOTOGRAPHS

Date:	June 19, 2021	Owner/Client:	New Gold Inc.
Day:	Saturday	OKC Project #:	1003-19
Prepared by:	Martin Moore	Project Location:	Rainy River - Ontario

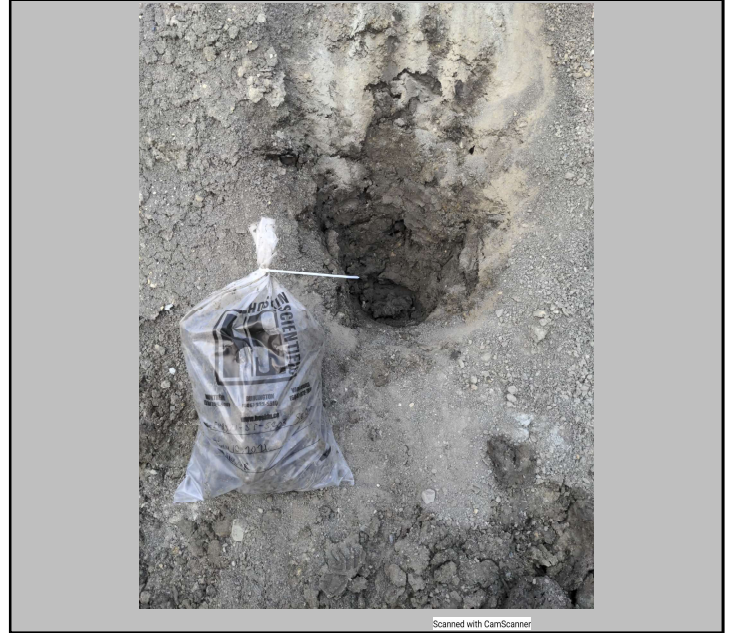
Photo #: 2

EMRS South East Quadrant Stockpile Proctor Sample. EMRS21-ST-S303.

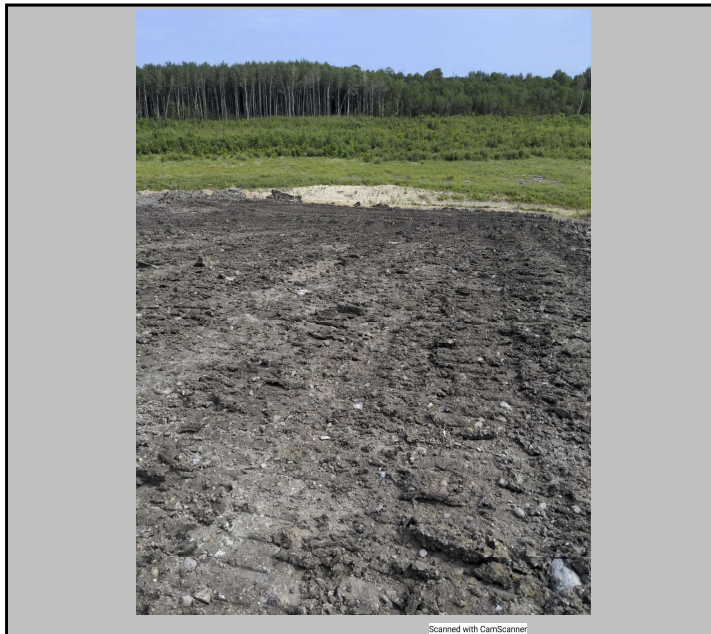
Photo #: 3

Panel 14 NCL Lift 3.

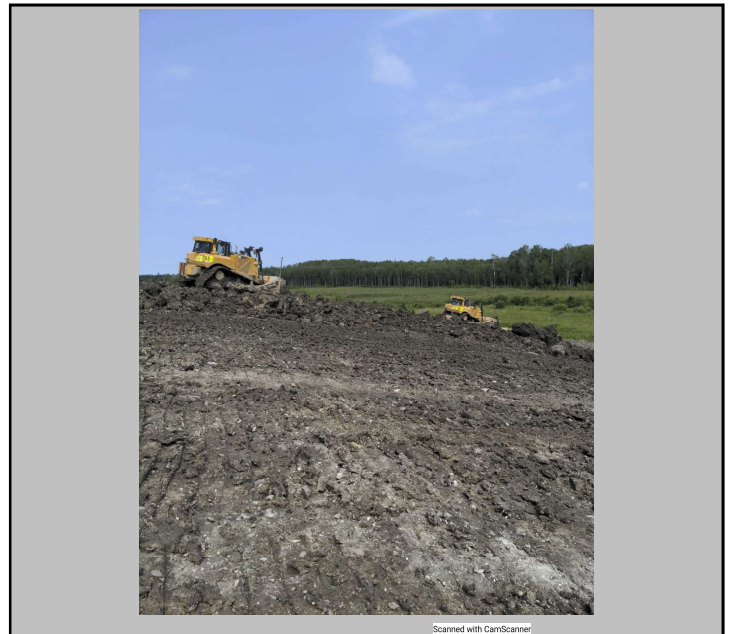
Photo #: 4

Panel 13 NCL Lift 4 placement.

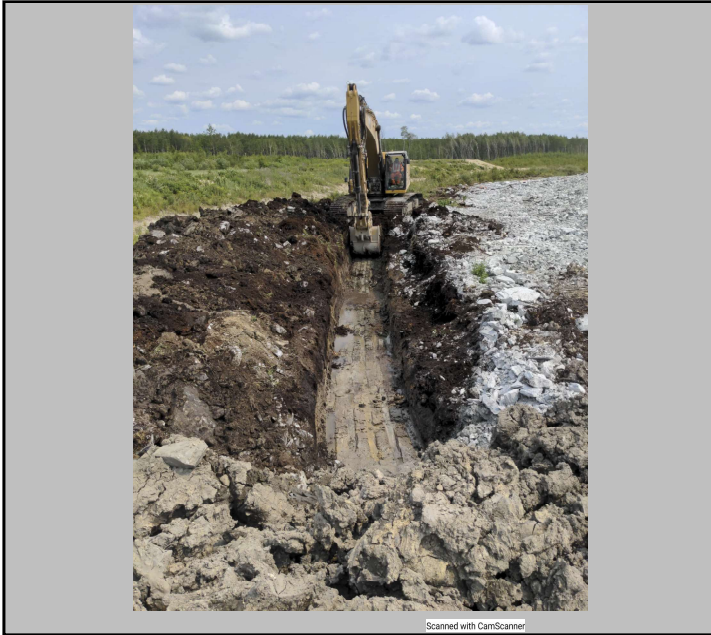
Photo #: 5

Key Trench excavation.

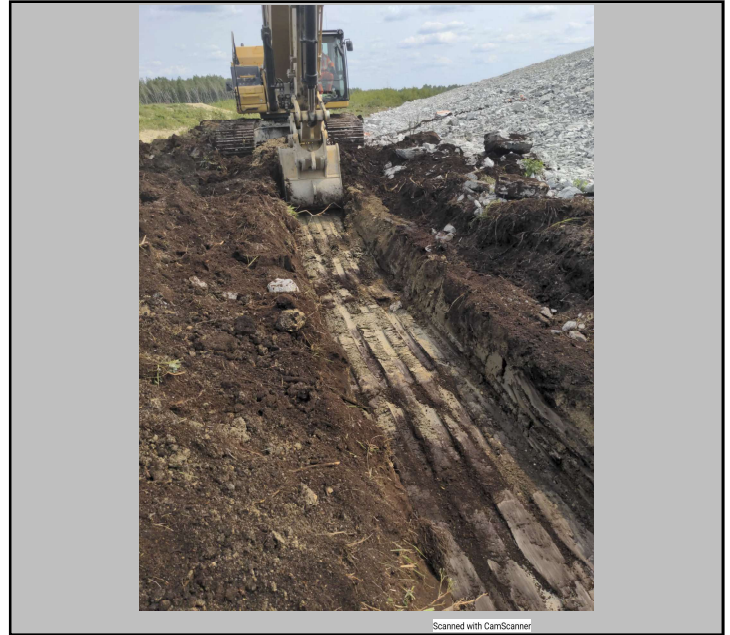
Photo #: 6

Key Trench excavation.

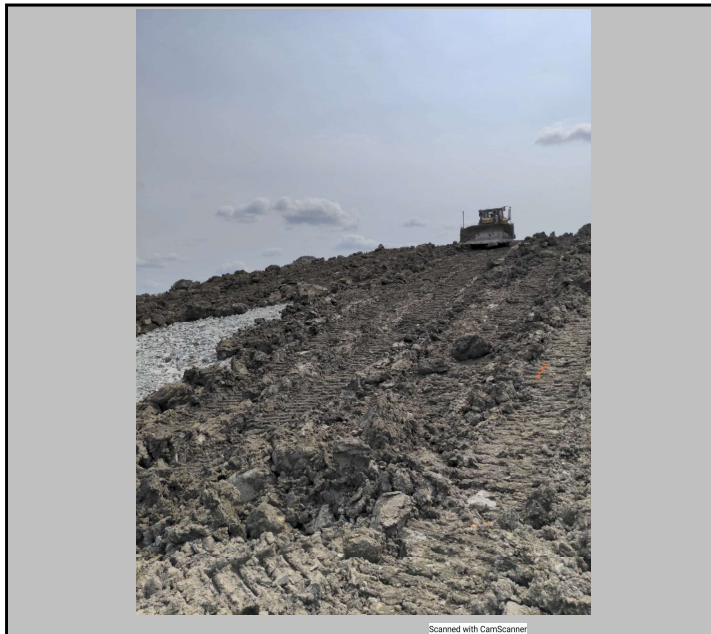
Photo #: 7

Panel 15 CCL Lift 1 placement.

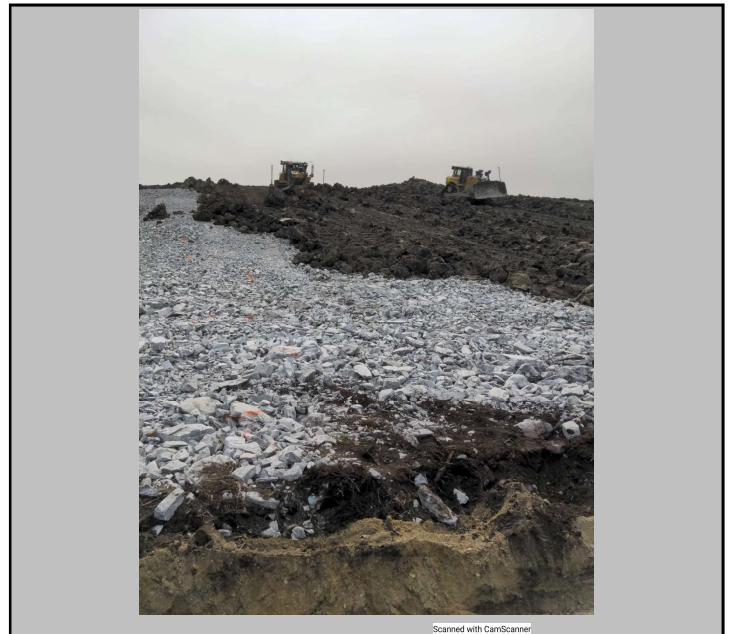
Photo #: 8

Panel 15 CCL Lift 1 placement.

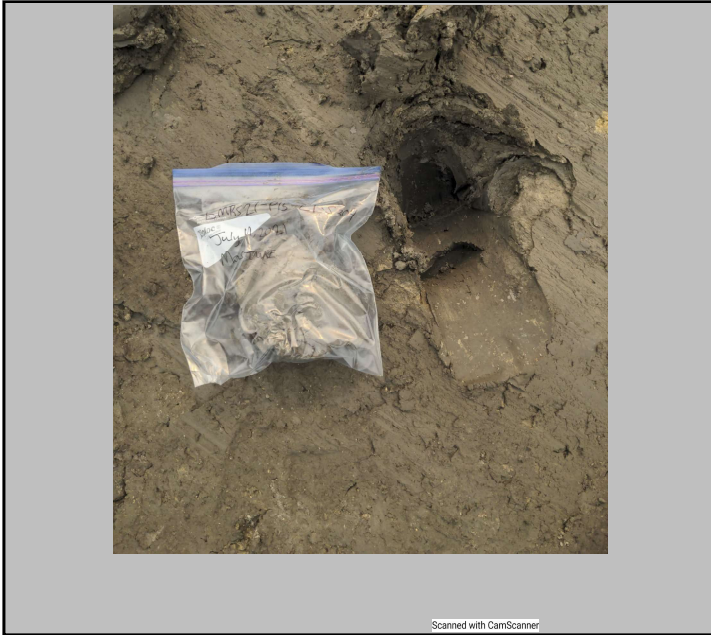
Photo #: 1

EMRS21-P15-L1-S304.

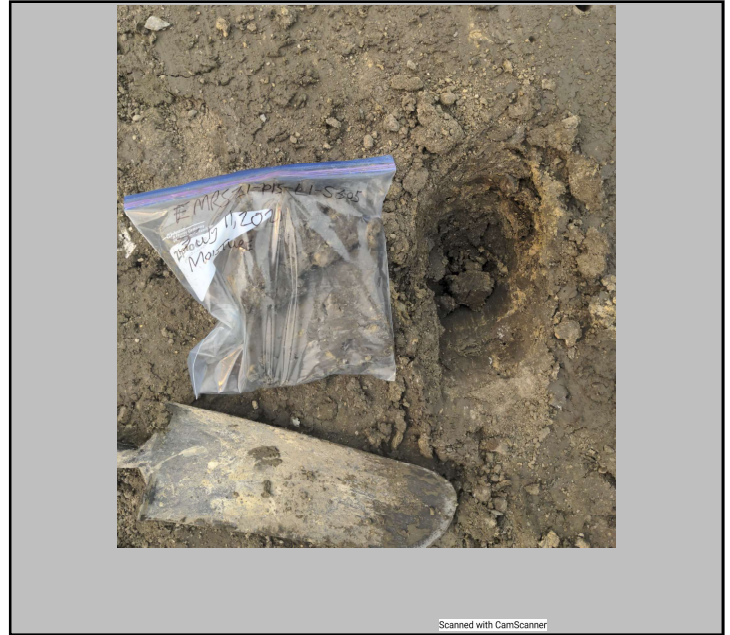
Photo #: 2

EMRS21-P15-L1-S305.

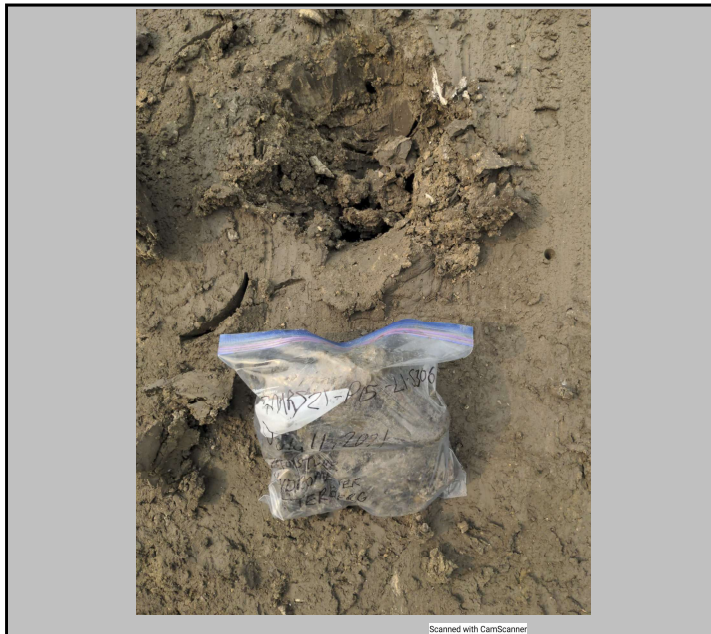
Photo #: 3

EMRS21-P15-L1-S306.

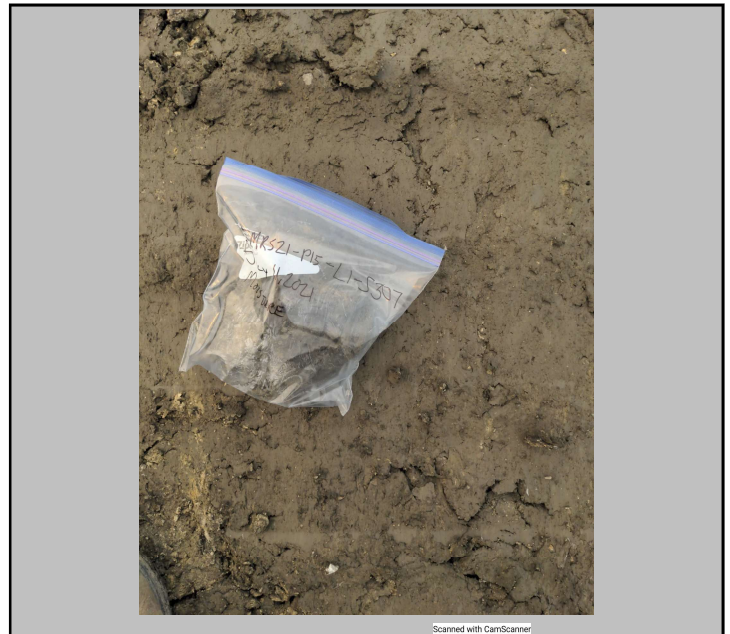
Photo #: 4

EMRS21-P15-L1-S307.

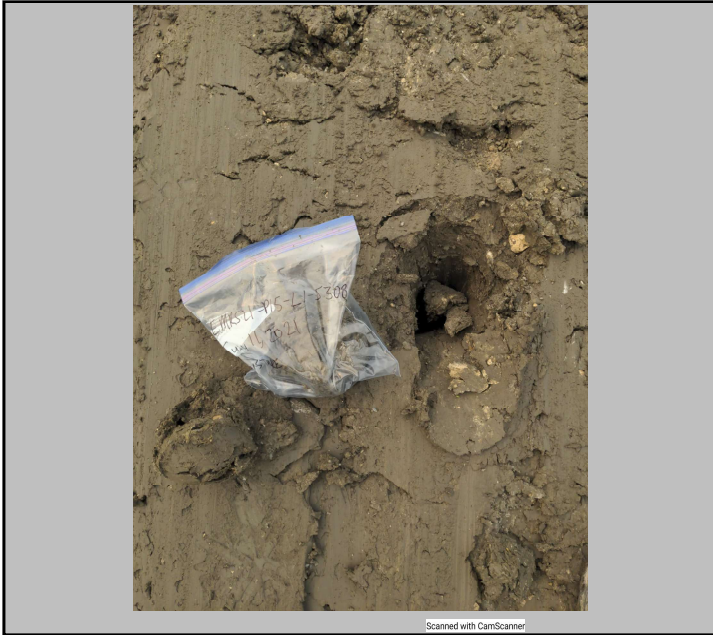
Photo #: 5

EMRS21-P15-L1-S308.

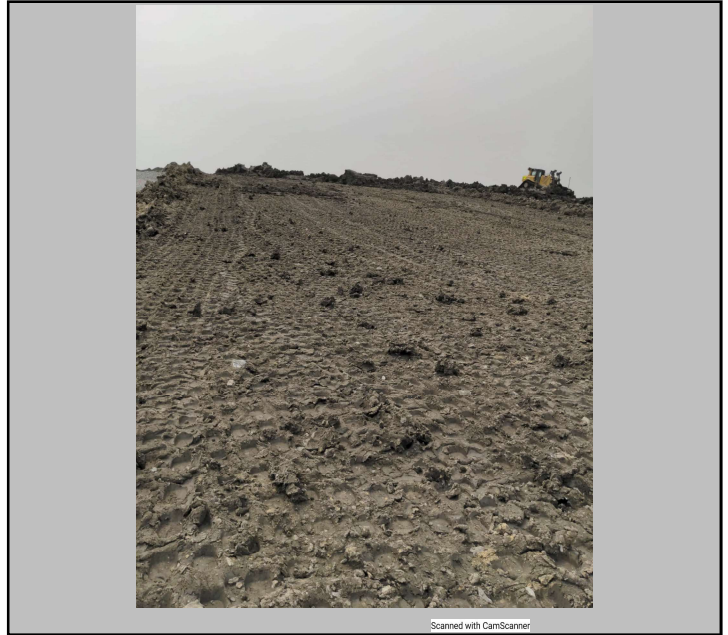
Photo #: 6

Panel 15 CCL Lift 1 complete.

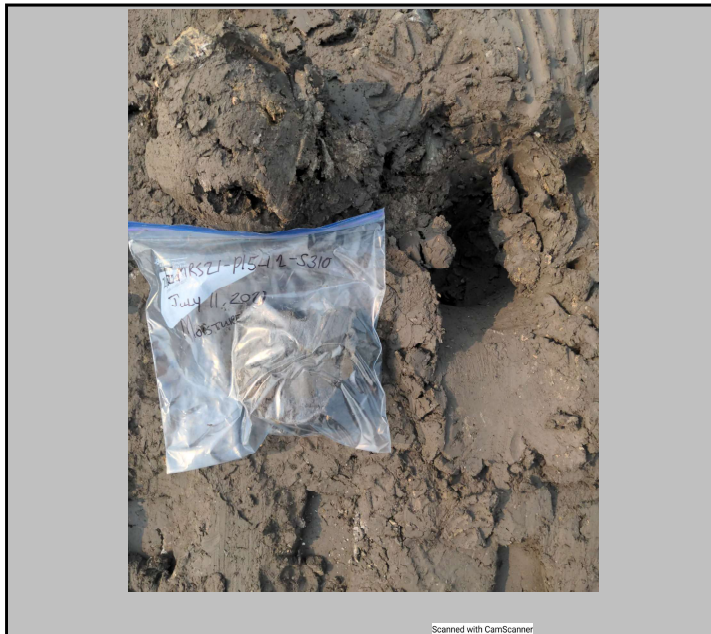
Photo #: 3

EMRS21-P15-L2-S310.

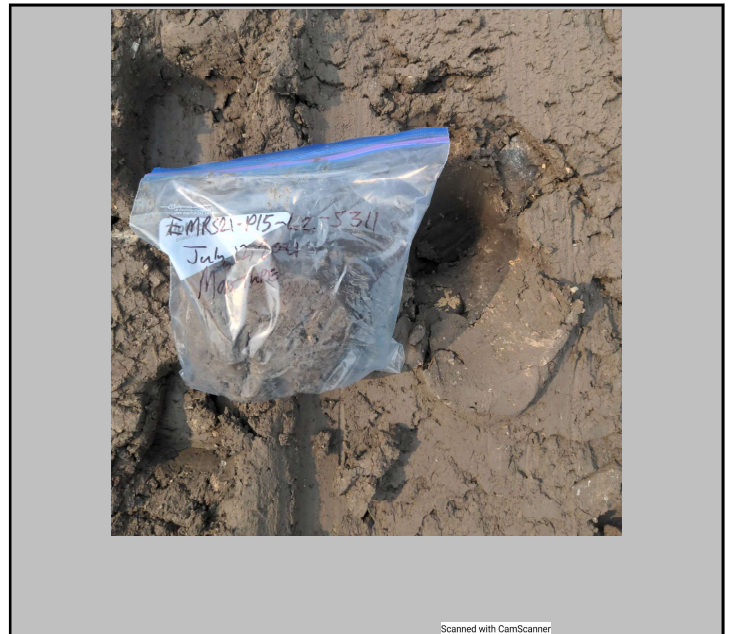
Photo #: 4

EMRS21-P15-L2-S311.

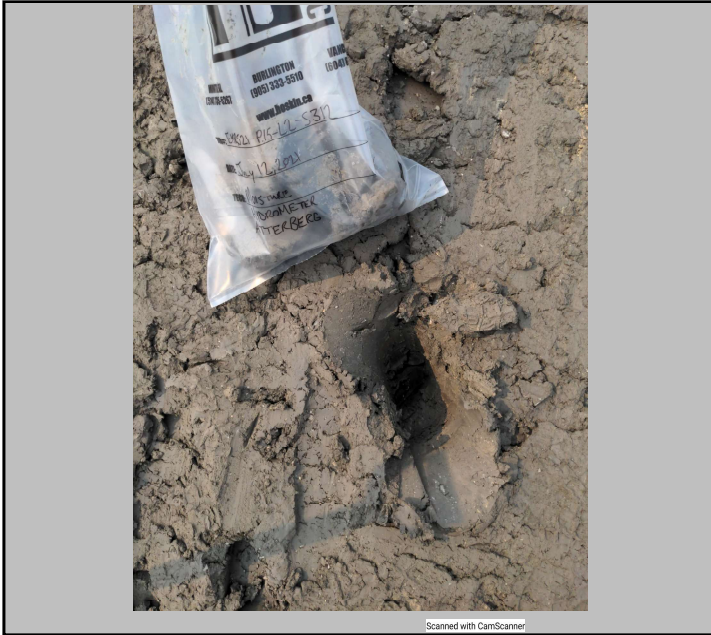
Photo #: 5

EMRS21-P15-L2-S312.

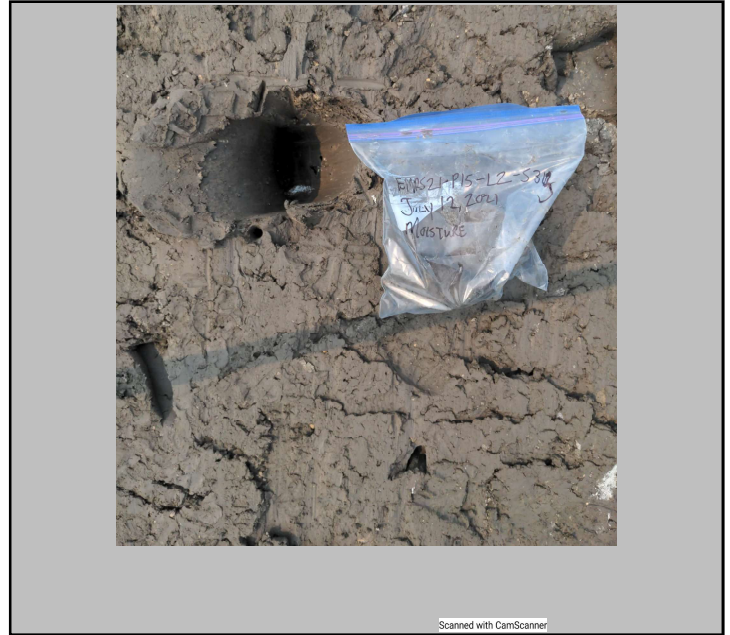
Photo #: 6

EMRS21-P15-L2-S313.

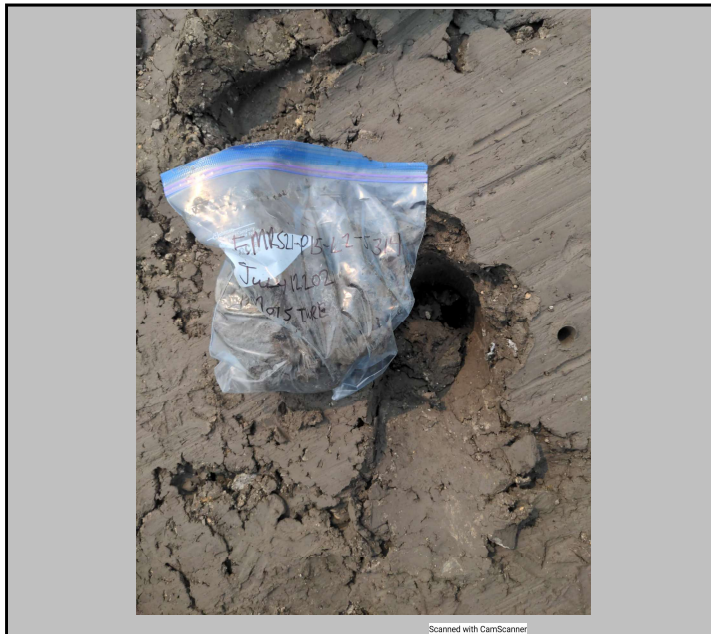
Photo #: 7

EMRS21-P15-L2-S314.

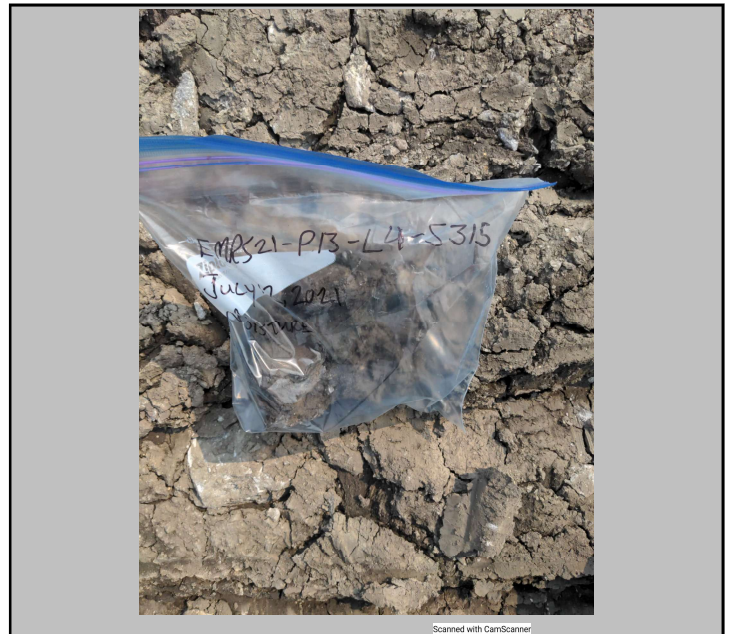
Photo #: 8

EMRS21-P13-L4-S315.

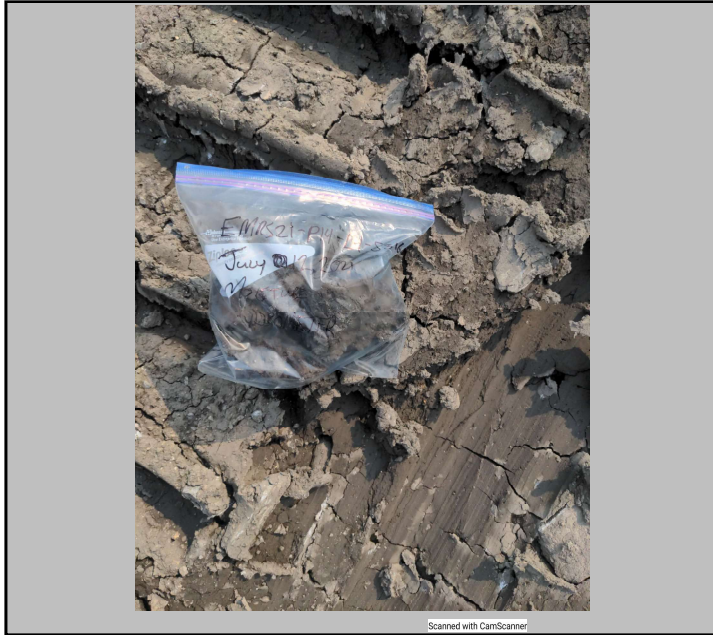
Photo #: 9

EMRS21-P14-L4-S316.

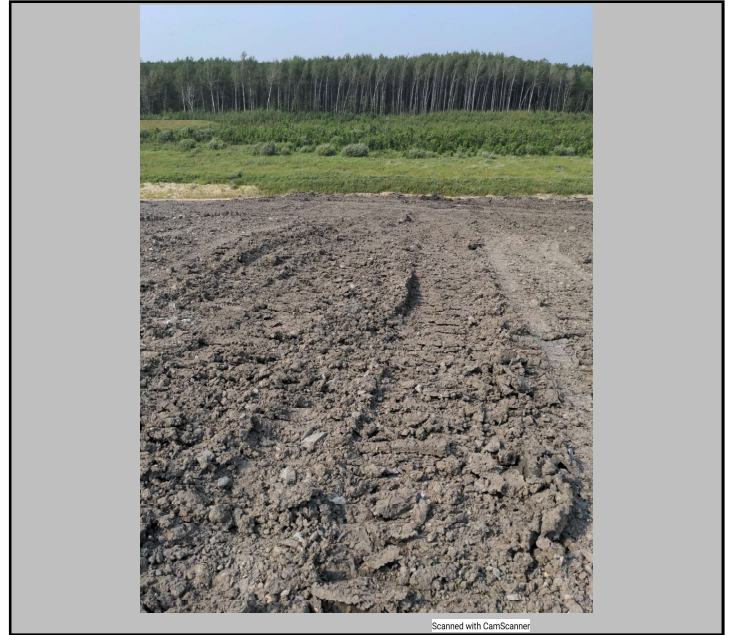
Photo #: 10

Panel 13 NCL Lift 4.

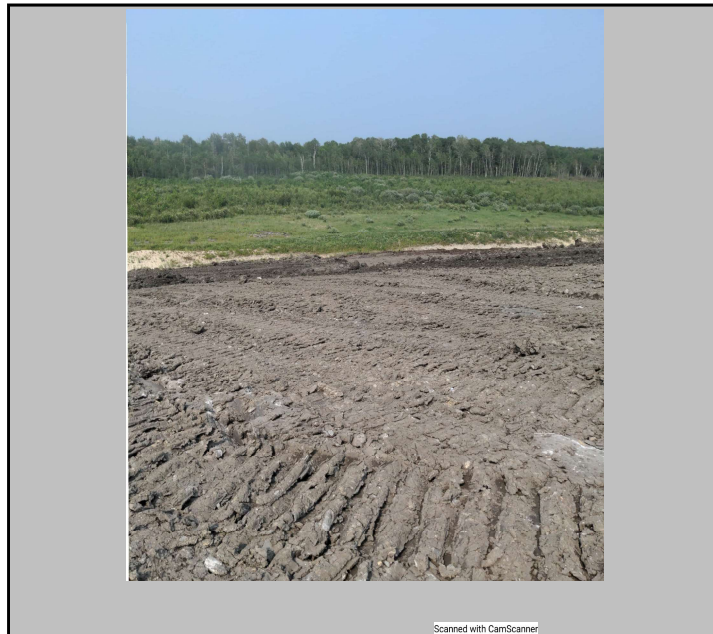
Photo #: 11

Panel 14 NCL Lift 4.

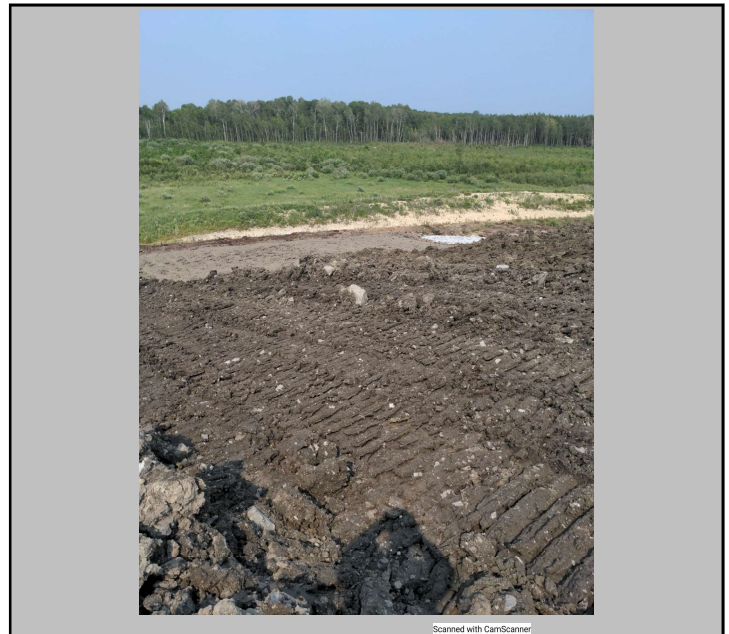
Photo #: 12

Panel 15 NCL Lift 3.

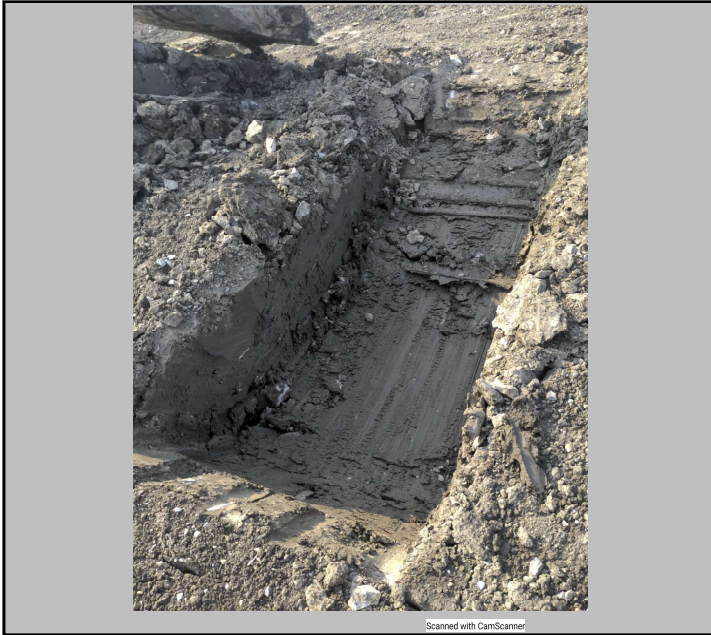
Photo #: 1

Okane Borehole excavation 2+804 O/S -68m.

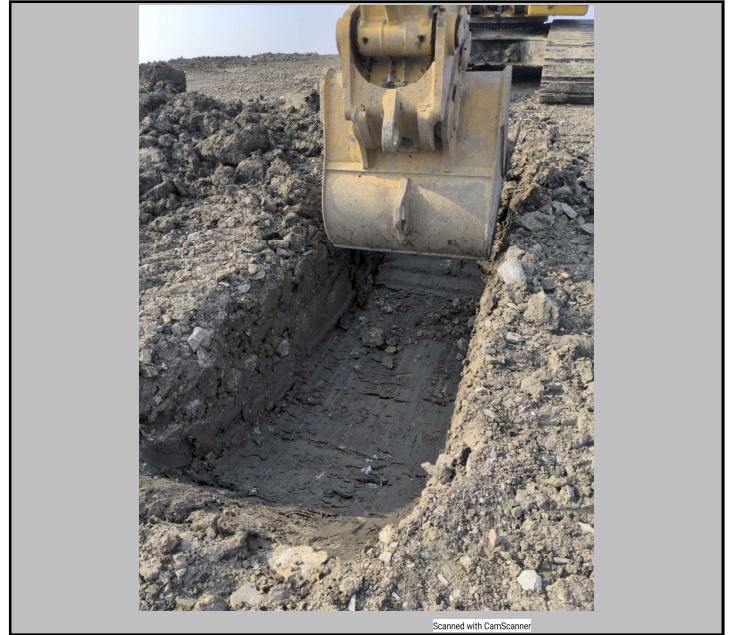
Photo #: 2

Okane Borehole excavation 2+649.5 O/S -34m.

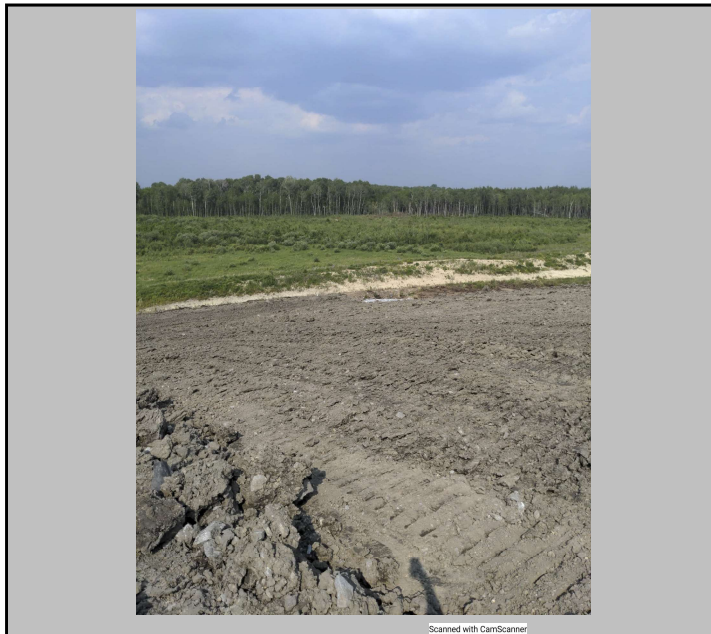
Photo #: 3

Panel 15 NCL Lift 3.

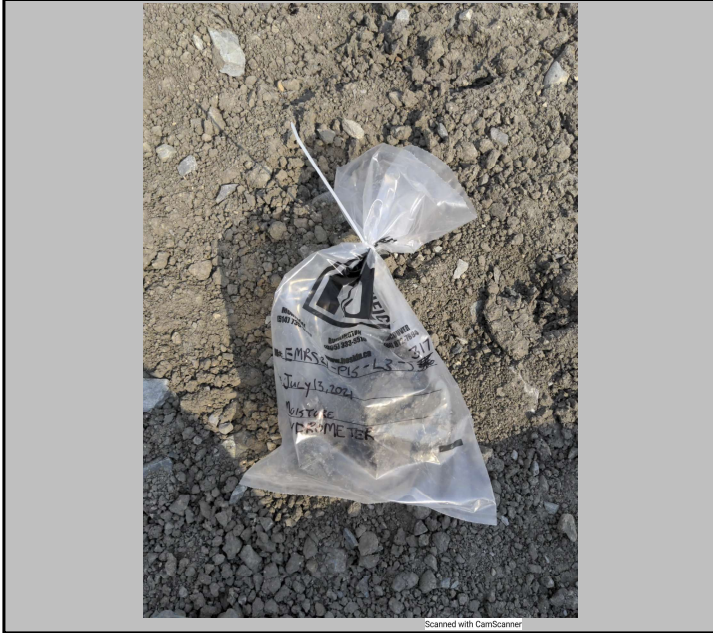
Photo #: 5

EMRS21-P15-L3-S317.

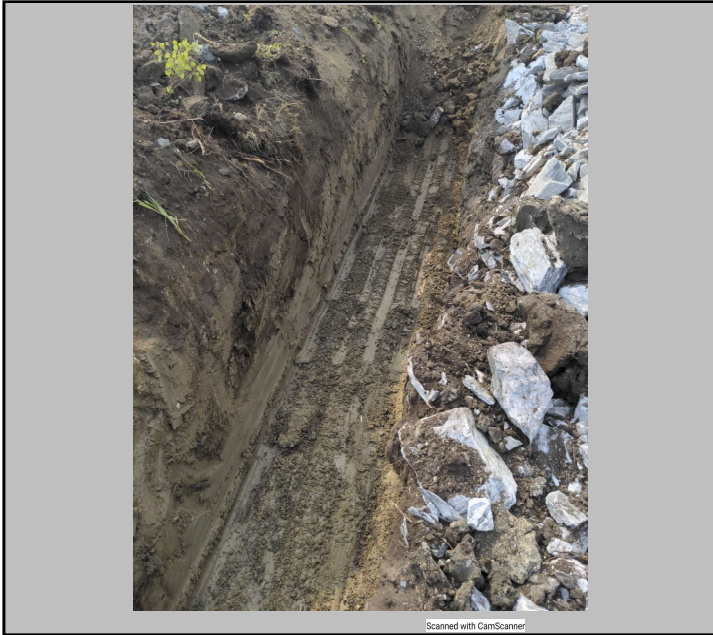
Photo #: 1

Key Trench

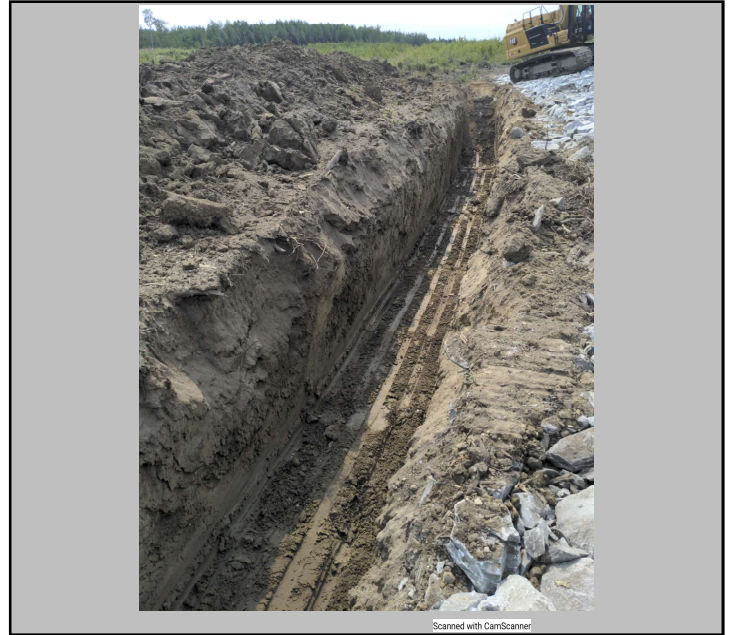
Photo #: 2

Key Trench

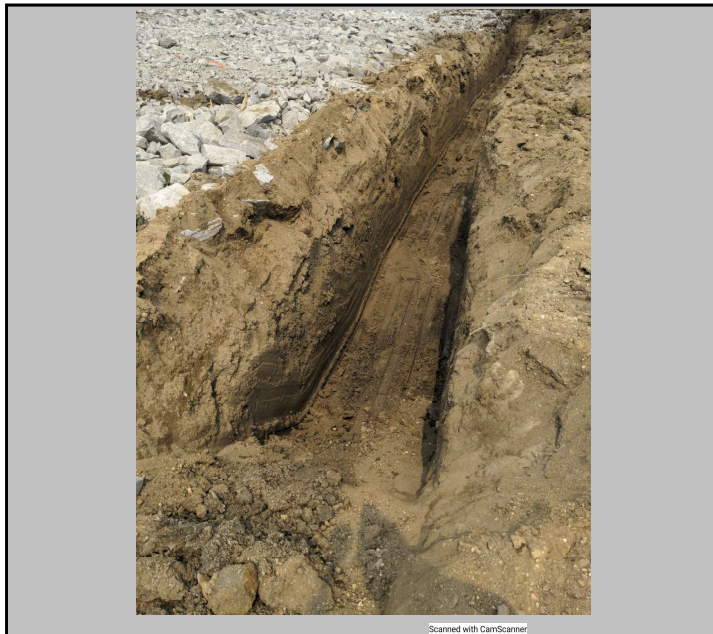
Photo #: 3

Key Trench

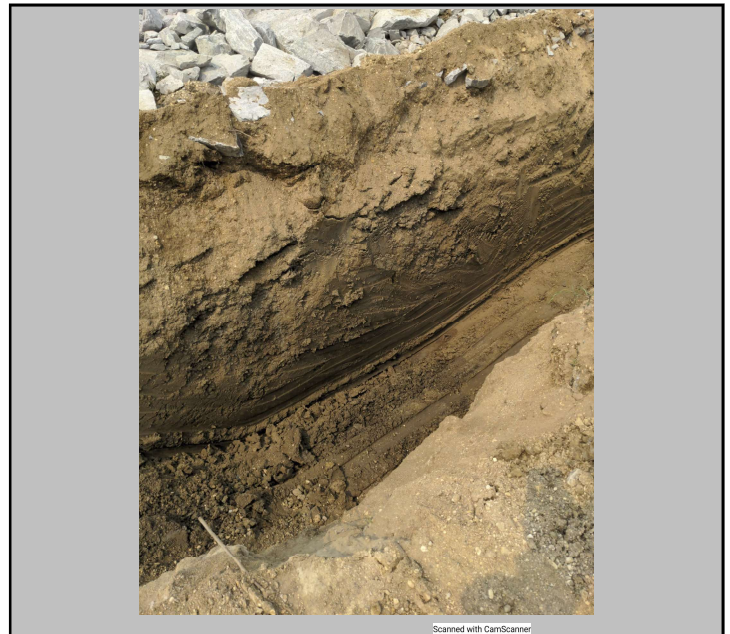
Photo #: 4

Key Trench

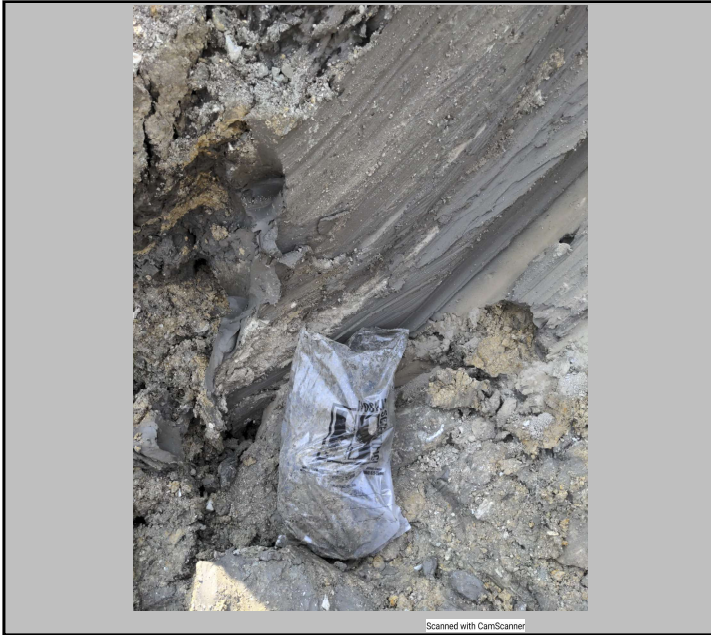
Photo #: 5

EMRS21-ST-S318.

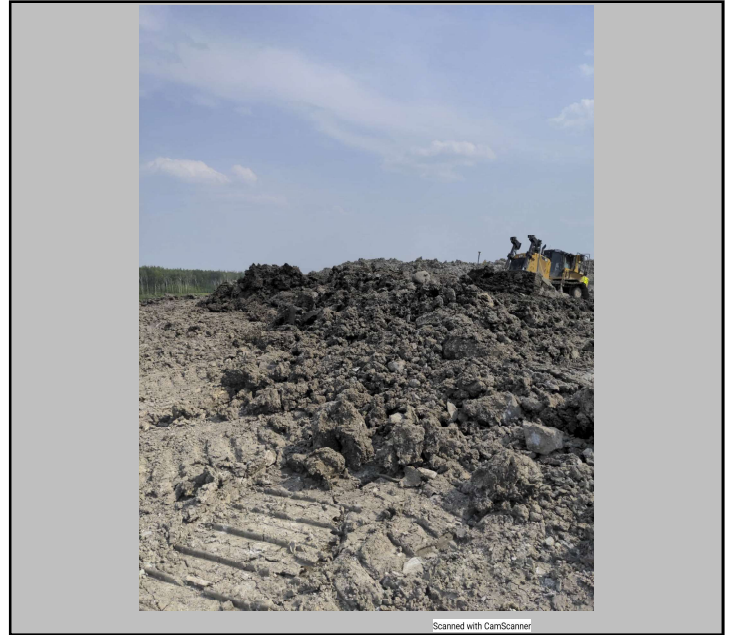
Photo #: 6

Panel 15 NCL Lift placement.

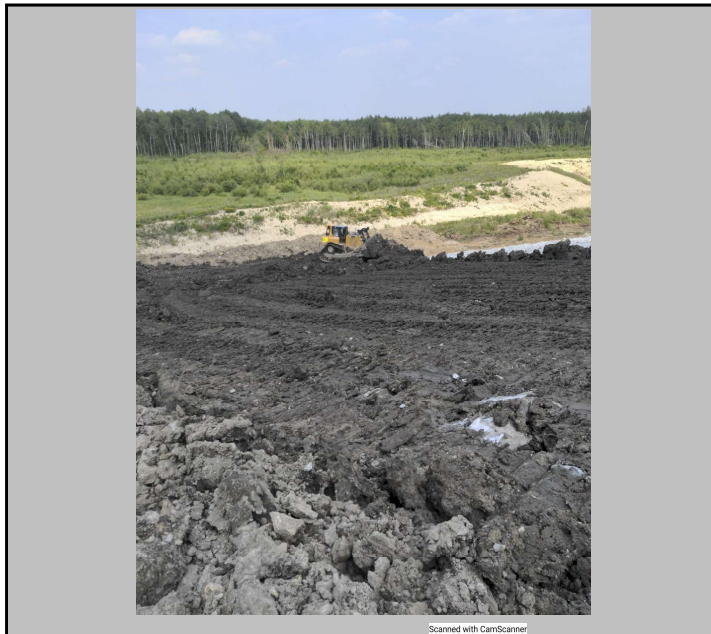
Photo #: 7

Panel 16 CCL Lift 1.
