Date:	July 16, 2021	Owner/Client:	New Gold Inc.
Day:	Friday	OKC Project #:	1003-19
Prepared by:	Martin Moore	Project Location:	Rainy River - Ontario

Date:	July 17, 2021	Owner/Client:	New Gold Inc.
Day:	Saturday	OKC Project #:	1003-19
Prepared by:	Martin Moore	Project Location:	Rainy River - Ontario

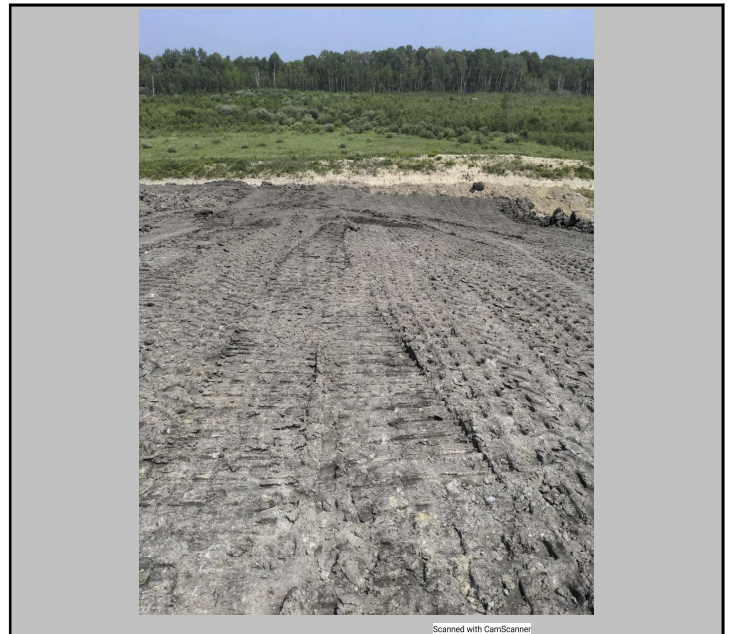
Photo #: 8

Panel 16 CCL Lift 2 complete.

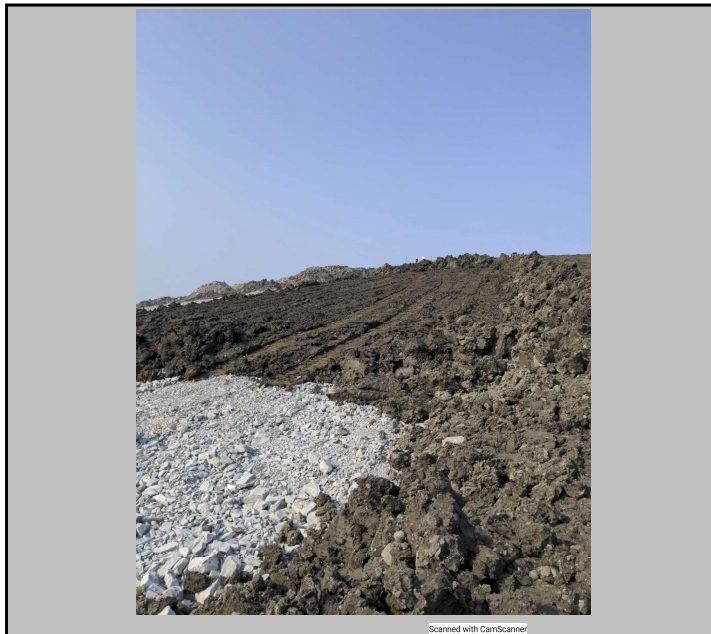
Photo #: 3

Panel 17 CCL Lift 1.

CCL material appeared dark grey/brown. The material appeared moist and pliable which could be rolled into strings without crumbling. Substantial amounts of large rocks found in stockpiled material Excavator 349 removing rocks from lift.

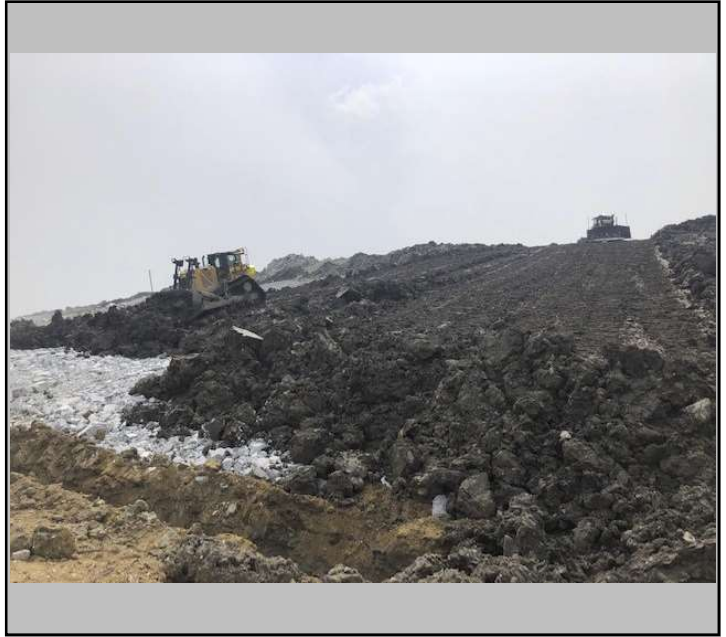
Photo #: 2

Panel 18 Lift 1

- Dozers filled in identified low spots
- Completed packing lift without vibration due to water present
- Carried out testing and sampling on CCL Lift 1
- Several rocks found while nuke testing giving many high compaction numbers and making the process take much longer
- Proctor taken from CCL Panel 18 Lift 1
- Dozers initiated pushing CCL Panel 18 Lift 2 for remainder of the day

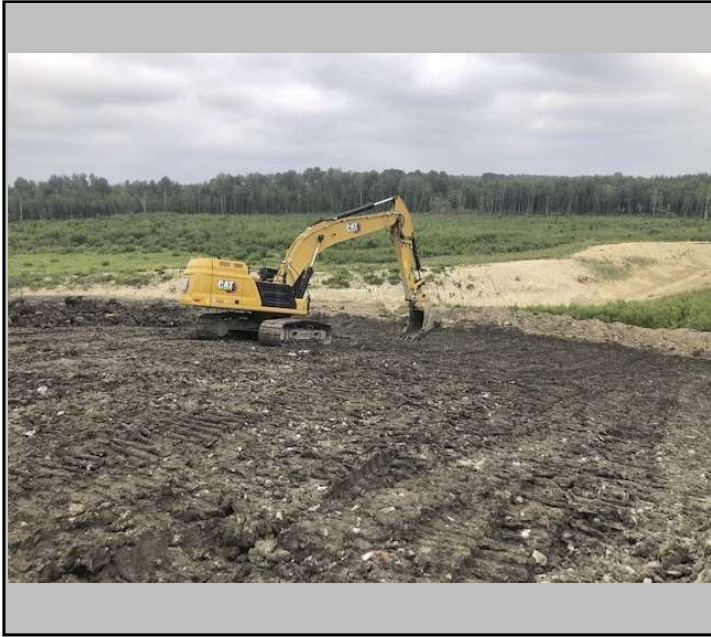
Photo #: 1

Excavator 349 removing rocks from Panel 18 L1

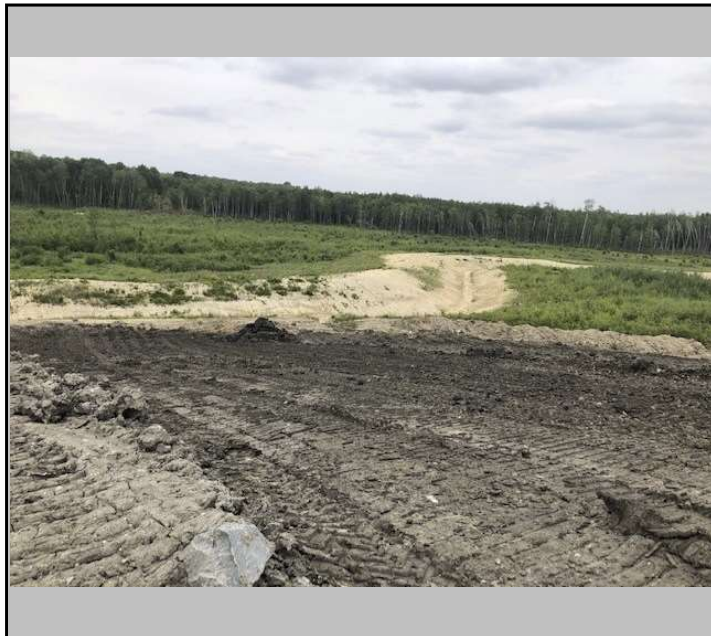
Photo #: 3

CCL Panel 17 Lift 2

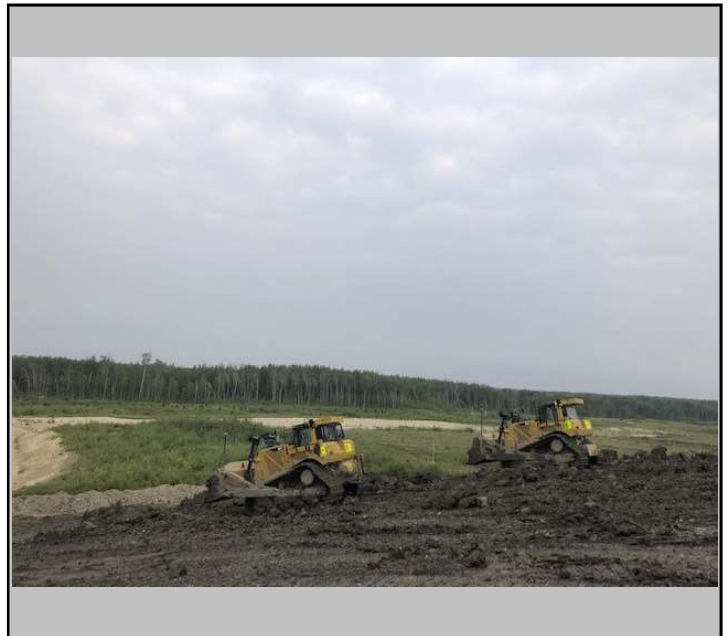
Photo #: 4

Dozers pushing CCL Panel 18 Lift 2

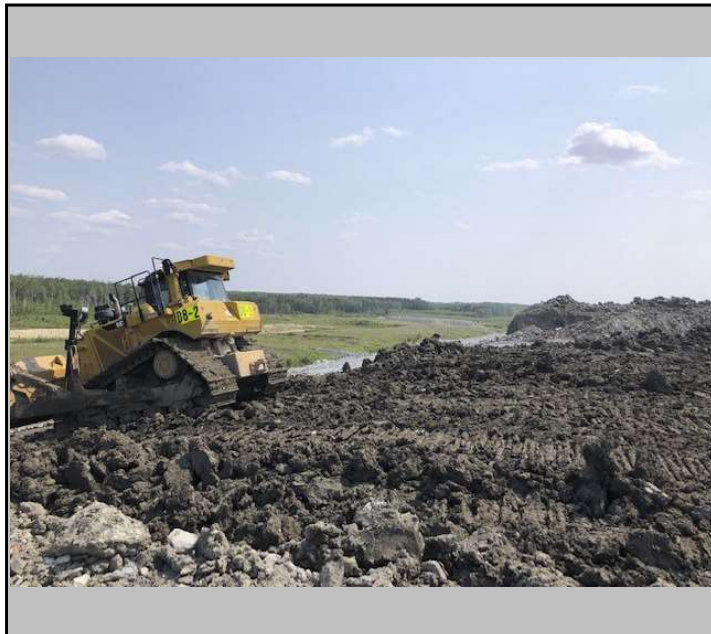
Photo #: 7

Panel 19 CCL Lift 2

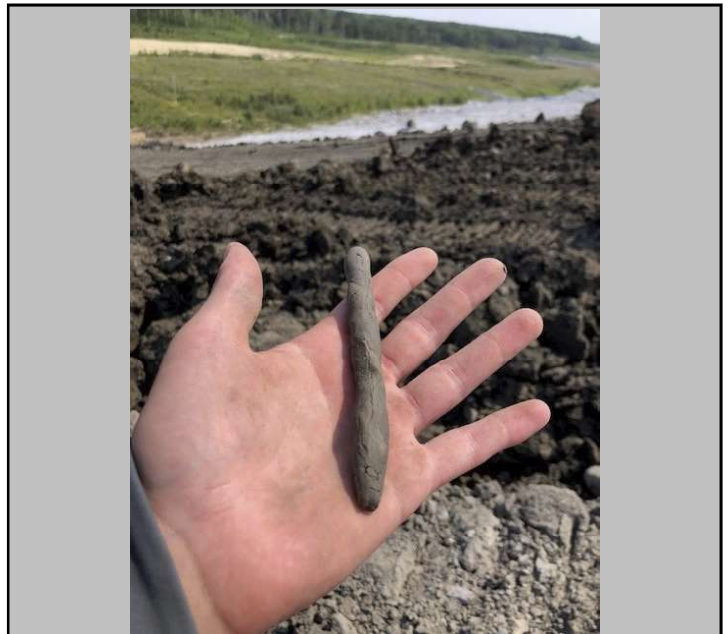
Photo #: 8

CCL Lift 2 material

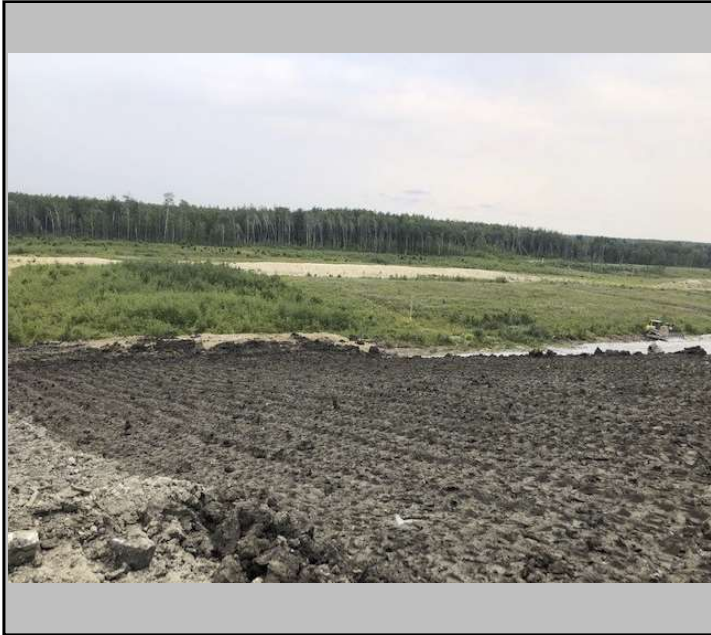
Photo #: 1

CCL Panel 19 Lift 2

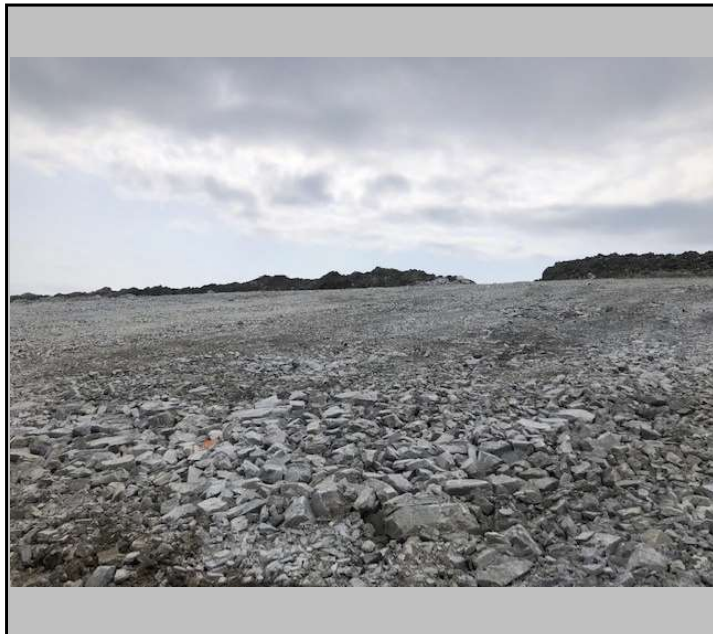
Photo #: 7

Approved base slope

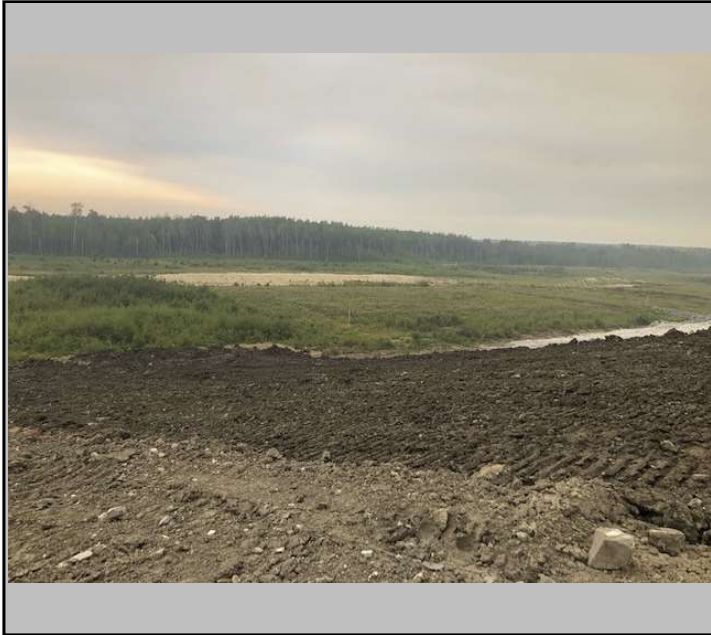
Photo #: 1

Panel 19 NCL Lift 3

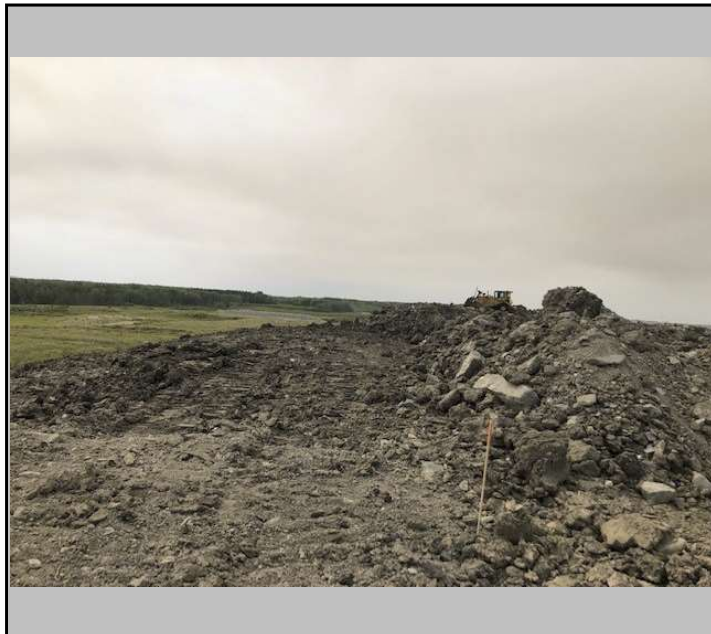
Photo #: 3

Panel 19 Lift 3 stockpiled ready for Lift 4

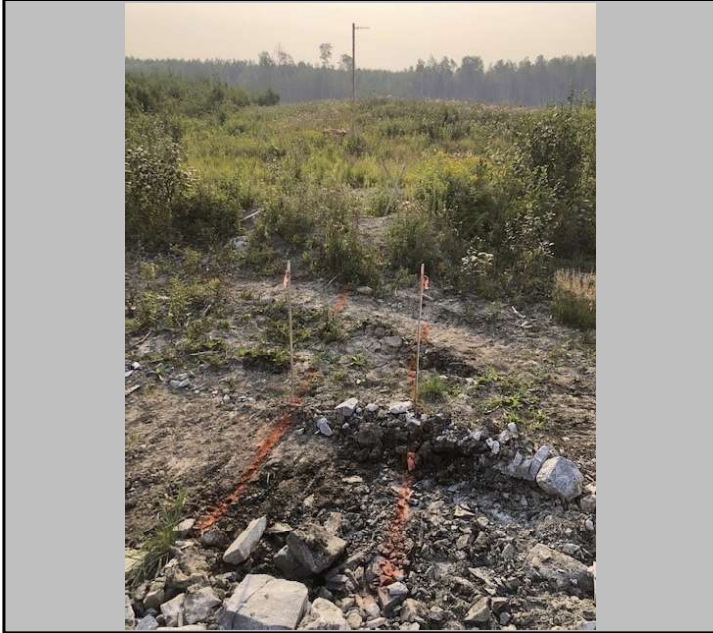
Photo #: 1

Utility Located Station 2+158.5

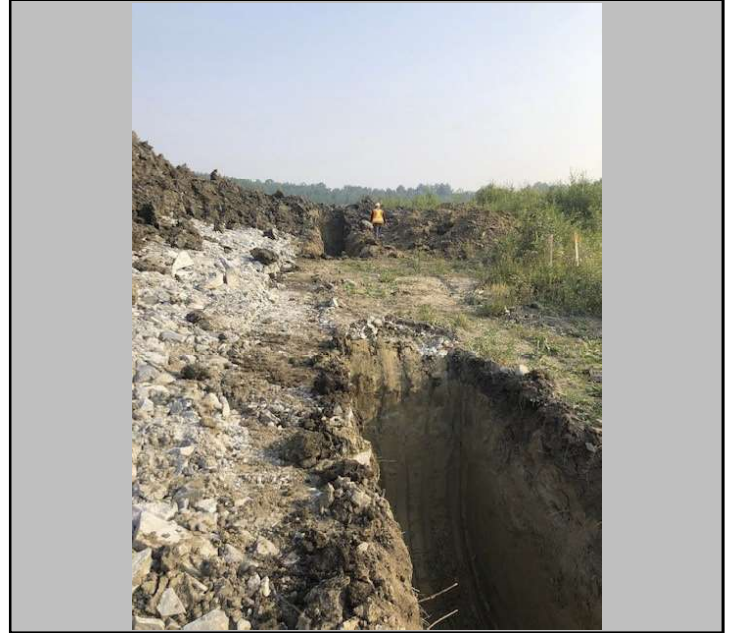
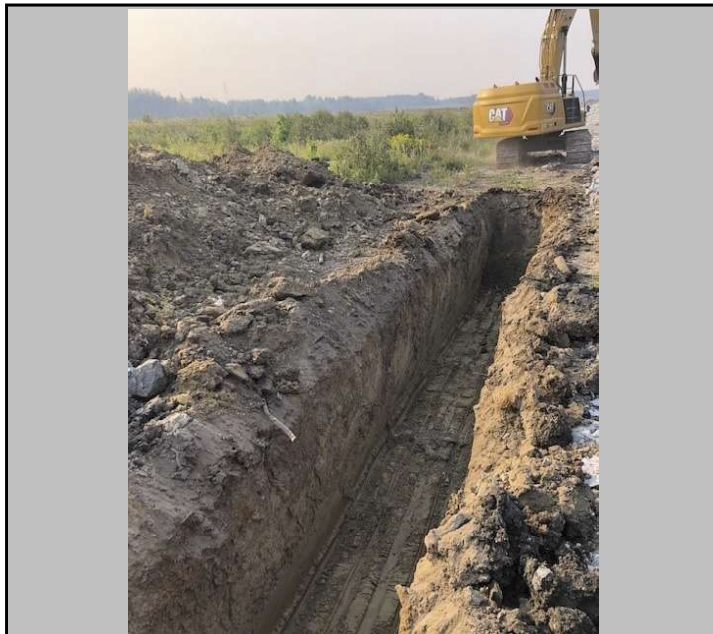
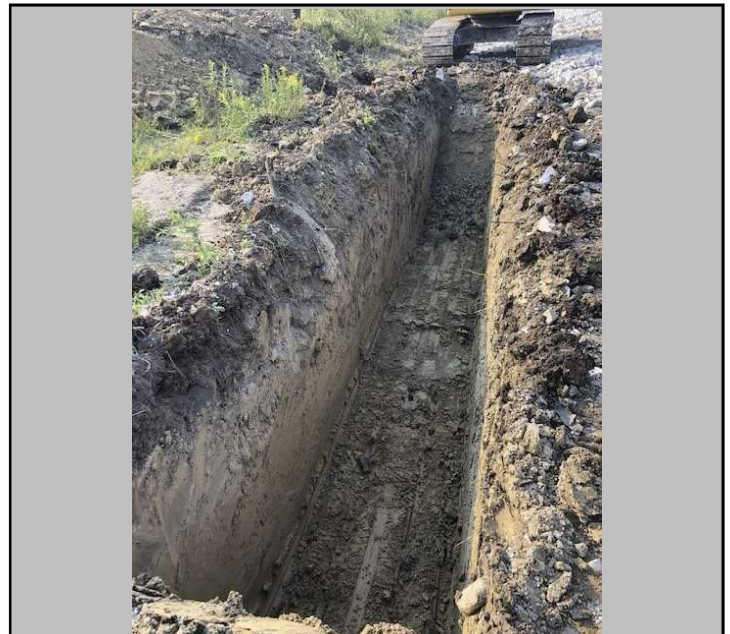
Key Trench Panel 20

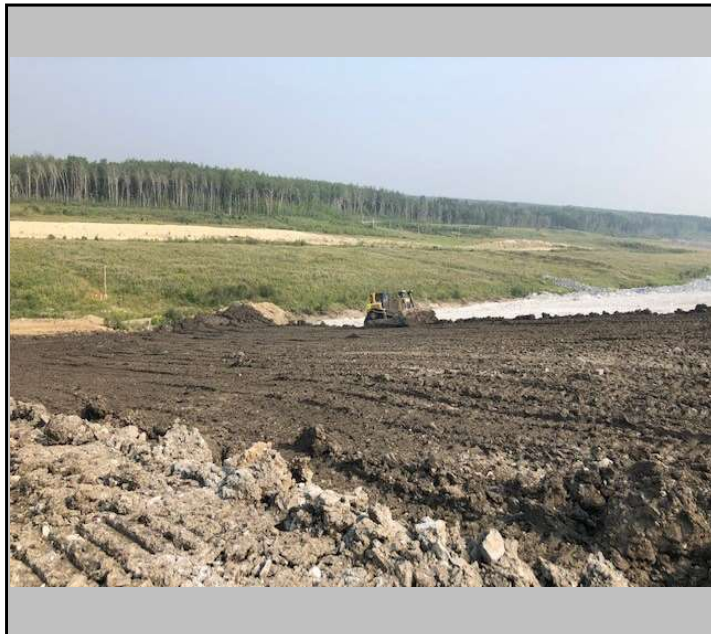
Photo #: 11

Panel 20 CCL Lift 2

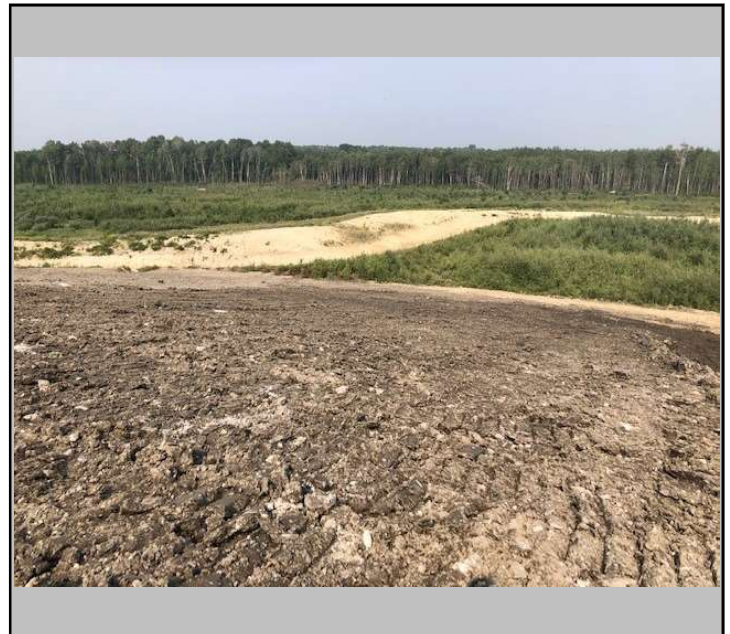
Photo #: 12

Panel 19 NCL Lift 4

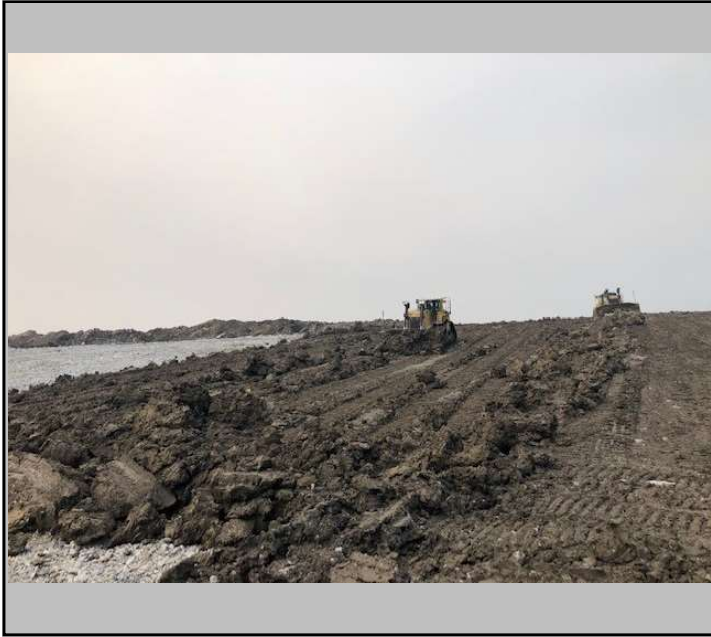
Photo #: 1

Panel 21 CCL L1 Placement

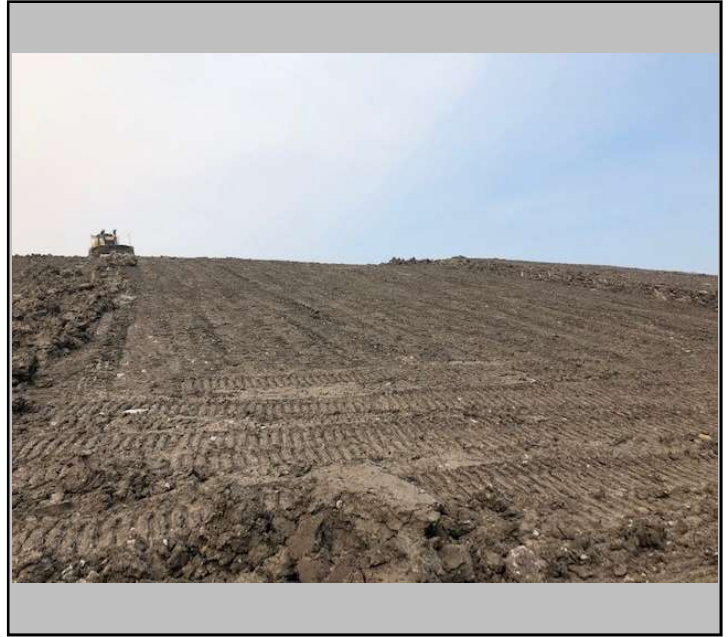
Photo #: 2

Panel 20 CCL L2

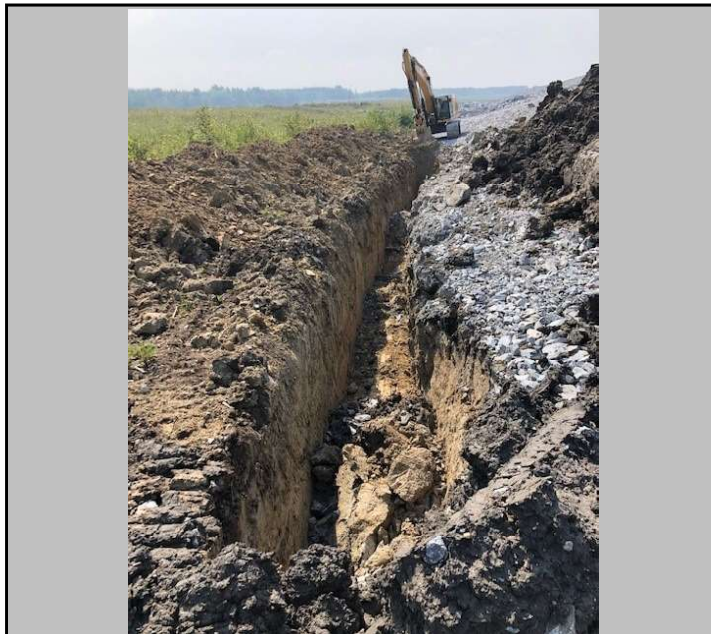
Photo #: 3

Panel 21 Key Trench

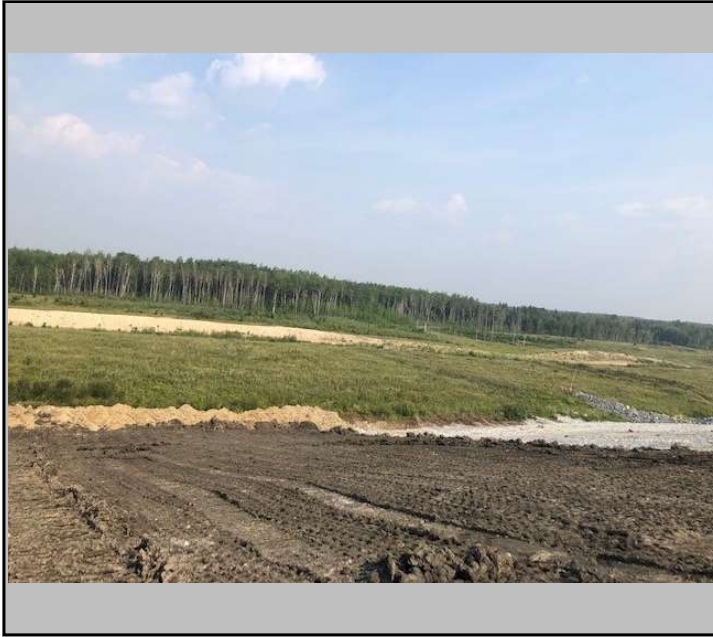
Photo #: 13

Panel 21 CCL Lift 1

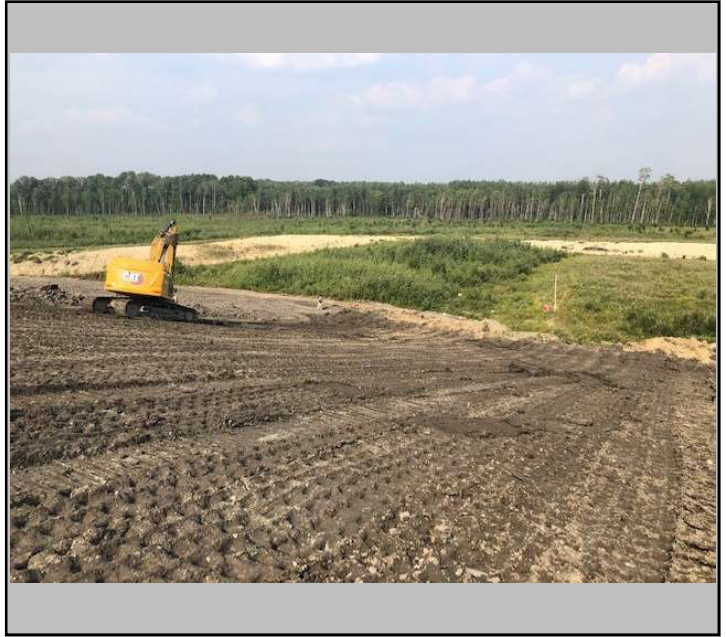
Photo #: 14

Panel 20 CCL Lift 2

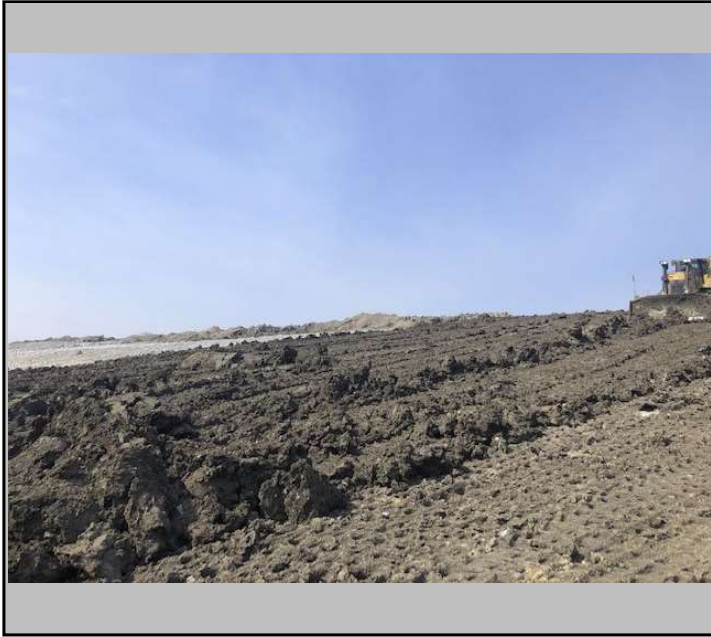
Photo #: 1

Placement Panel 21 Lift 2

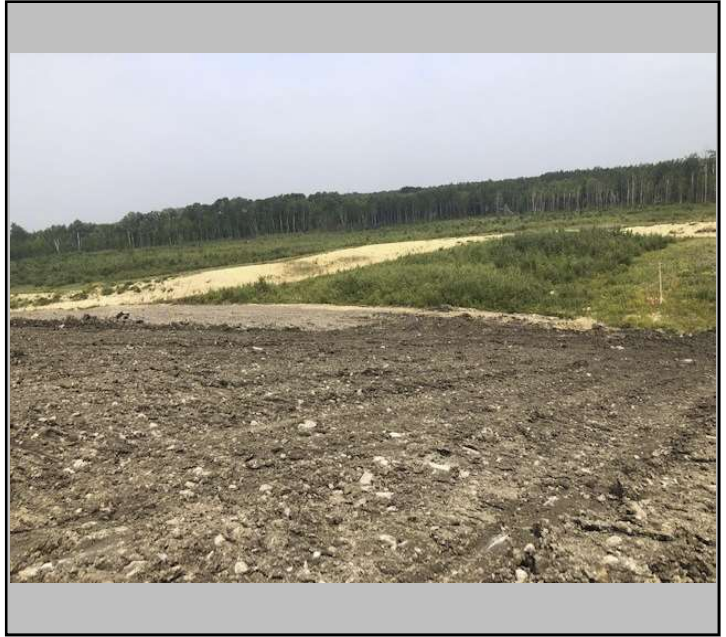
Photo #: 2

Panel 21 NCL Lift 3

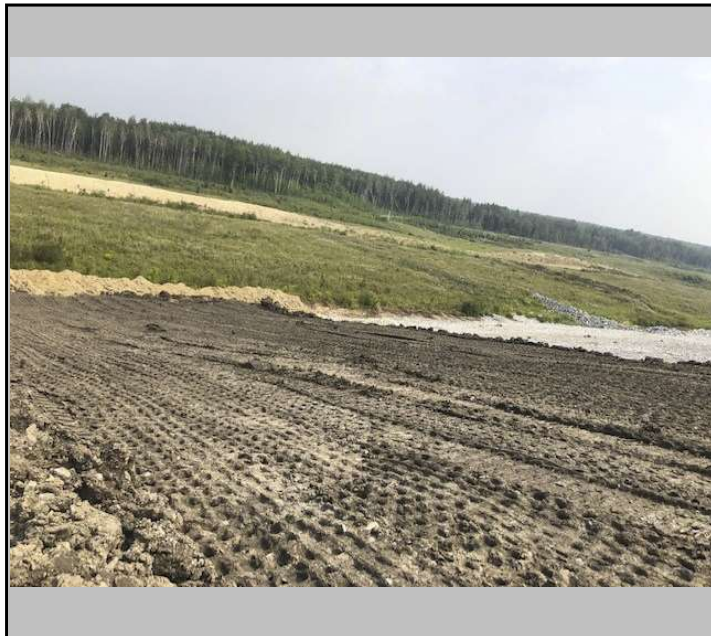
Photo #: 3

Panel 21 CCL Lift 2

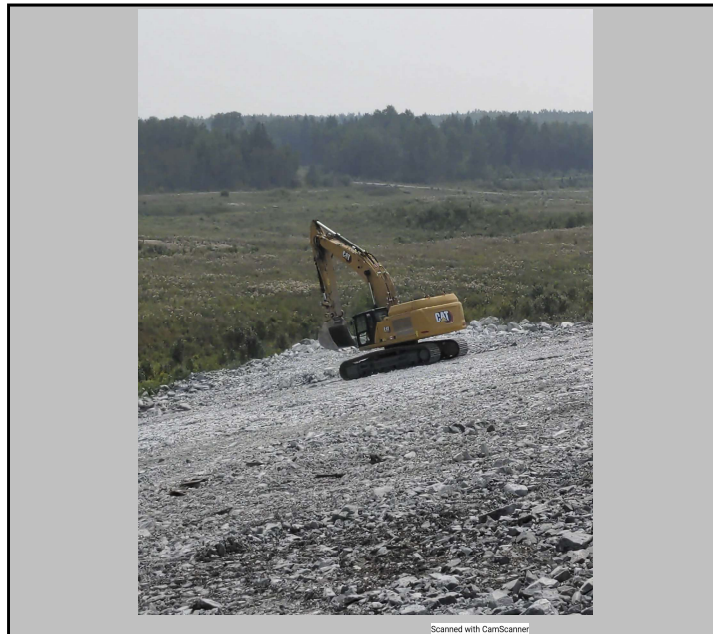
Photo #: 3

EMRS Base slope work.

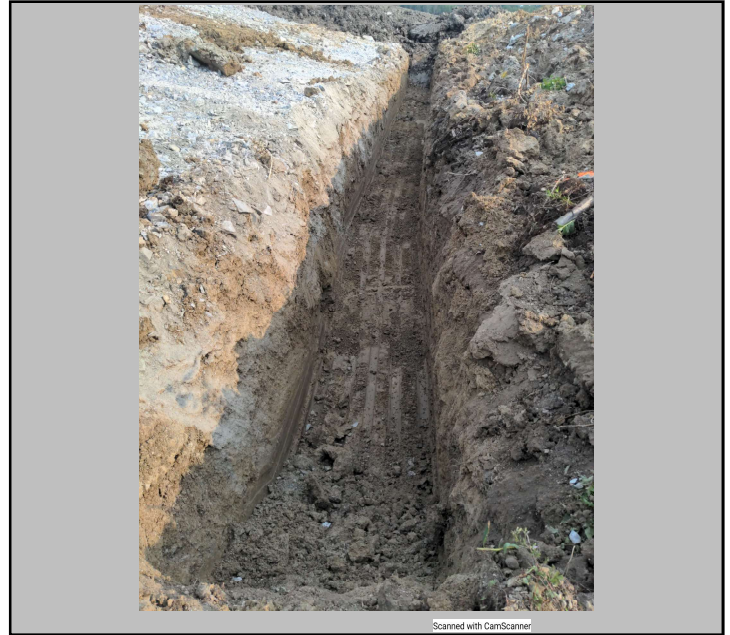
Photo #: 2

Panel 22 Key Trench excavation.

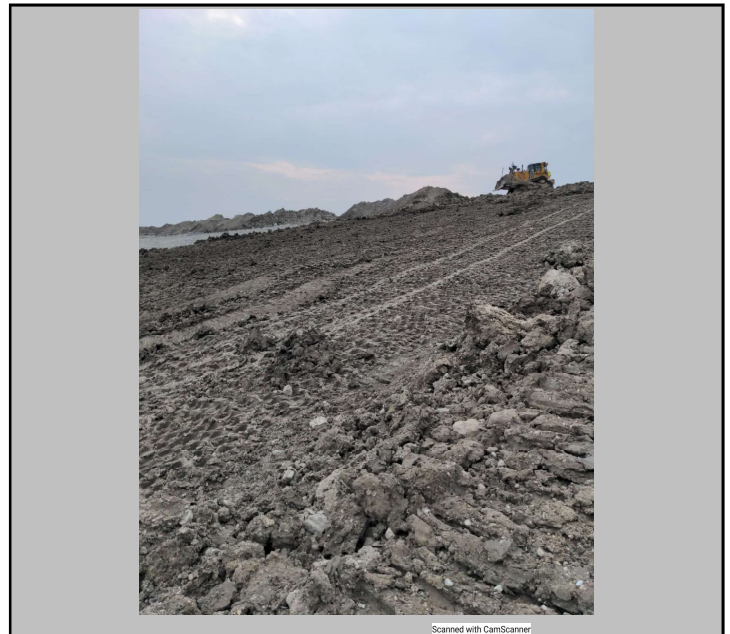
Photo #: 8

Panel 22 CCL Lift 1.

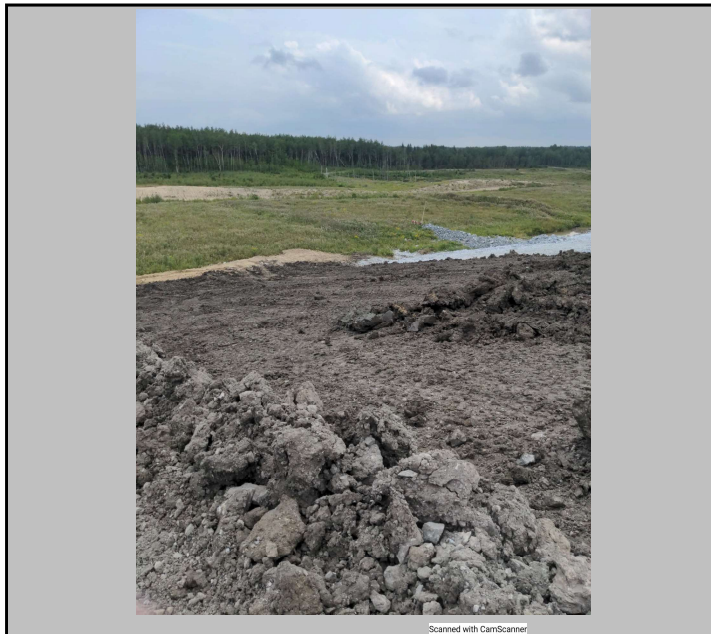
Photo #: 7

Panel 22 CCL Lift 2.

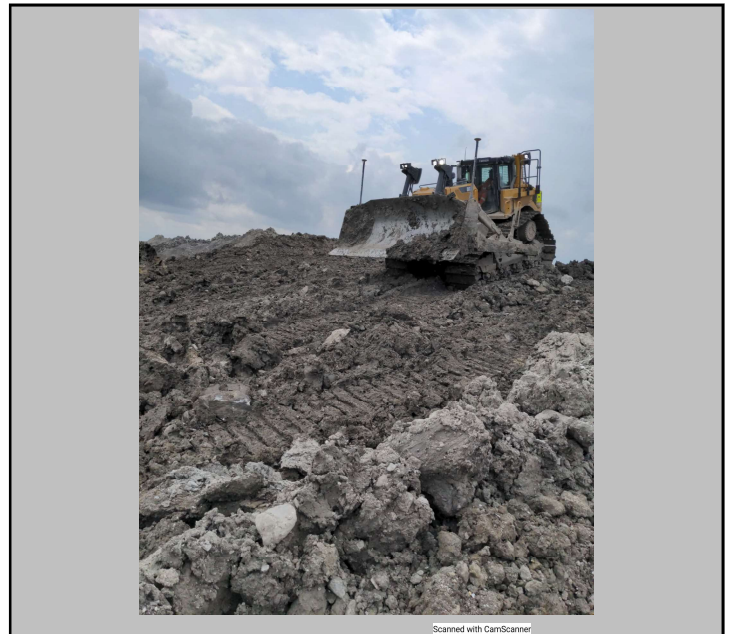
Photo #: 8

Panel 22 NCL Lift 3 placement.

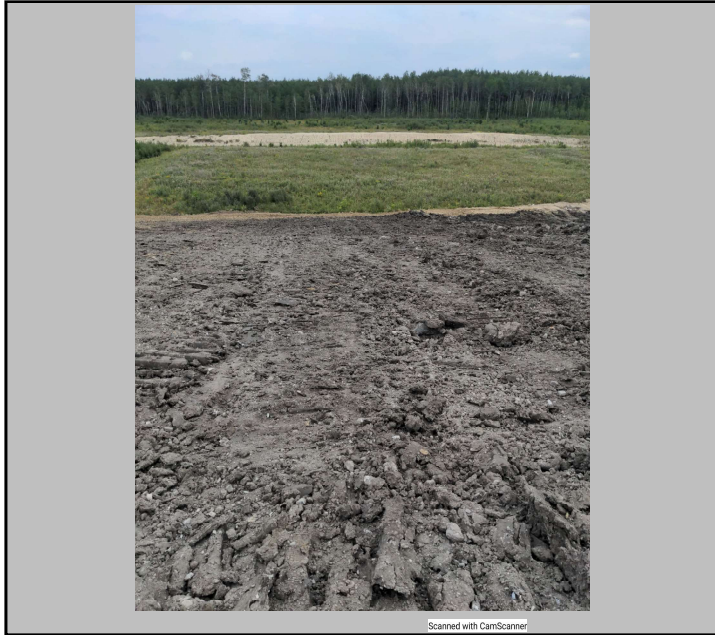
Photo #: 9

Panel 21 NCL Lift 4.

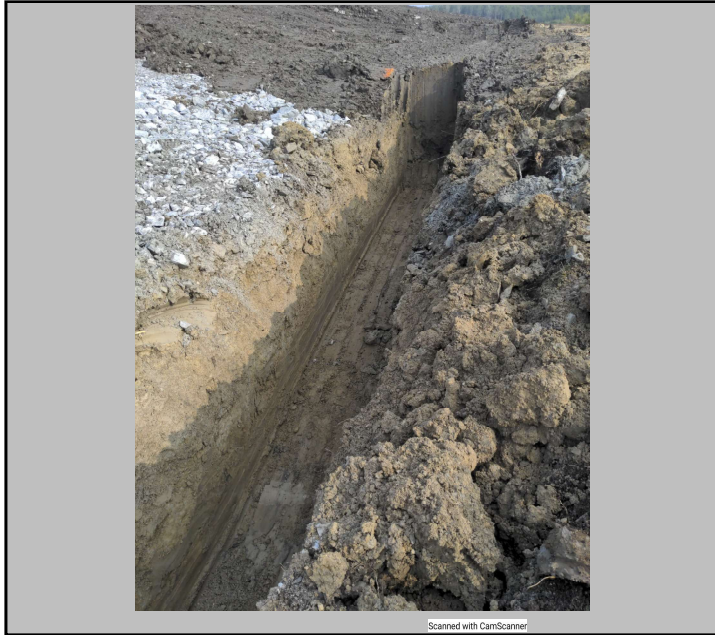
Photo #: 1

Panel 23 Key Trench ~2.5m deep.

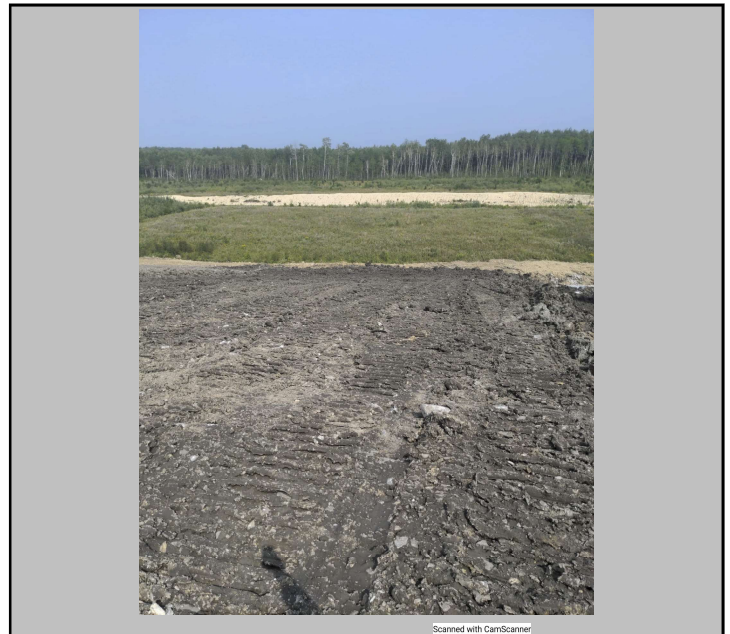
Photo #: 4

Panel 22 NCL Lift 3 complete.

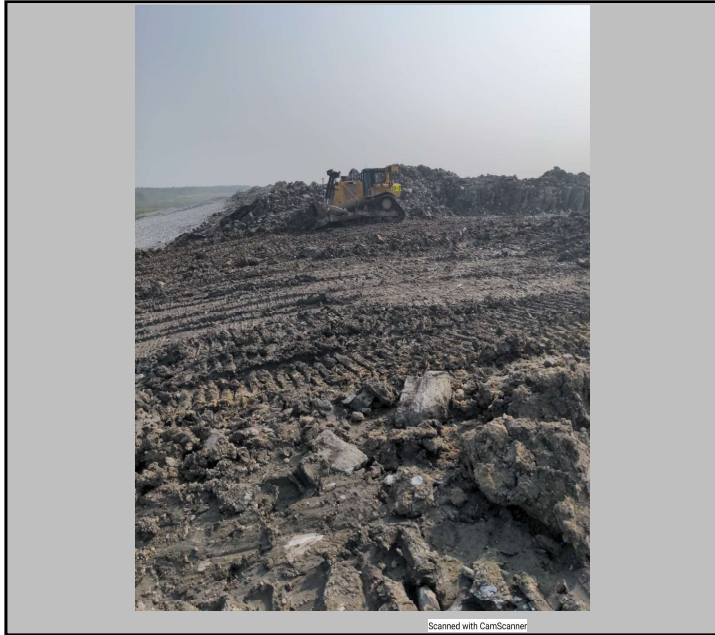
Photo #: 5

Panel 23 CCL Lift 1 placement.

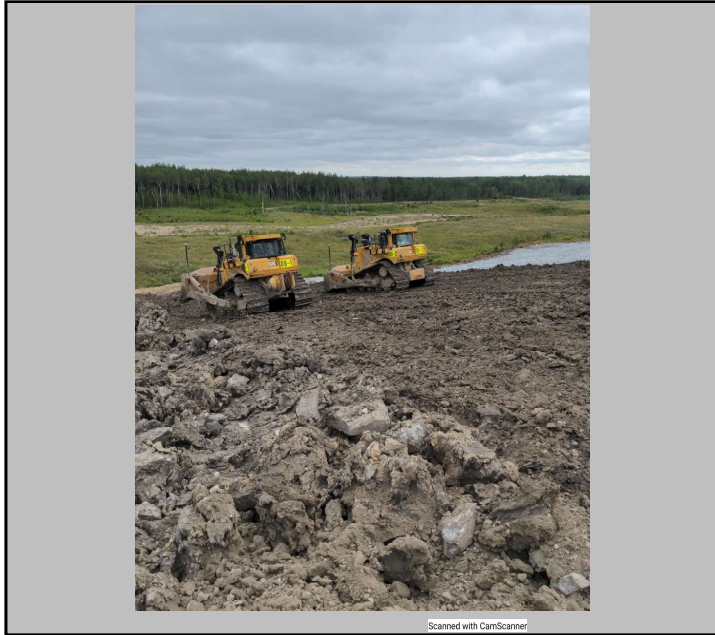
Photo #: 1

Panel 23 CCL Lift 2 Placement.

CCL material appeared dark brown/grey with some spots of lighter brown. Material hauled in from the EMRS stockpile. There appeared to be a low abundance of rocks in the lift. One section with dry material excavated and replaced with more visually suitable material.

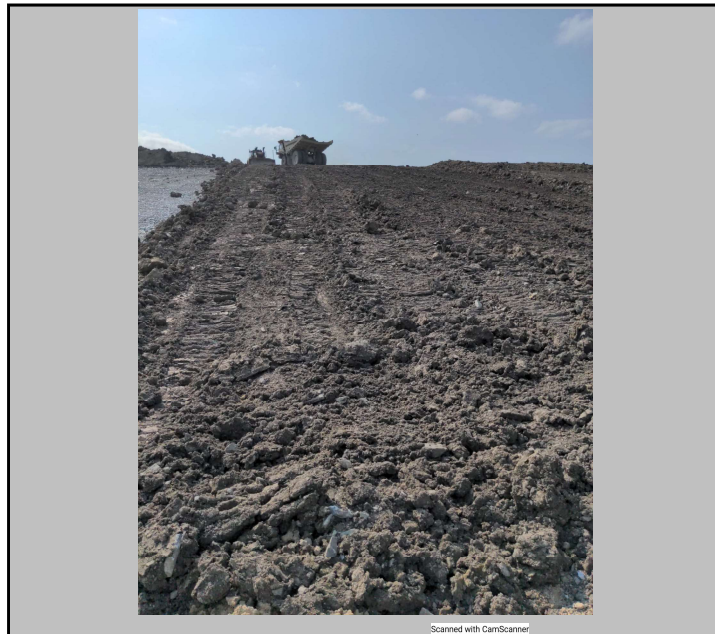
Photo #: 3

Panel 23 CCL Lift 2 Placement.

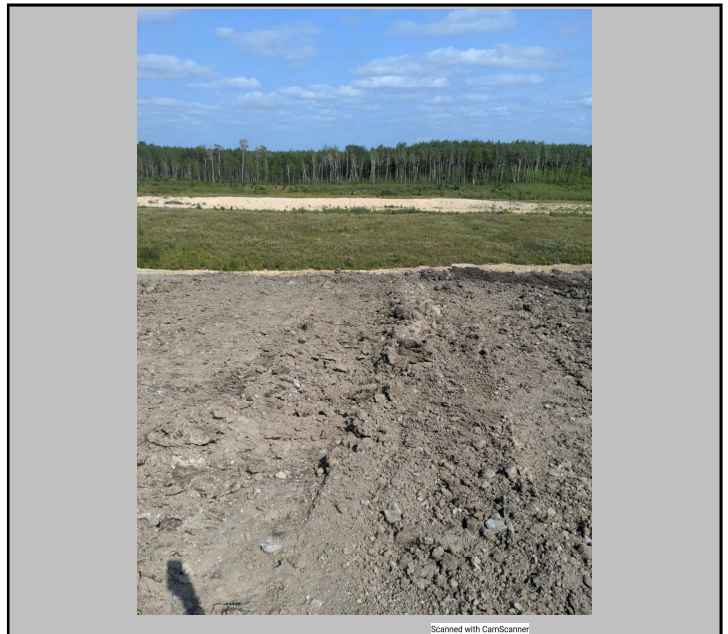
Photo #: 4

Panel 22 NCL Lift 4 placement.

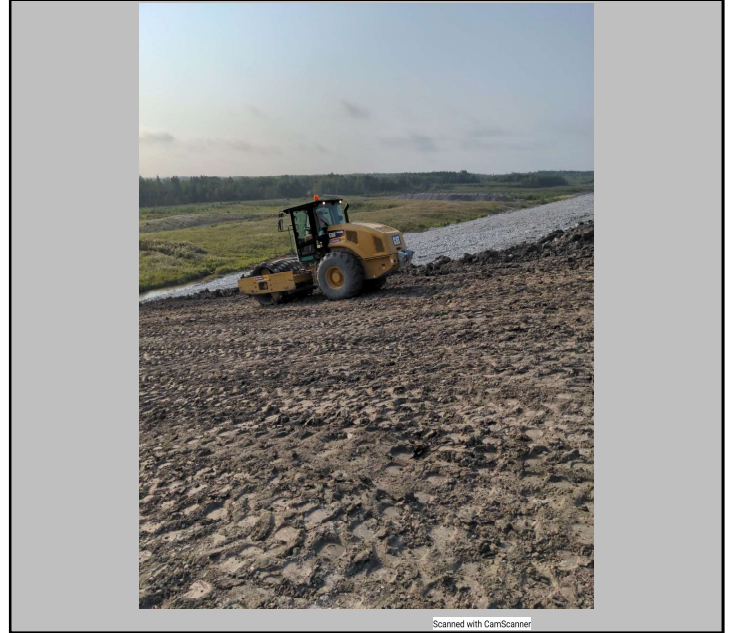
Photo #: 2

Packer completing compaction of Panel 23 CCL Lift 2.

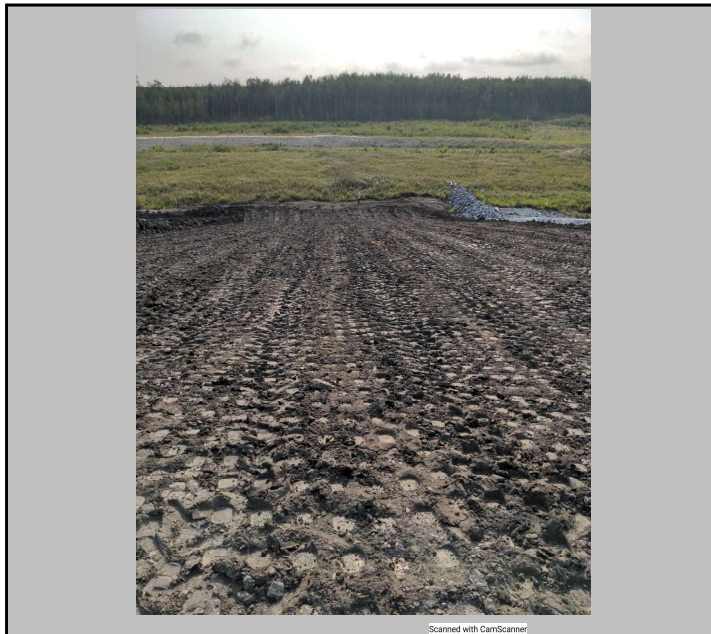
Photo #: 3

Panel 23 CCL Lift 2 complete.

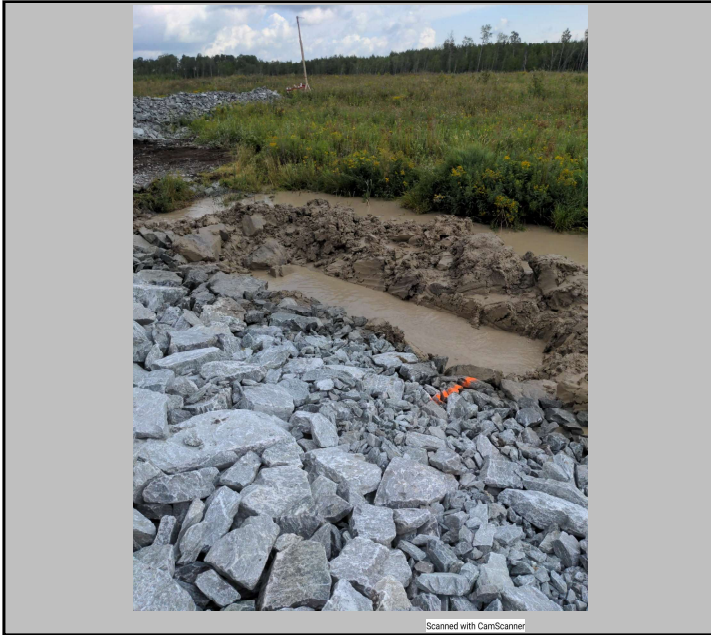
Photo #: 1

Panel 24 Key Trench

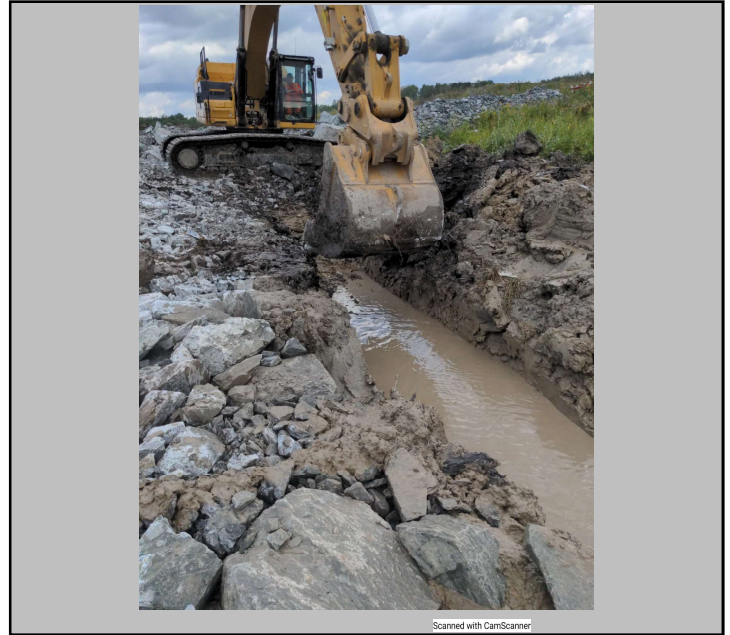
Photo #: 2

Panel 24 Key Trench.

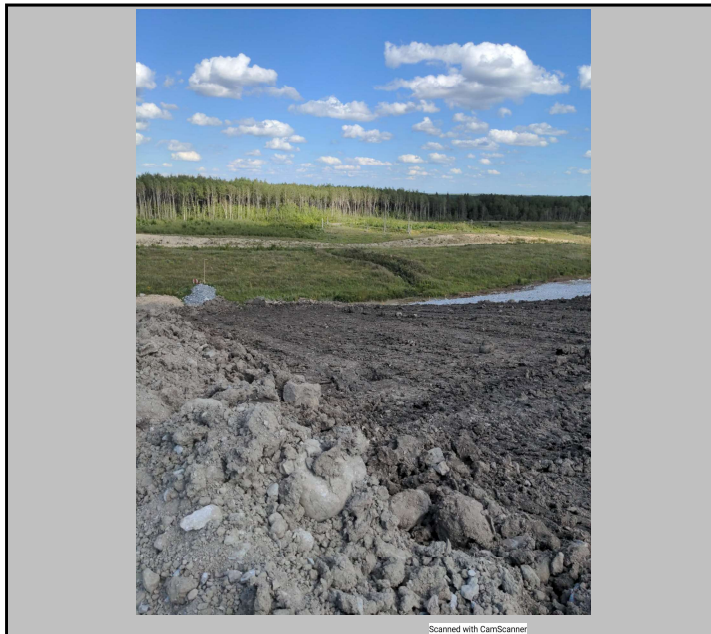
Photo #: 3

Panel 24 CCL Lift 1.

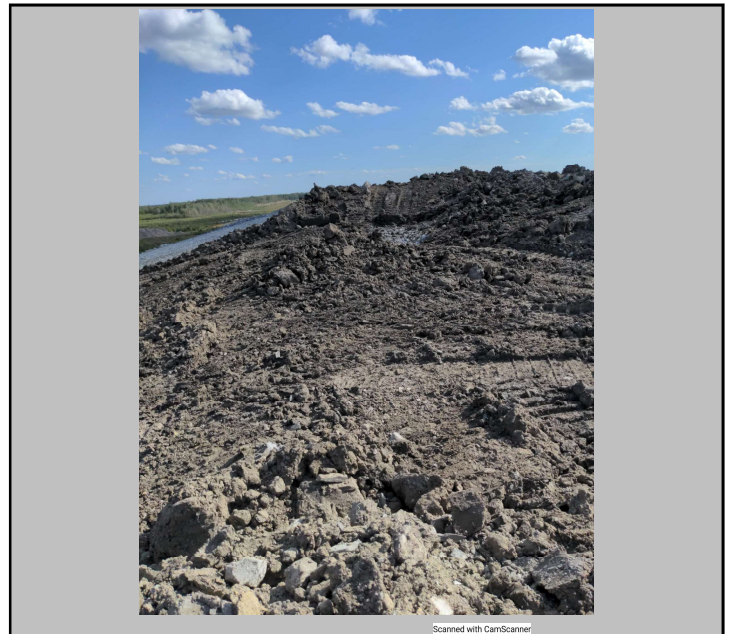
Photo #: 4

Panel 24 CCL Lift 1.

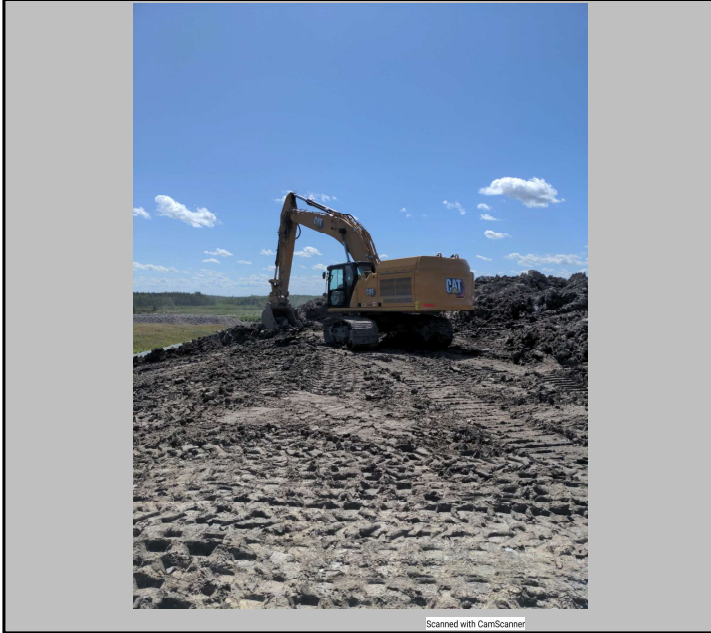
Photo #: 1

CAT 349 removing oversize boulders from Panel 24 Lift 1.

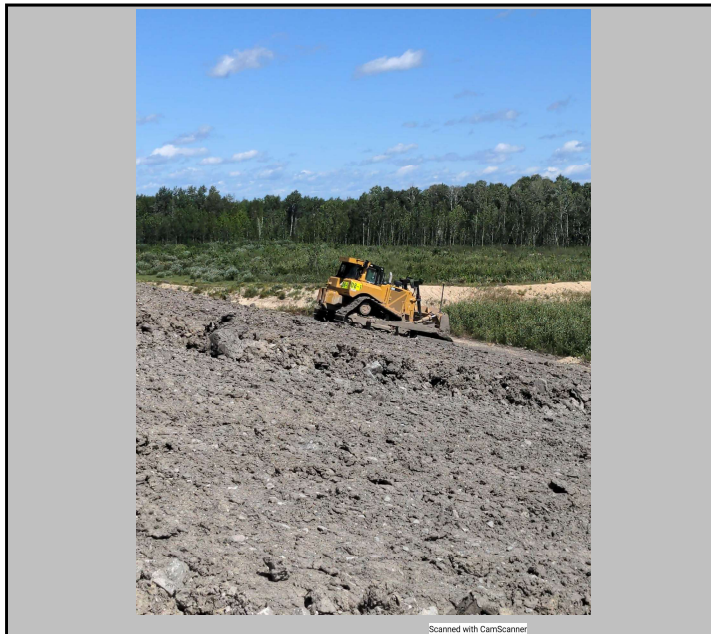
Photo #: 3

D8-1 track pacing Panel 22 NCL Lift 4.

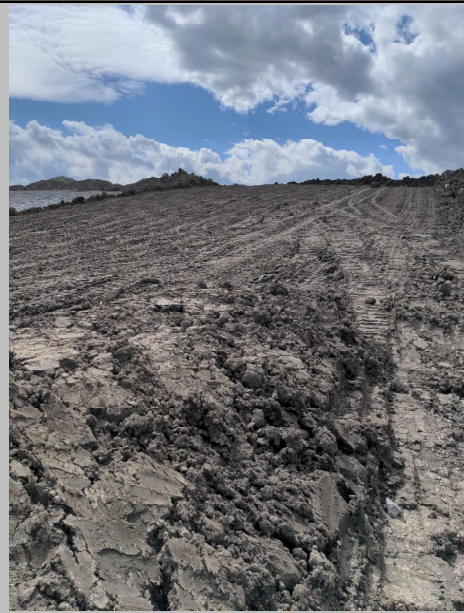
Photo #: 10

Panel 24 CCL Lift 1 complete.

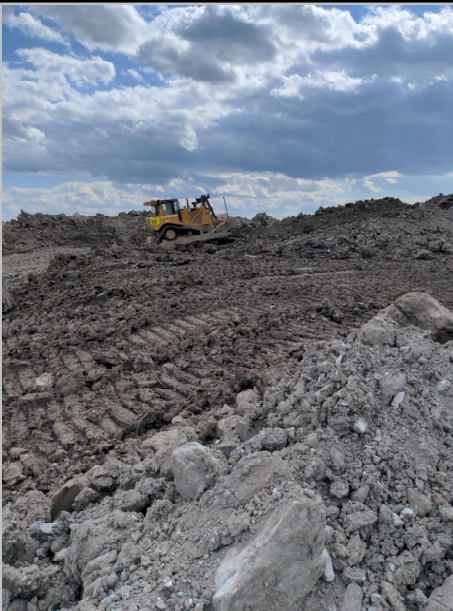
Photo #: 11

Panel 24 CCL Lift 2 placement.

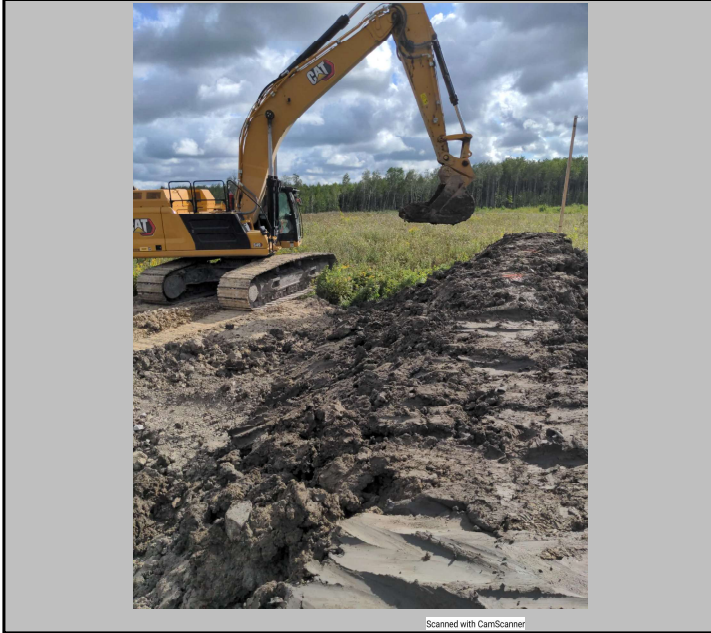
Photo #: 1

Panel 24 VWP Instrument burrito Lift 2 clay placement.

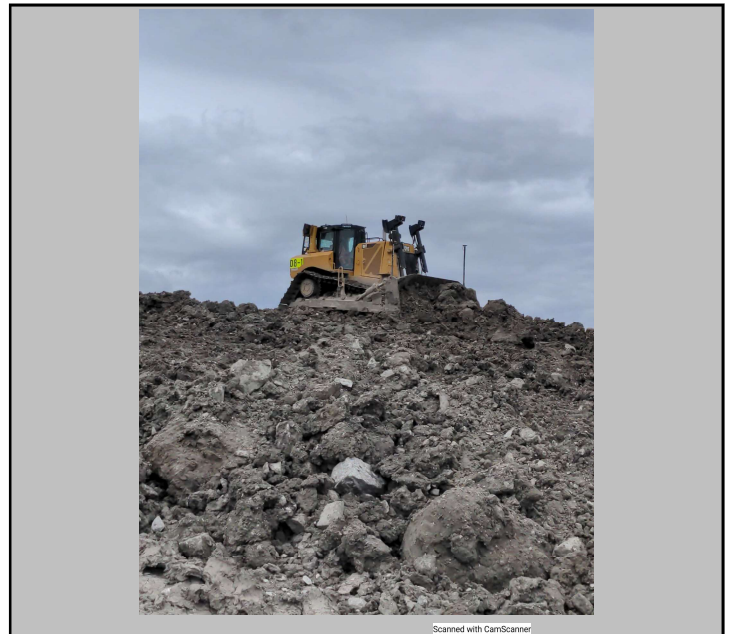
Photo #: 3

Packing Panel 24 CCL Lift 2.
