Date:	July 16, 2021	Owner/Client:	New Gold Inc.
Day:	Friday	OKC Project #:	1003-19
Prepared by:	Martin Moore	Project Location:	Rainy River - Ontario

Date:	July 17, 2021	Owner/Client:	New Gold Inc.
Day:	Saturday	OKC Project #:	1003-19
Prepared by:	Martin Moore	Project Location:	Rainy River - Ontario

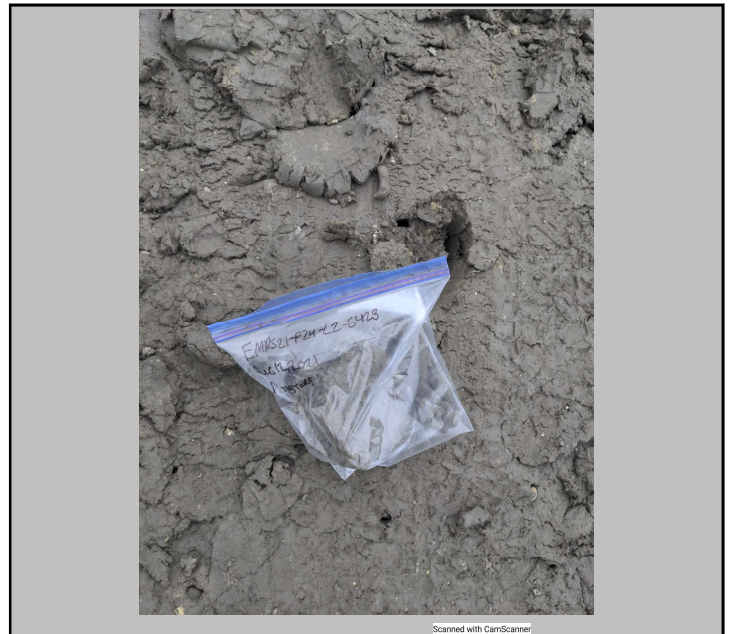
Photo #: 7

EMRS21-P24-L2-S427.

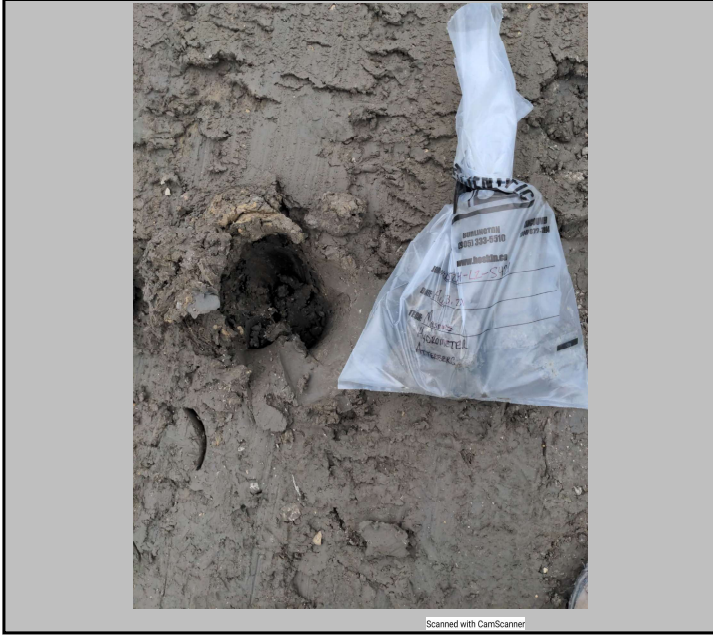
Photo #: 8

EMRS21-P24-L2-S428.

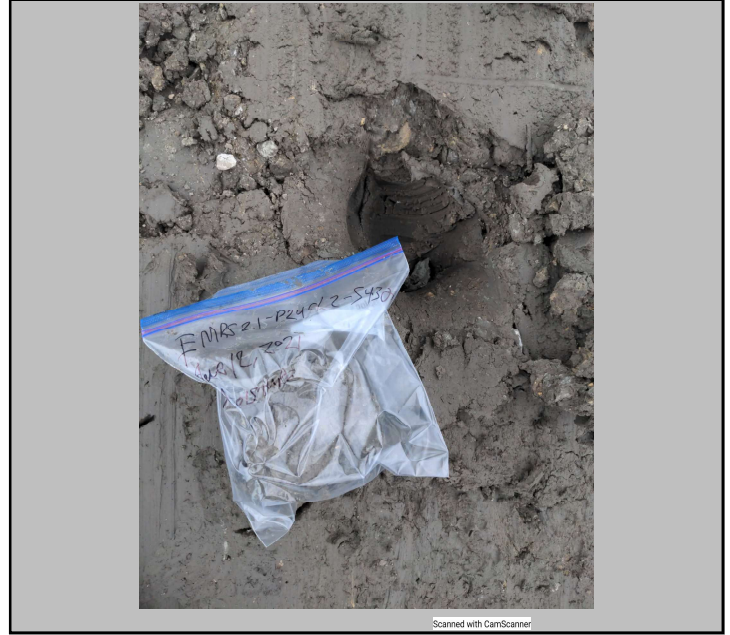
Photo #: 9

EMRS21-P24-L2-S429.

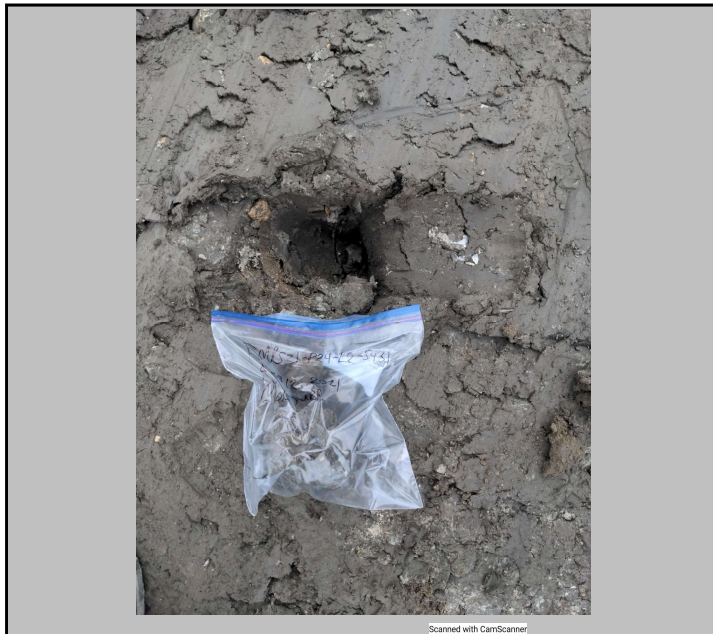
Photo #: 10

EMRS21-P24-L2-S430.

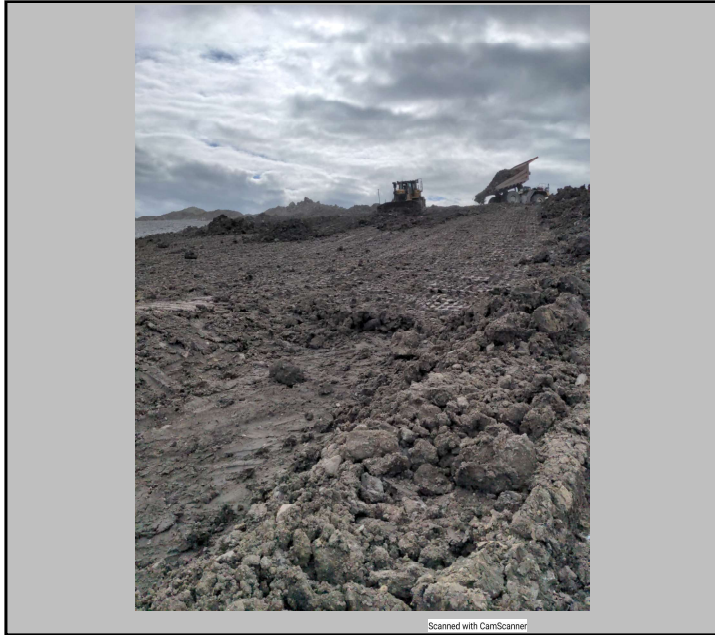
Photo #: 12

Panel 24 CCL Lift 2 complete and NCL Lift 3 placement.

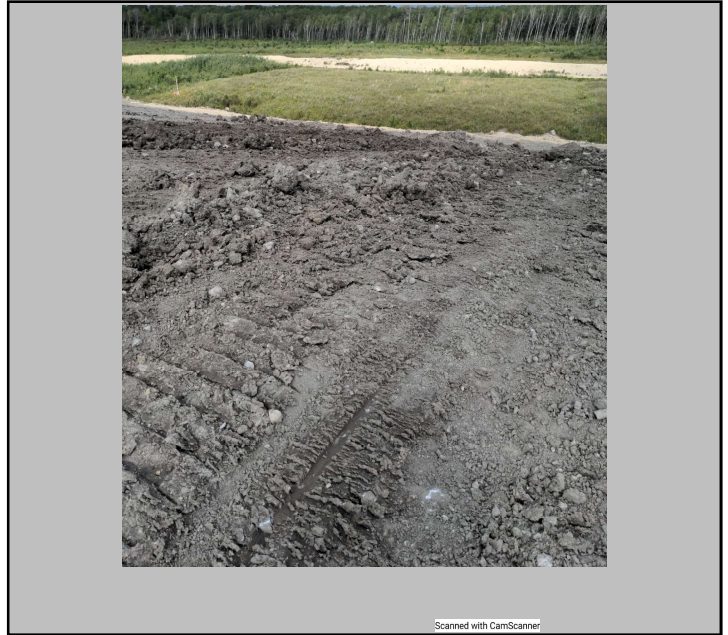
Photo #: 13

Panel 24 NCL Lift 3 placement.
