<b>Date:</b>	August 14, 2021	<b>Owner/Client:</b>	New Gold Inc.
<b>Day:</b>	Saturday	<b>OKC Project #:</b>	1003-19
<b>Prepared by:</b>	Martin Moore	<b>Project Location:</b>	Rainy River - Ontario

<b>Date:</b>	August 15, 2021	<b>Owner/Client:</b>	New Gold Inc.
<b>Day:</b>	Sunday	<b>OKC Project #:</b>	1003-19
<b>Prepared by:</b>	Martin Moore	<b>Project Location:</b>	Rainy River - Ontario

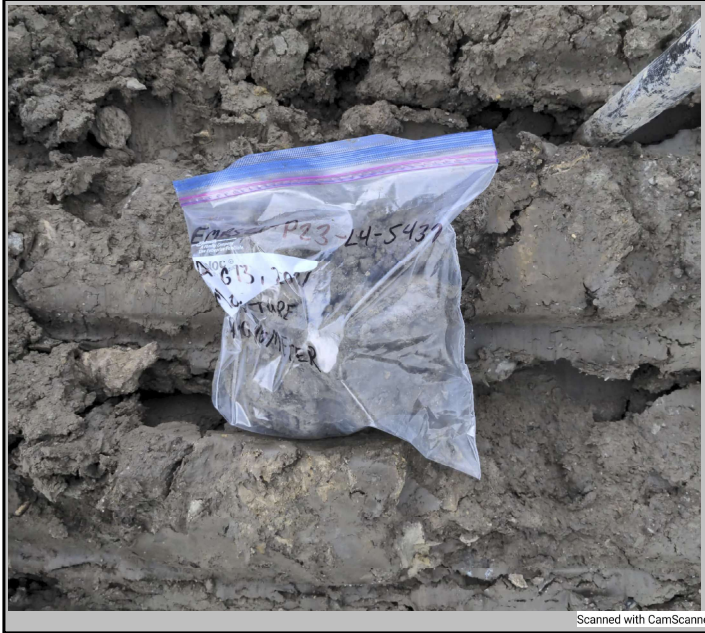
Photo #: 1

EMRS21-P23-L4-S432.

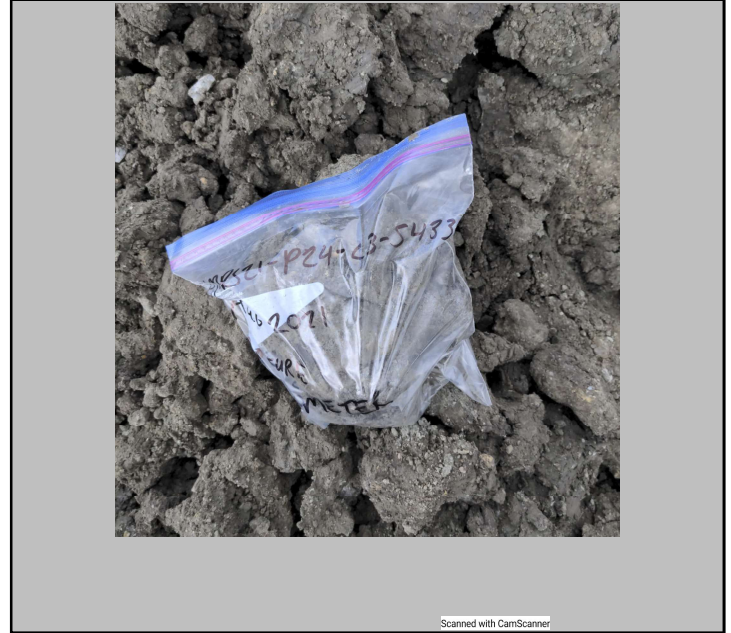
Photo #: 2

EMRS21-P24-L3-S433.

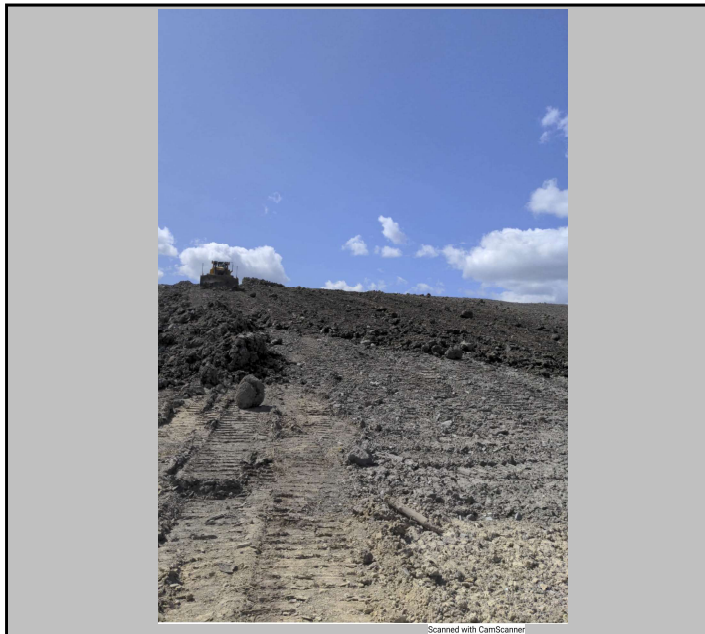
Photo #: 3

Panel 24 Lift 4 placement.

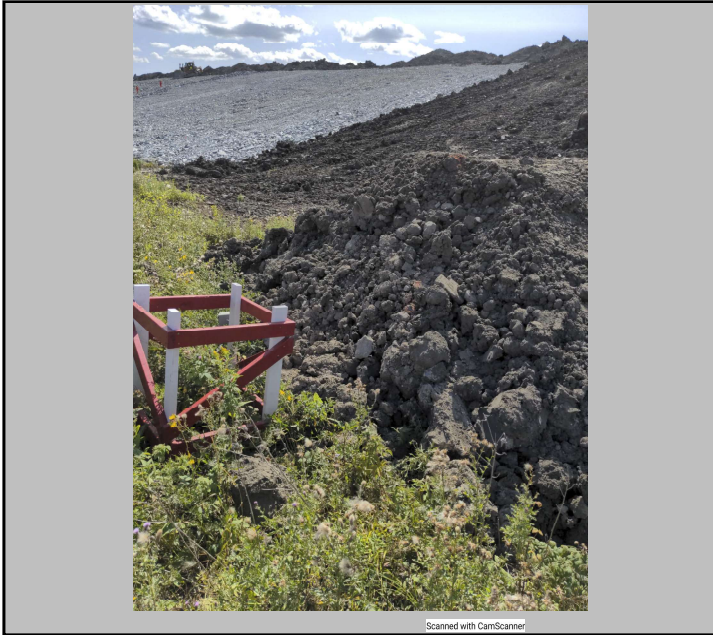
Photo #: 5

VWP Instrument behind the burrito.

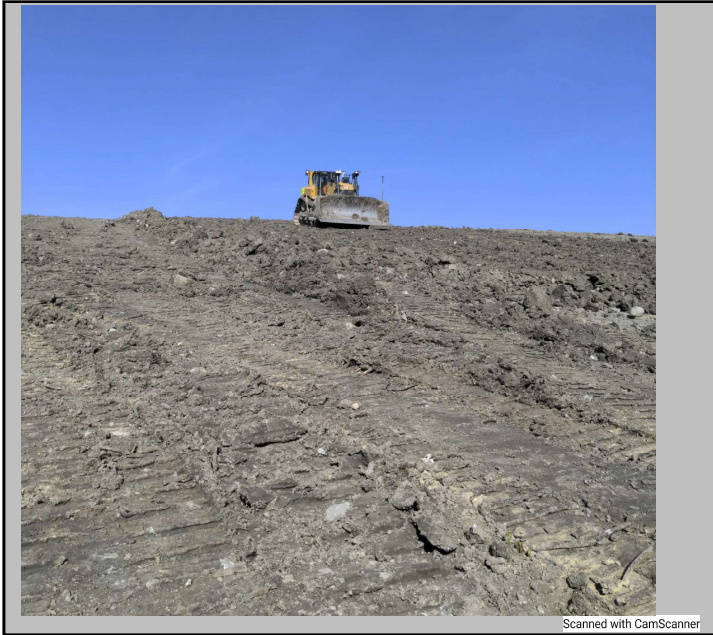
Photo #: 1

Panel 23 NCL Lift 4 placement.

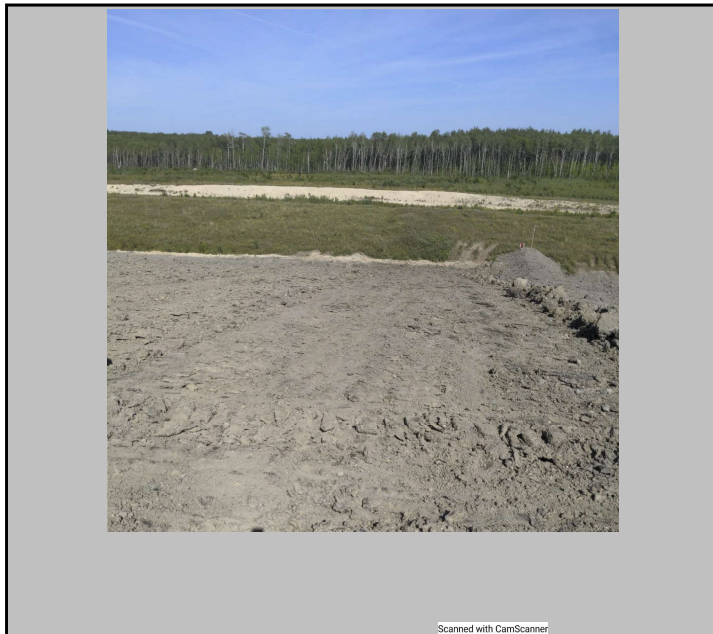
Photo #: 3

Panel 23 NCL Lift 4 complete.

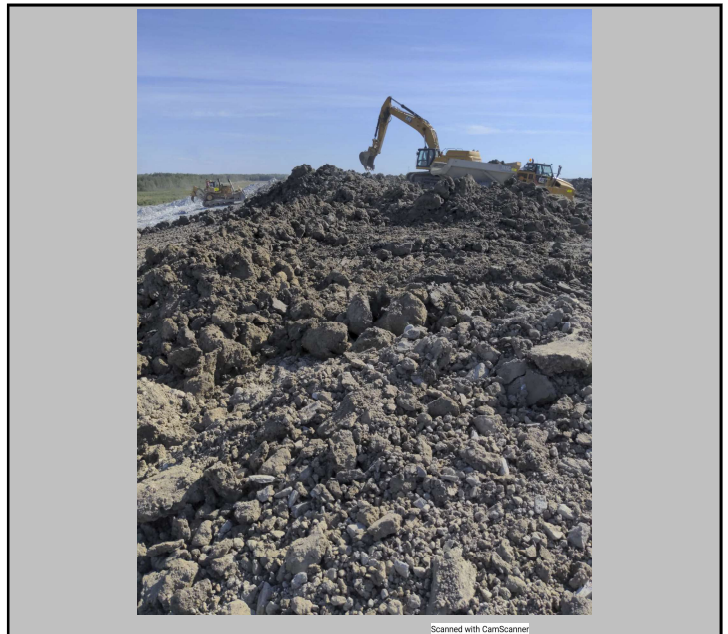
Photo #: 4

Panel 24 NCL Lift 4 placement.

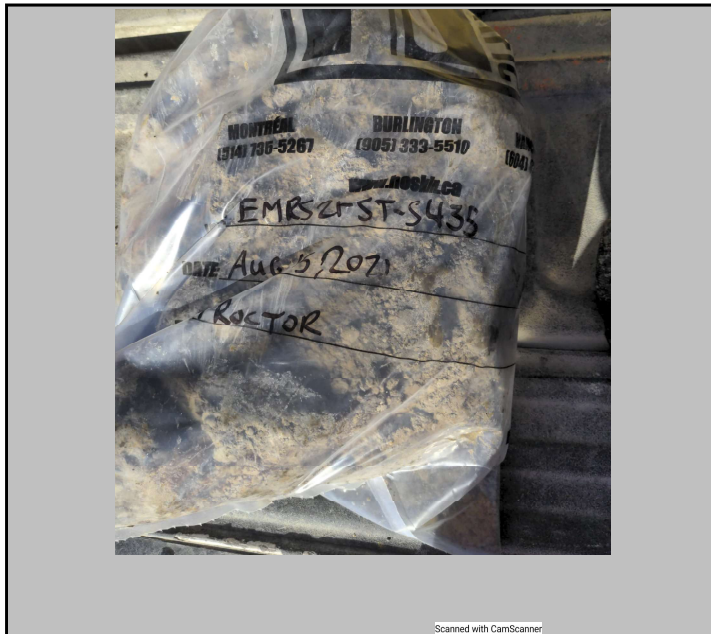
Photo #: 3

EMRS21-ST-S435.

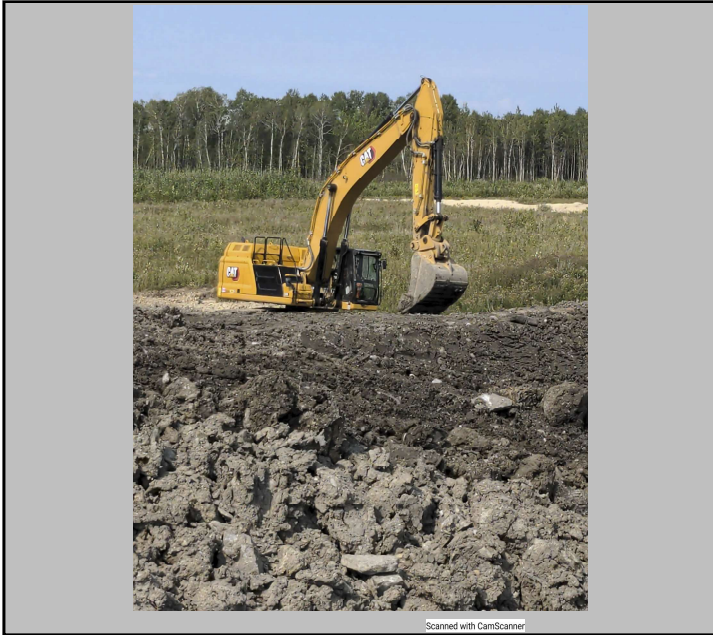
Photo #: 5

Panel 24 NCL Lift 4 burrito placement.

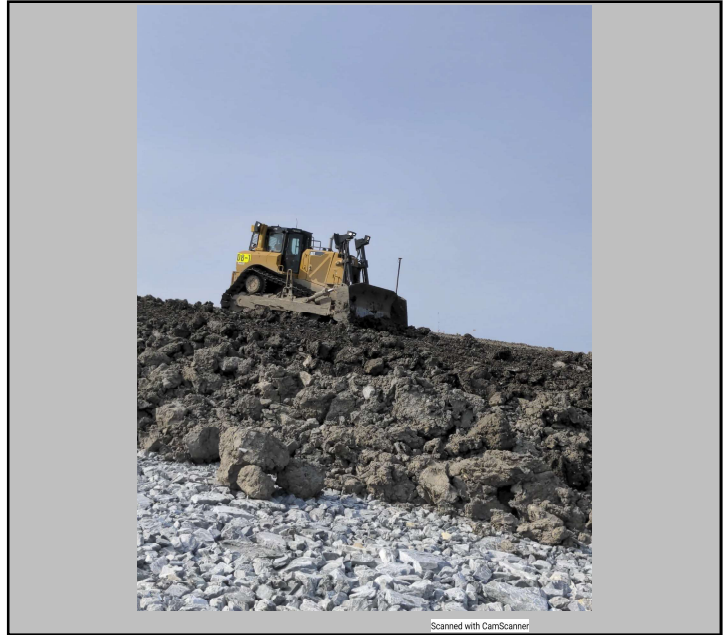
Photo #: 6

Panel 24 NCL Lift 4 placement.

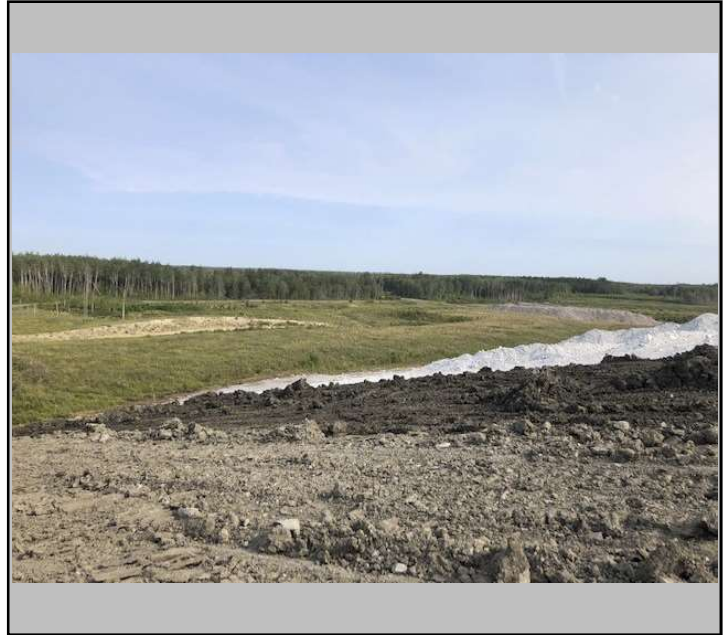
Photo #: 2

Panel 25 CCL Lift 1 Placement

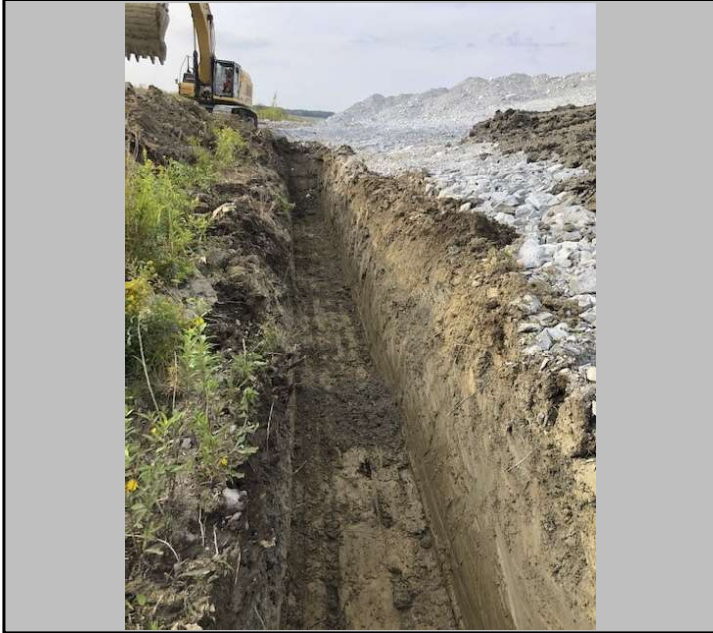
Photo #: 1

Panel 25 Key Trench

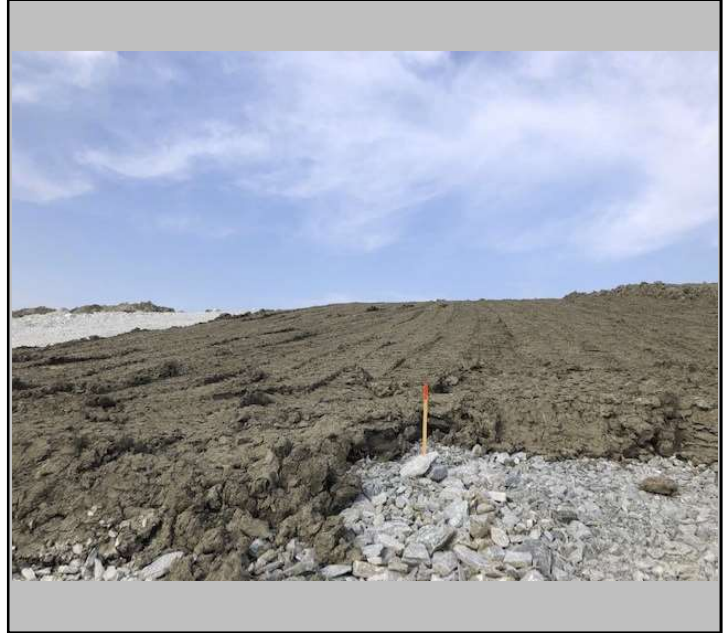
Photo #: 2

Panel 25 CCL Lift 1 before trimming

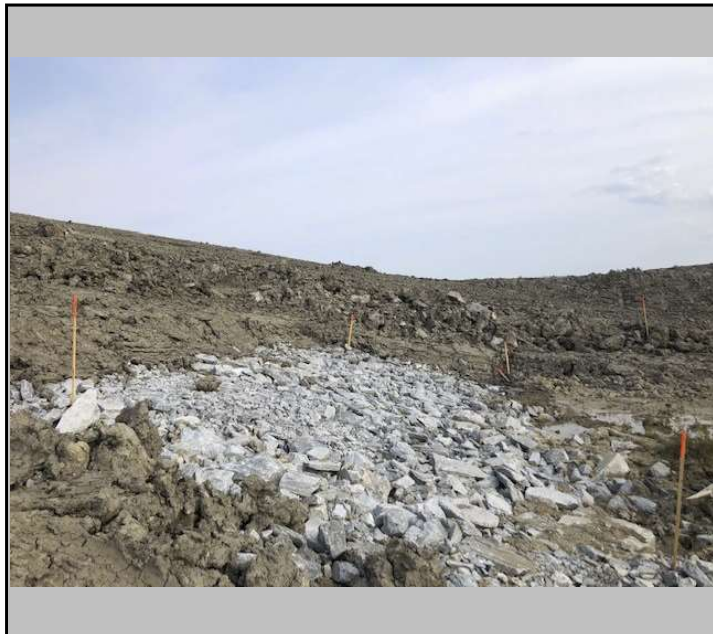
Photo #: 3

Toe Drain Panel 25

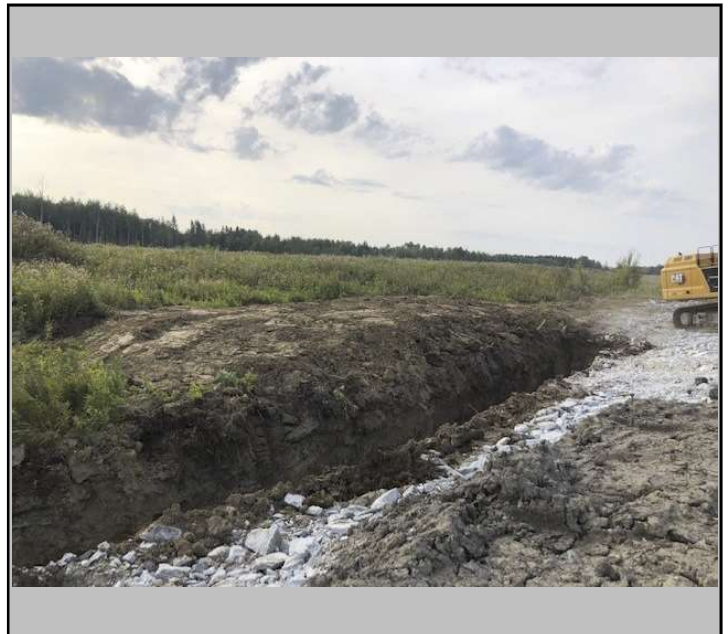
Photo #: 4

Panel 25 Excavation material

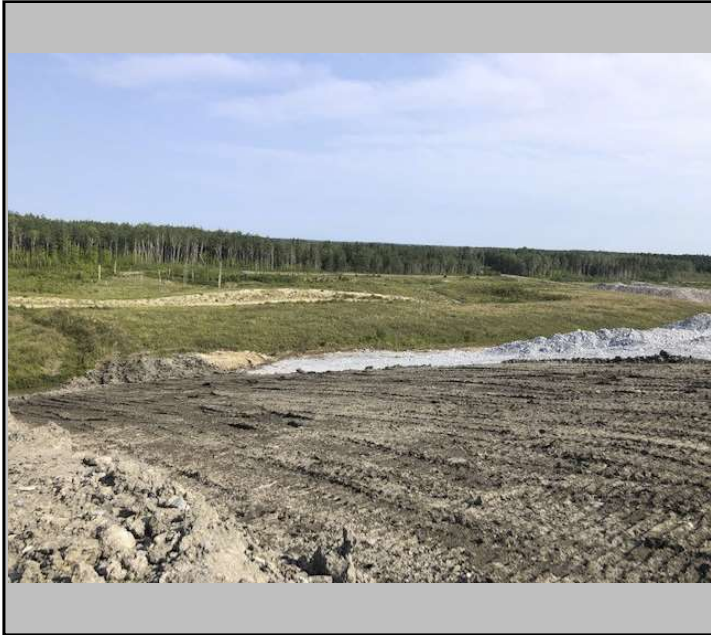
Photo #: 1

- CCL Lift 1 too wet to approve lift left to dry out
- Testing yielded inadequate compaction results and high moisture
- D8-2 track packing CCL Lift 2 and allowing it to dry out
- Excavator 349 removing waste rock from stockpiles
- Attempted testing later in the day conditions still too wet and not compacted enough
- Sheepsfoot roller packing CCL Lift 1 and preparing to approve tomorrow morning

CCL material was a mixture of WML and Brenna. Material was pliable and could be rolled into strings without crumbling. Low abundance of rocks found in CCL lift 1.

CCL Panel 25 Lift 1

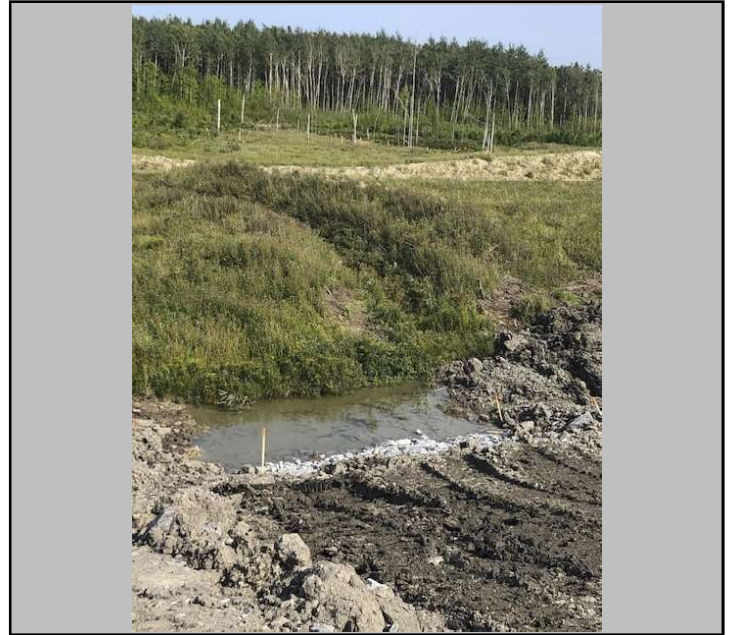
Photo #: 2

Toe Drain Panel 25

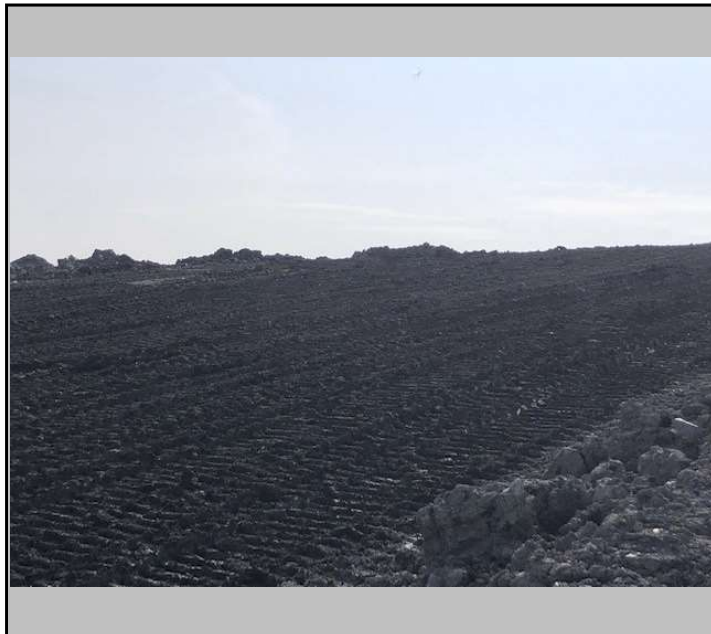
Photo #: 3

CCL Panel 25 Lift 1

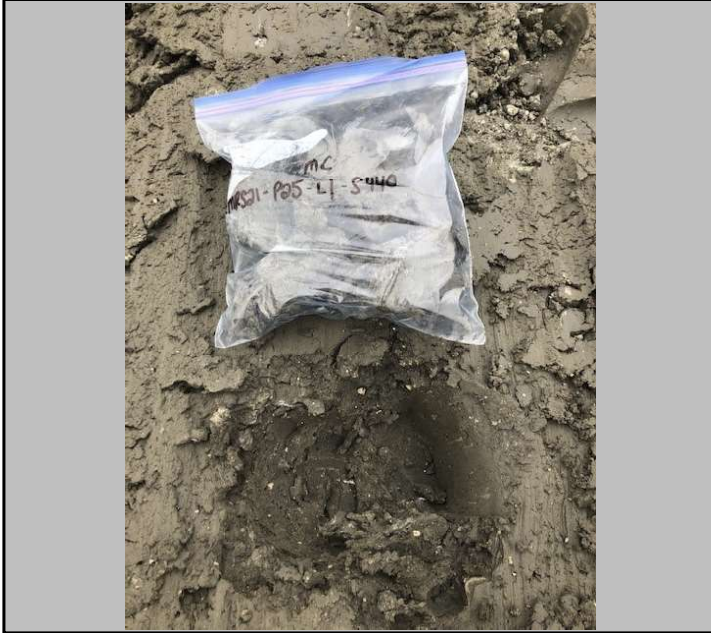
Photo #: 1

EMRS21-P25-L1-S440

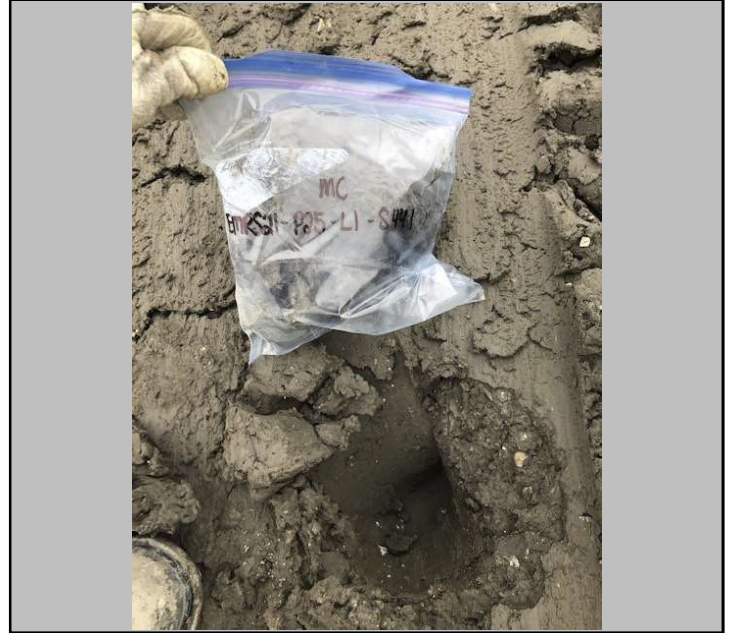
Photo #: 2

EMRS21-P25-L1-S441

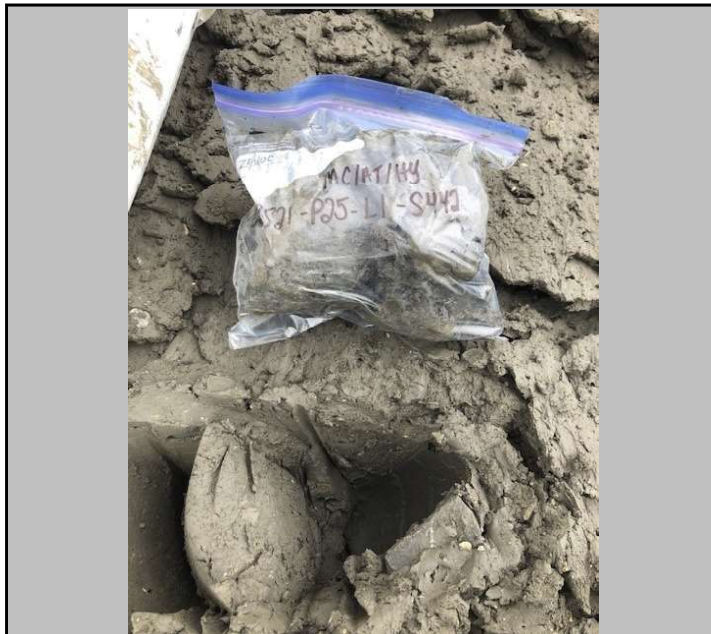
Photo #: 3

EMRS21-P25-L1-S442

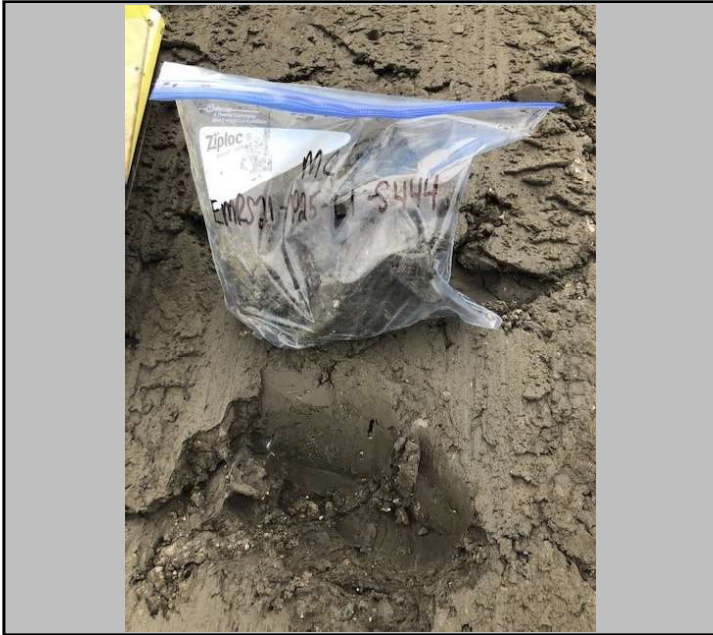
Photo #: 5

EMRS21-P25-L1-S444

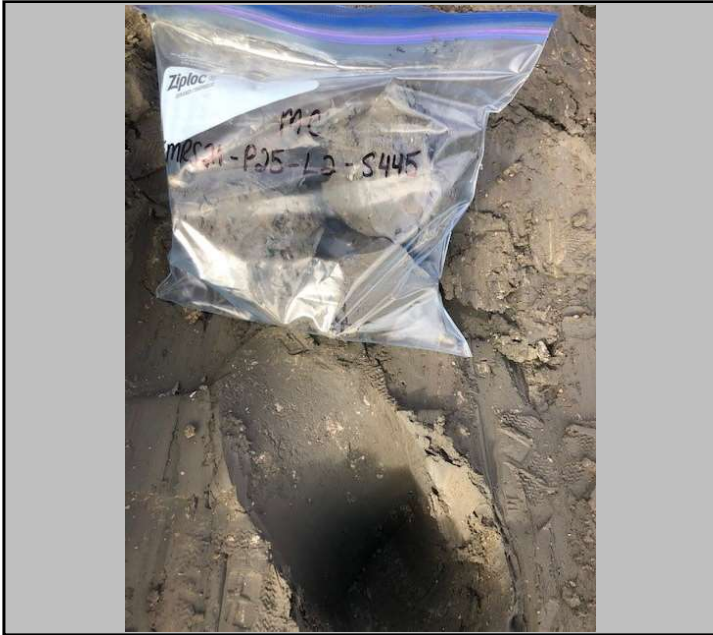
Photo #: 1

EMRS21-P25-L2-S445

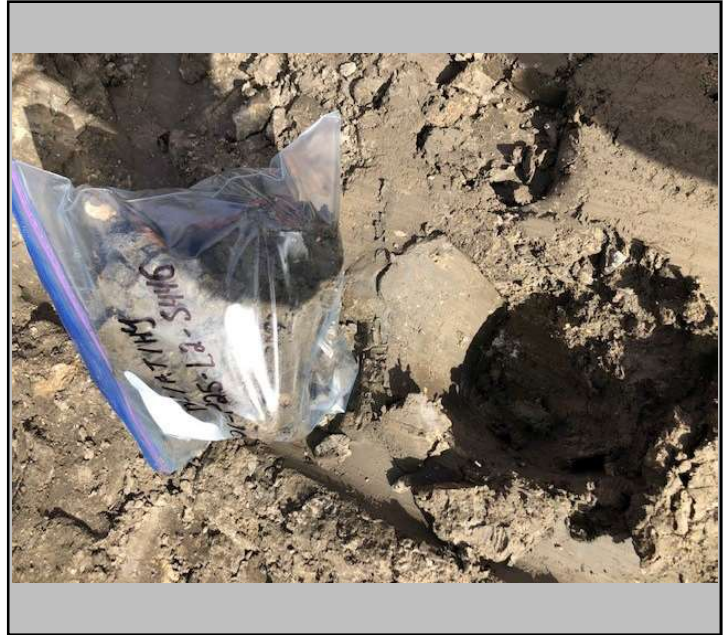
Photo #: 2

EMRS21-P25-L2-S446

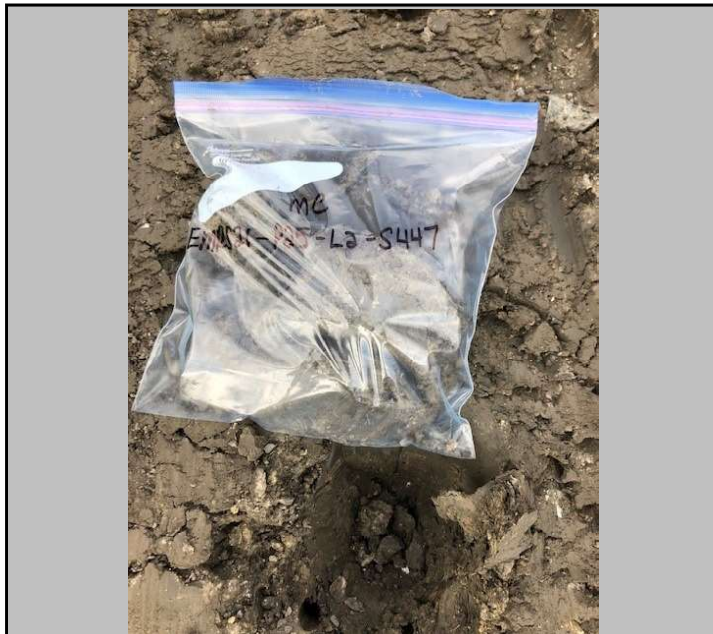
Photo #: 3

EMRS21-P25-L2-S447

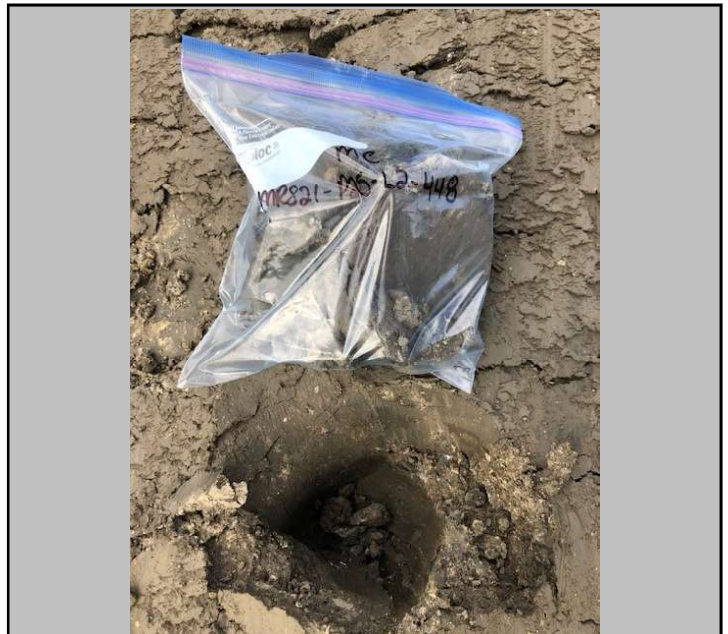
Photo #: 4

EMRS21-P25-L2-S448

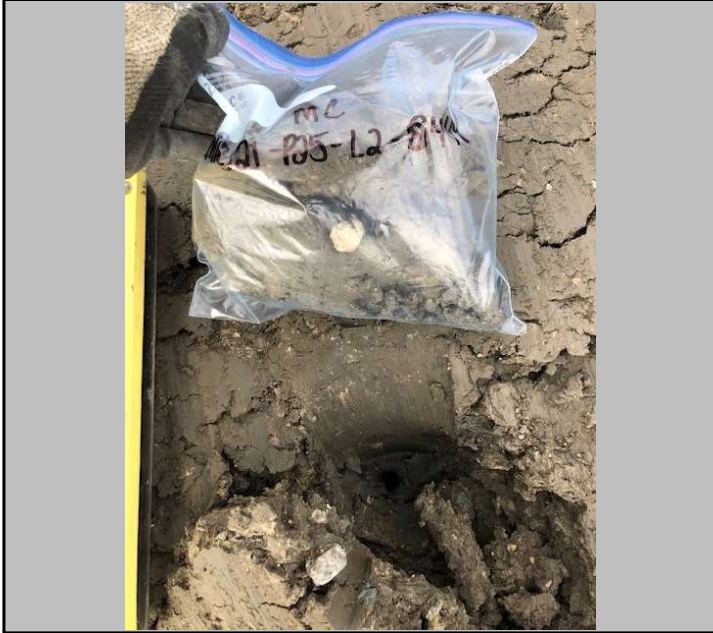
Photo #: 5

EMRS21-P25-L2-S449

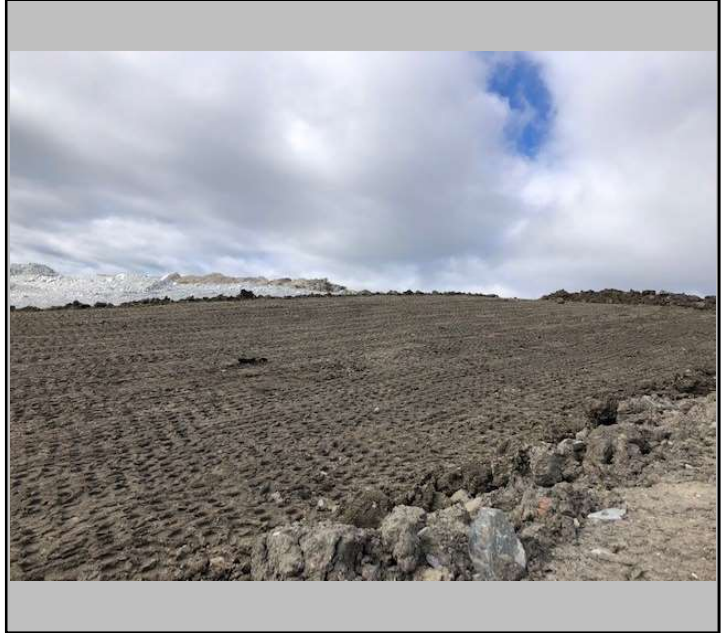
Photo #: 6

Panel 25 CCL Lift 2

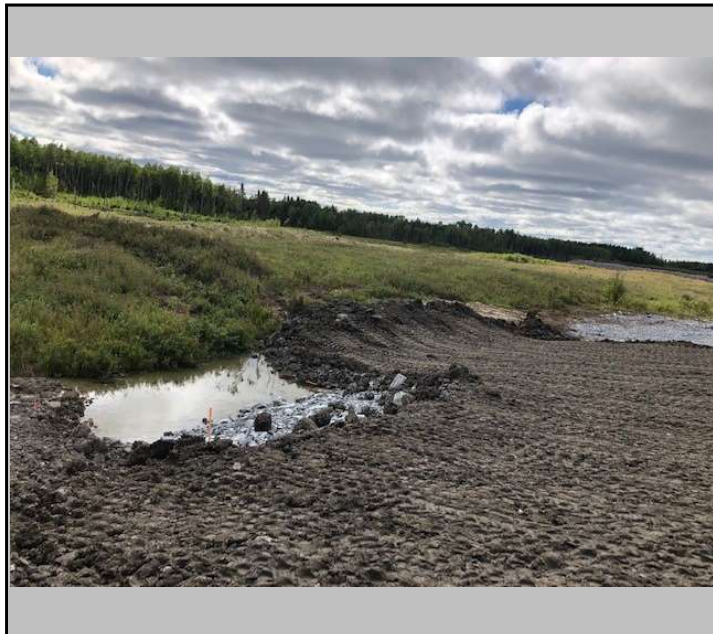
Photo #: 7

Toe Drain Panel 25

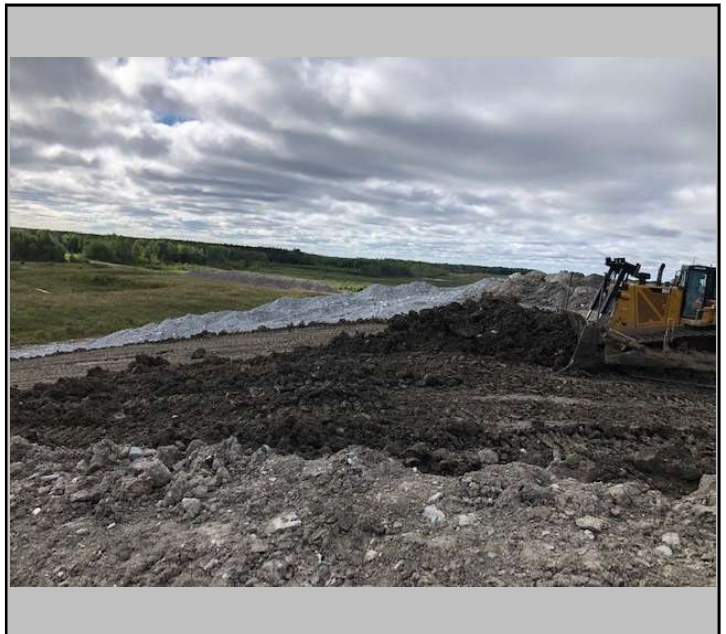
Photo #: 8

D8-2 pushing NCL Lift 3

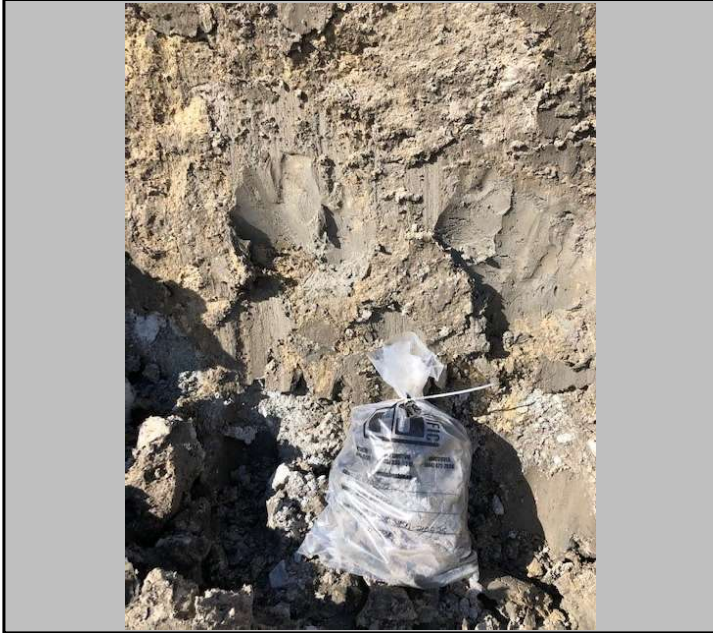
Photo #: 9

EMRS21-ST-S450

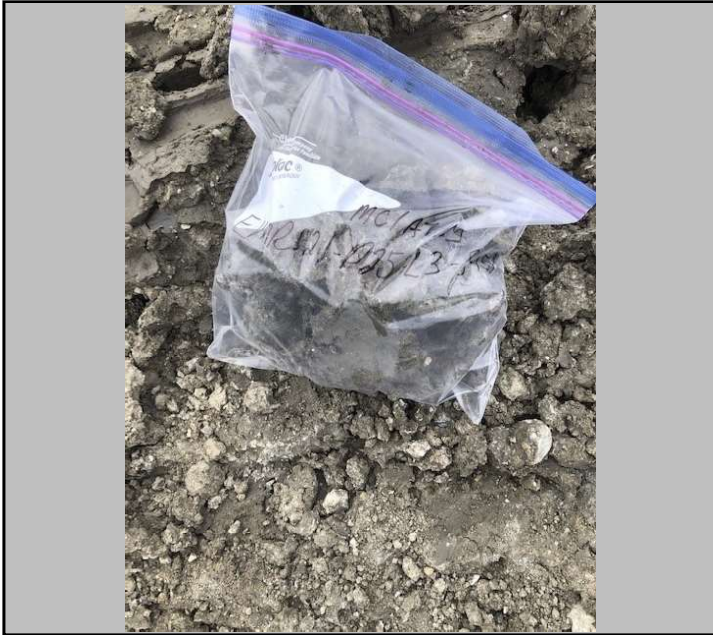
Photo #: 1

EMRS21-P25-L3-S451

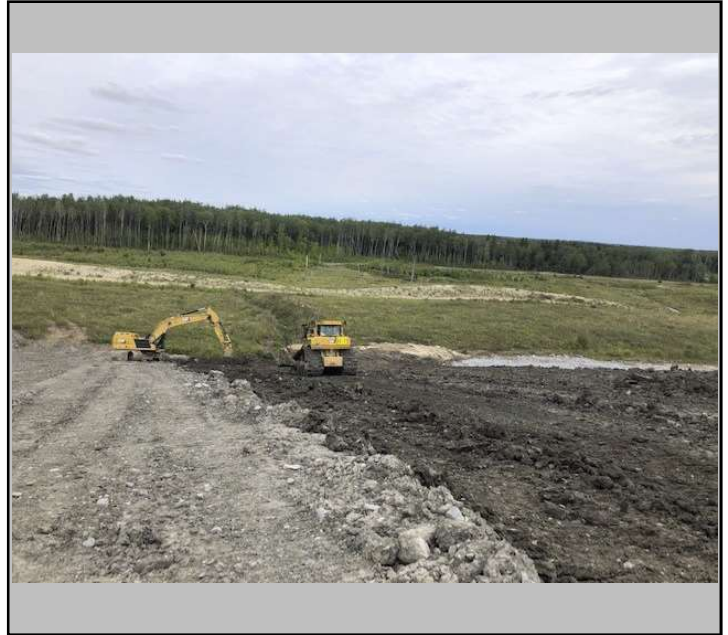
Photo #: 2

Panel 25 NCL Lift 4

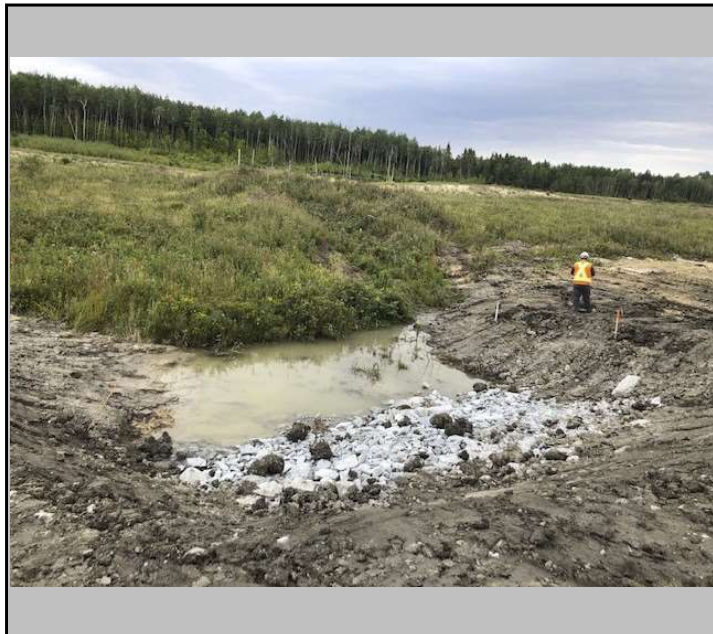
Photo #: 3

Toe Drain

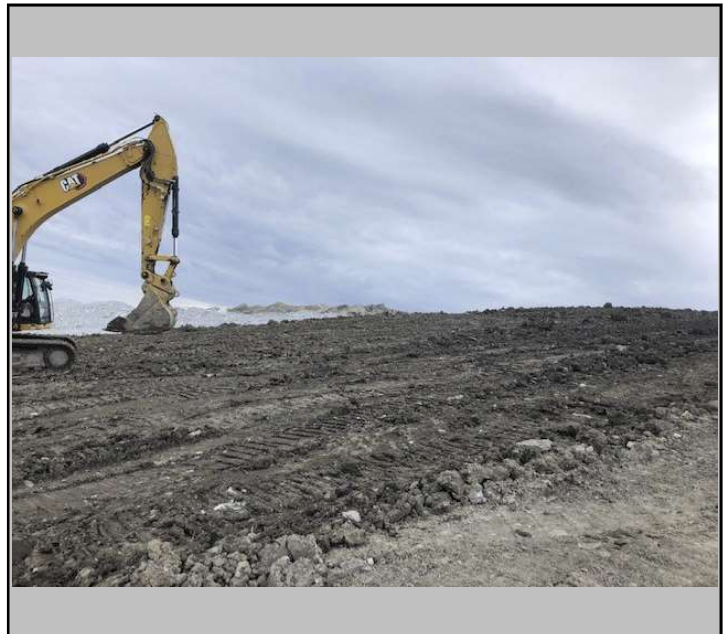
Photo #: 4

Panel 25 Lift 4 in progress

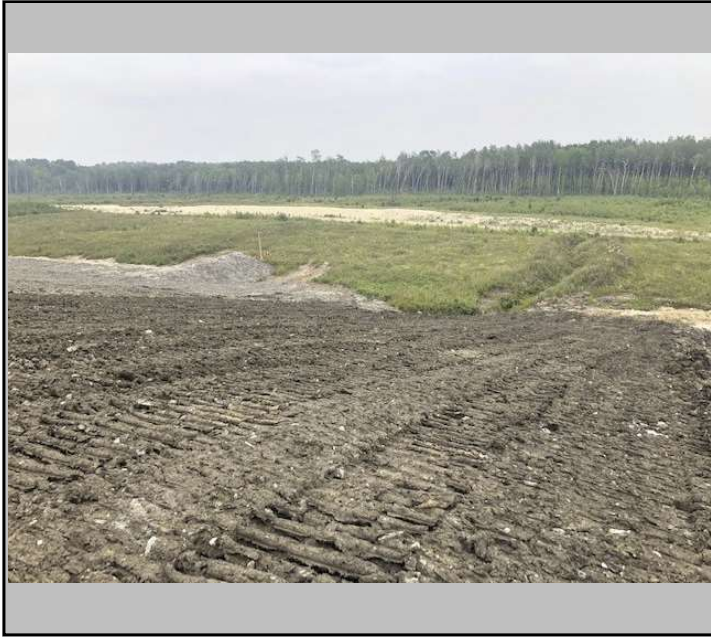
Photo #: 1

Panel 25 NCL Lift 4

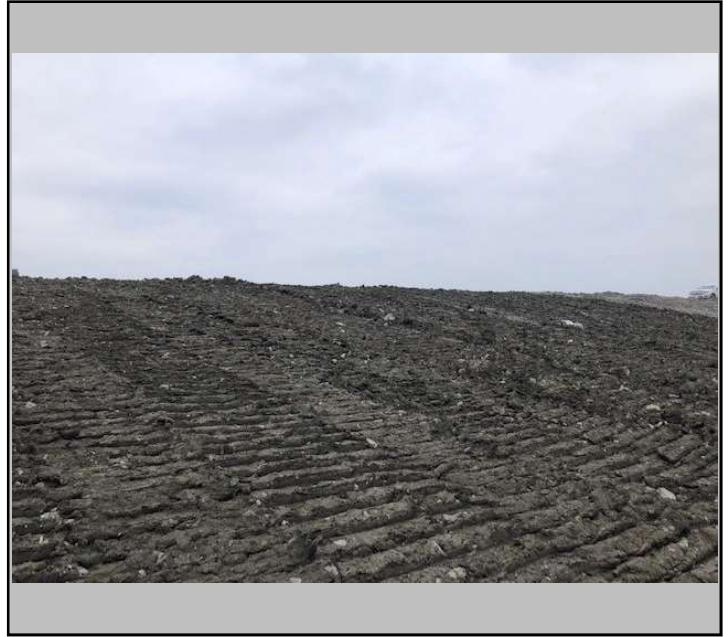
Photo #: 2

Panel 25 NCL Lift 4

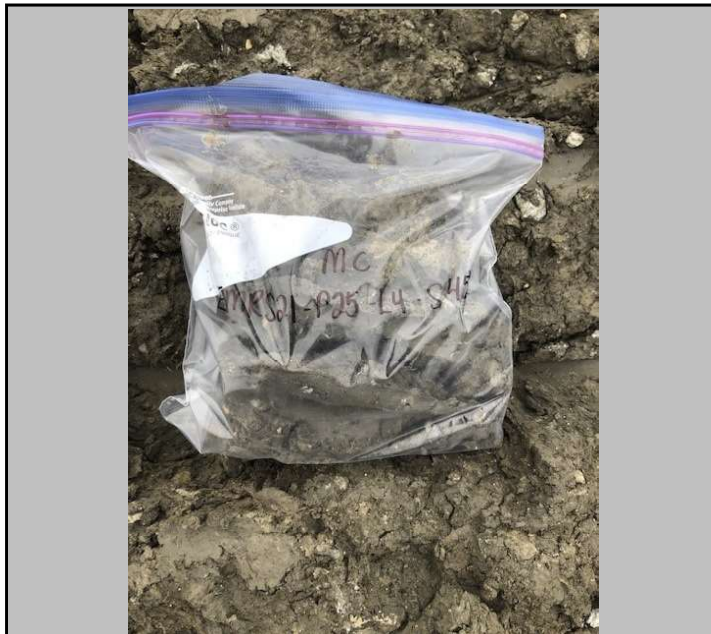
Photo #: 3

EMRS21-P25-L4-S452

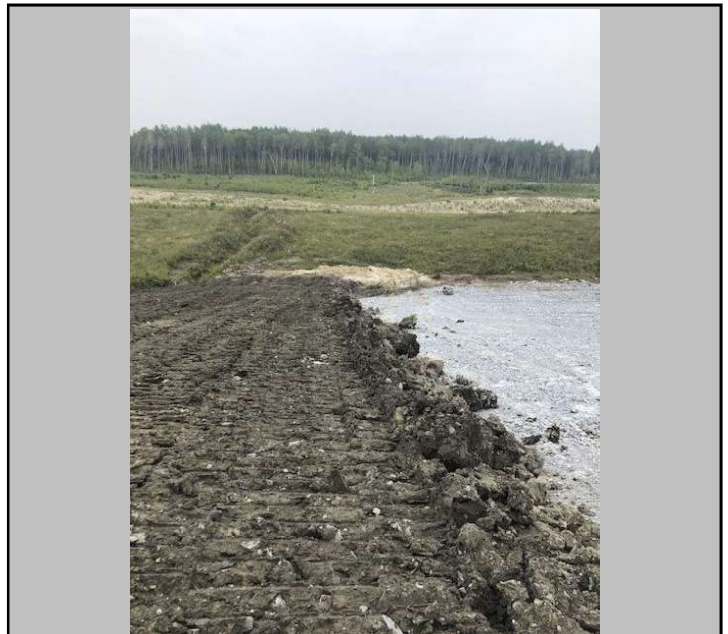
Photo #: 4

Panel 25 Edge

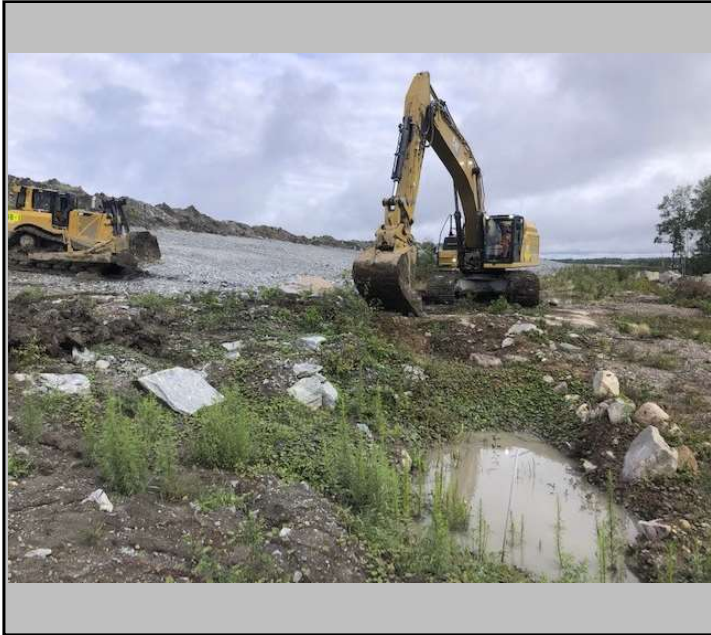
Photo #: 1

Bedrock at toe of Panel 27 and removal of organic material and oversize

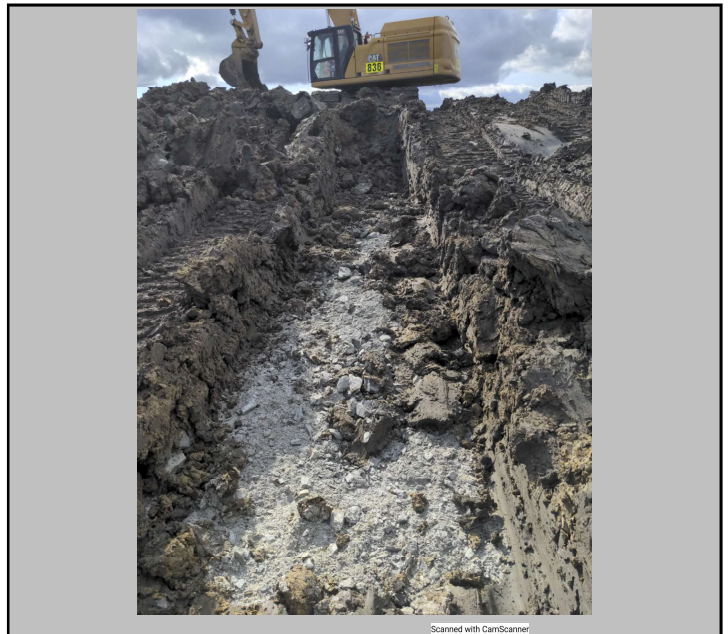
Photo #: 4

Crest and Bench exposed.

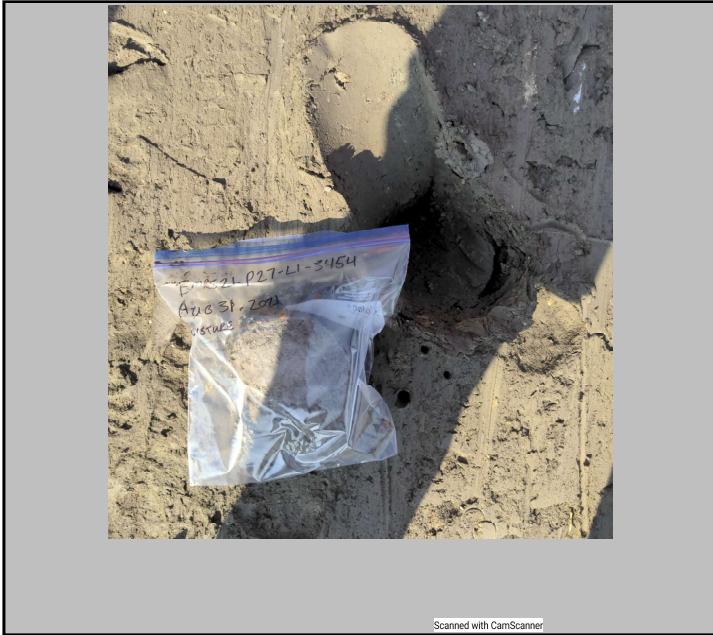
Photo #: 1

EMRS21-P27-L1-S454.

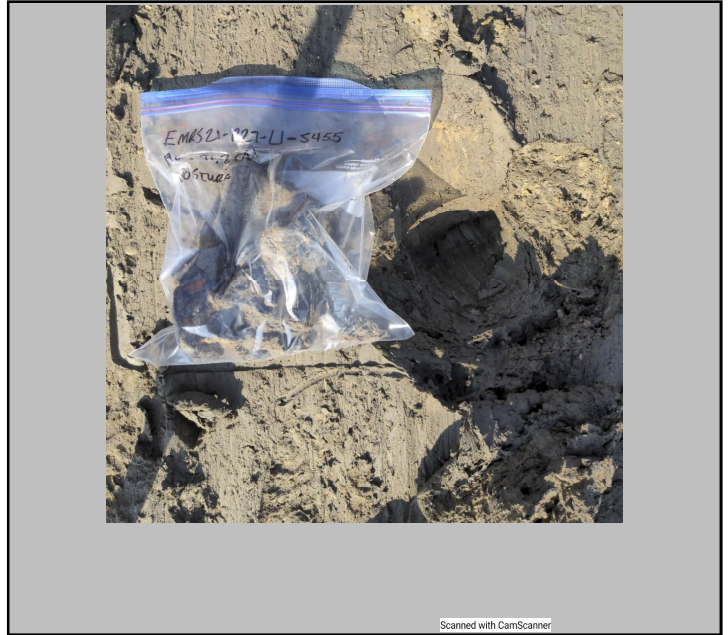
Photo #: 2

EMRS21-P27-L1-S455.

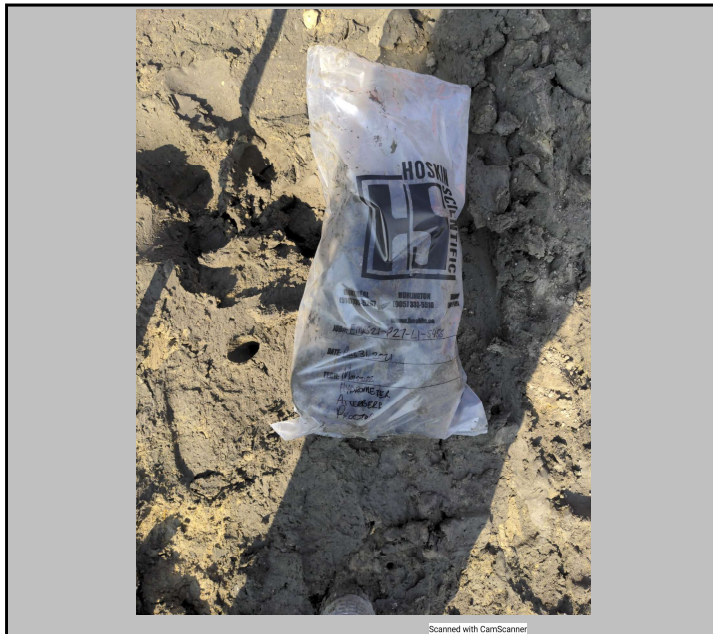
Photo #: 3

EMRS21-P27-L1-S456.

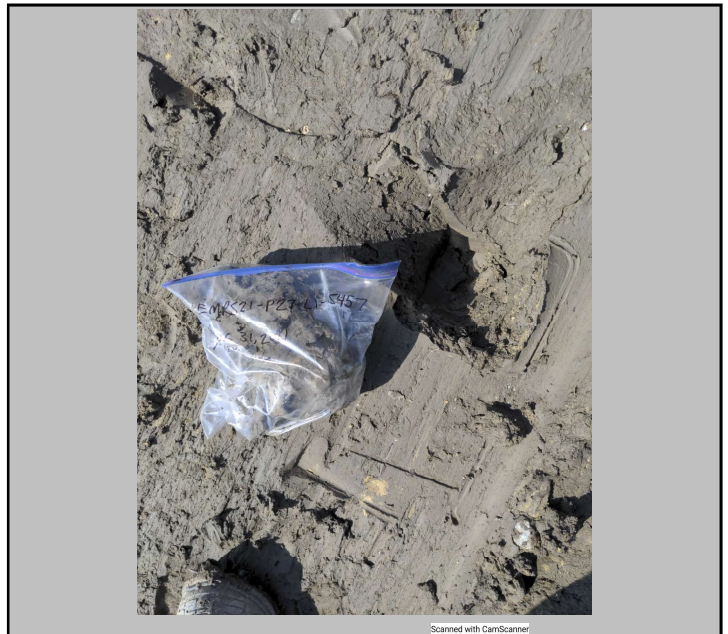
Photo #: 4

EMRS21-P27-L1-S457.

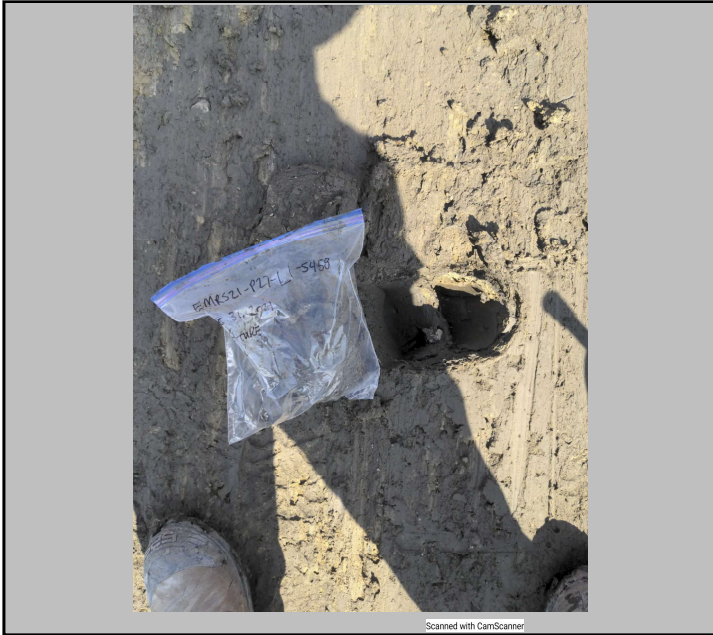
Photo #: 5

EMRS21-P27-L1-S458.

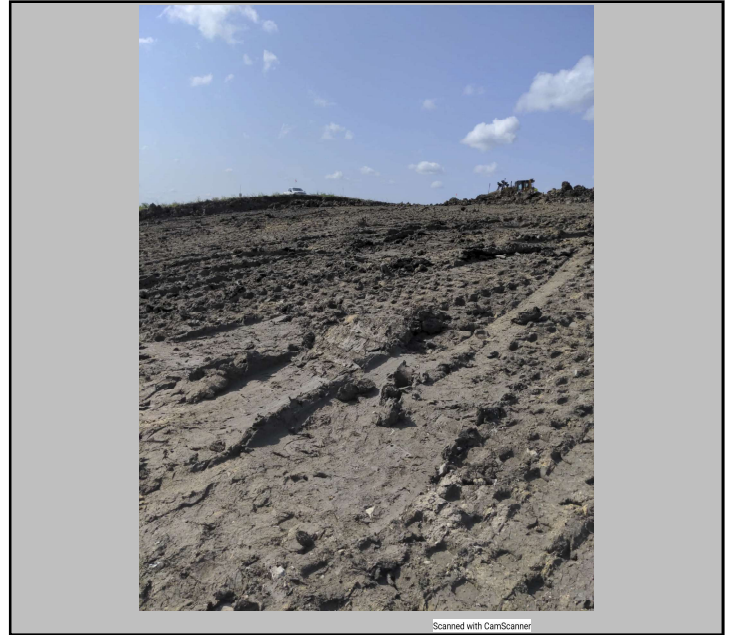
Photo #: 6

Panel 27 CCL Lift 1.

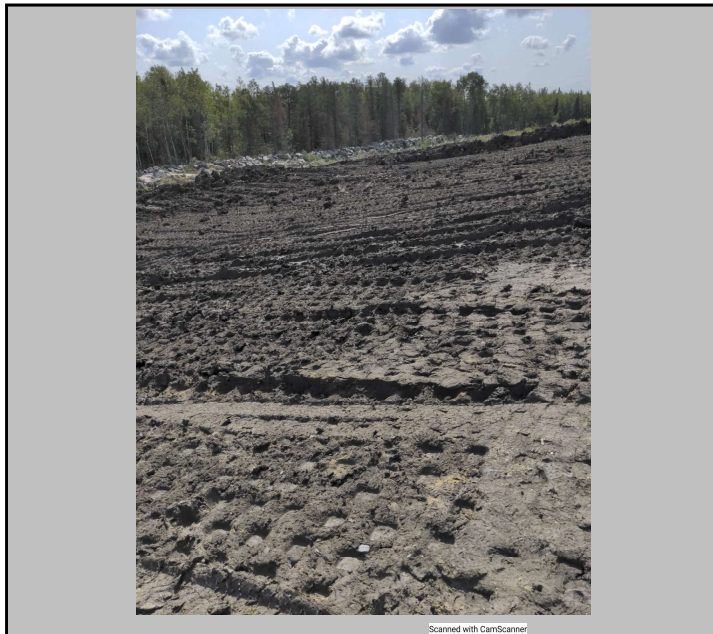
Photo #: 7

Panel 27 CCL Lift 1.

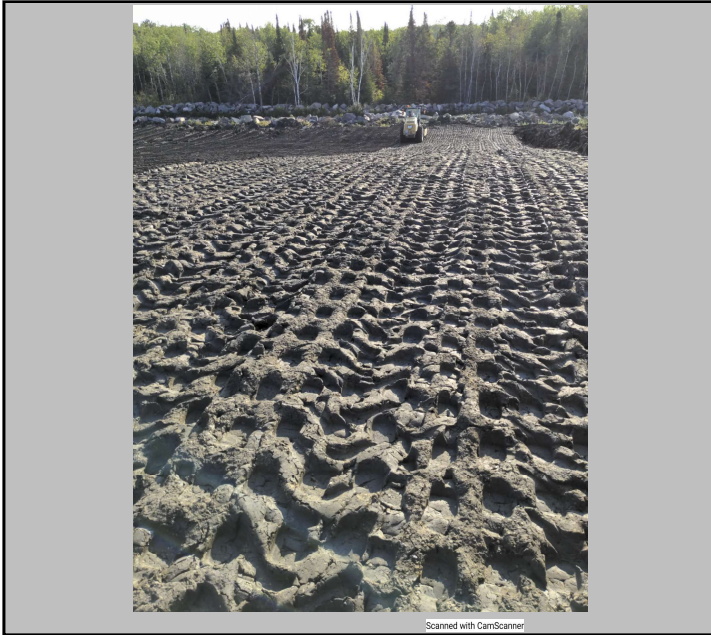
Photo #: 1

Panel 27 CCL Lift 2 packing.
