<b>Date:</b>	August 14, 2021	<b>Owner/Client:</b>	New Gold Inc.
<b>Day:</b>	Saturday	<b>OKC Project #:</b>	1003-19
<b>Prepared by:</b>	Martin Moore	<b>Project Location:</b>	Rainy River - Ontario

<b>Date:</b>	August 15, 2021	<b>Owner/Client:</b>	New Gold Inc.
<b>Day:</b>	Sunday	<b>OKC Project #:</b>	1003-19
<b>Prepared by:</b>	Martin Moore	<b>Project Location:</b>	Rainy River - Ontario

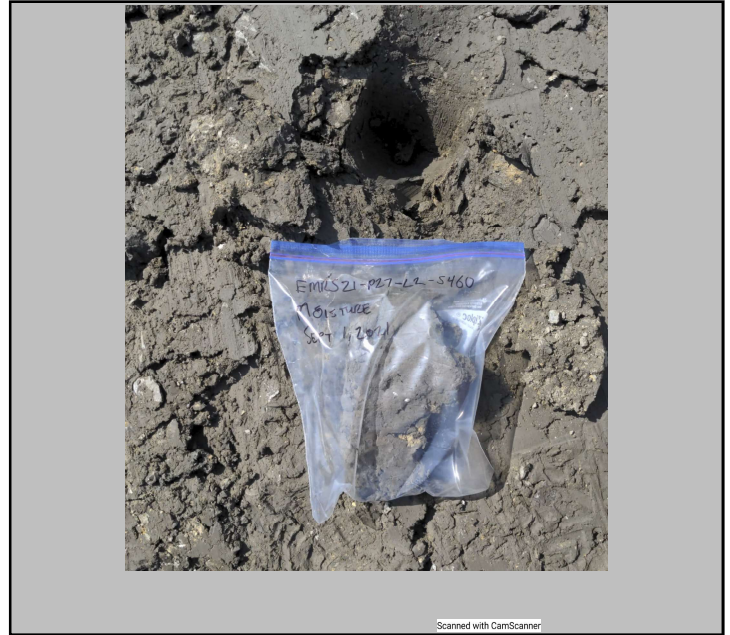
Photo #: 2

EMRS21-P27-L2-S460.

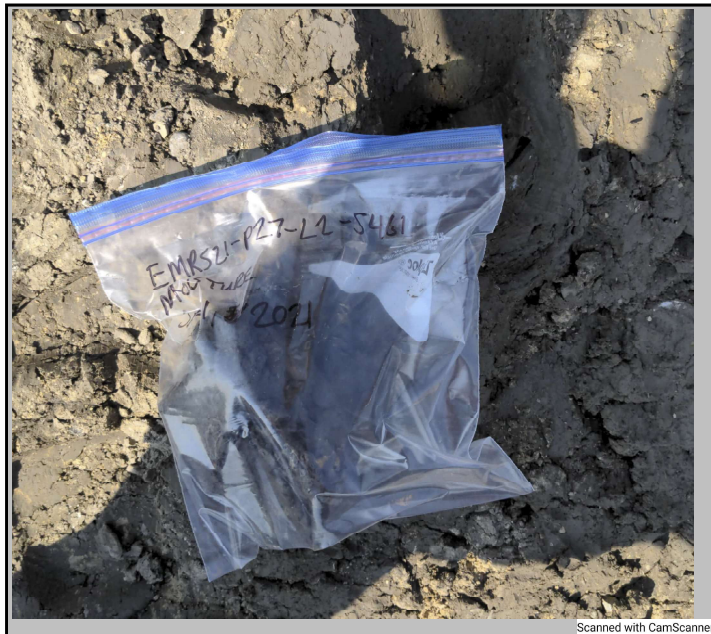
Photo #: 3

EMRS21-P27-L2-S461.

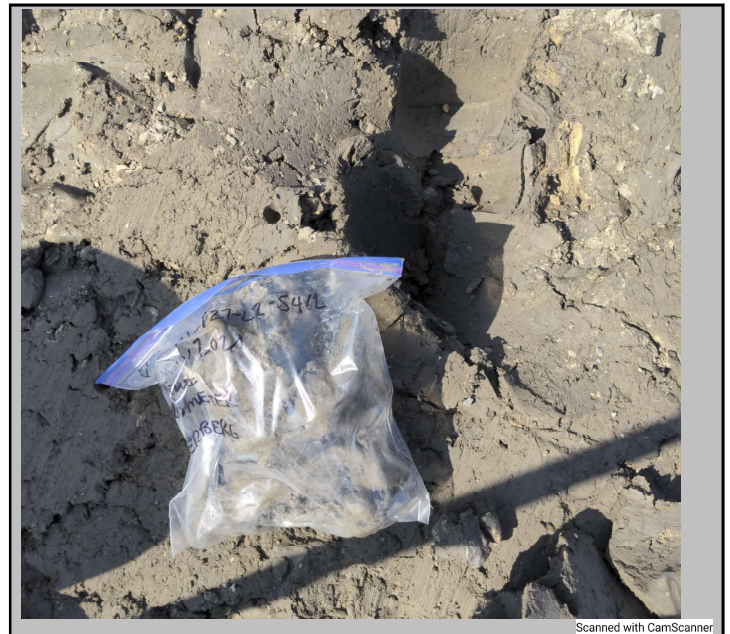
Photo #: 4

EMRS21-P27-L2-S462.

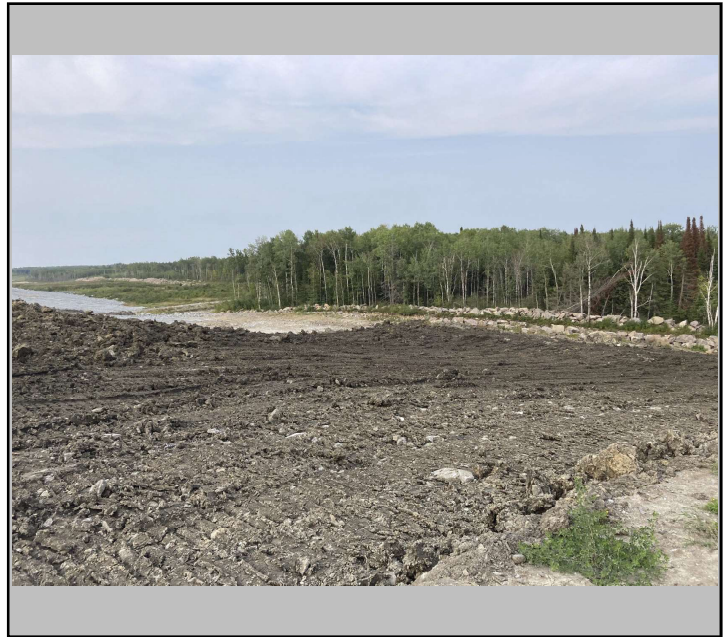
Photo #: 6

Panel 27 NCL Lift 3.

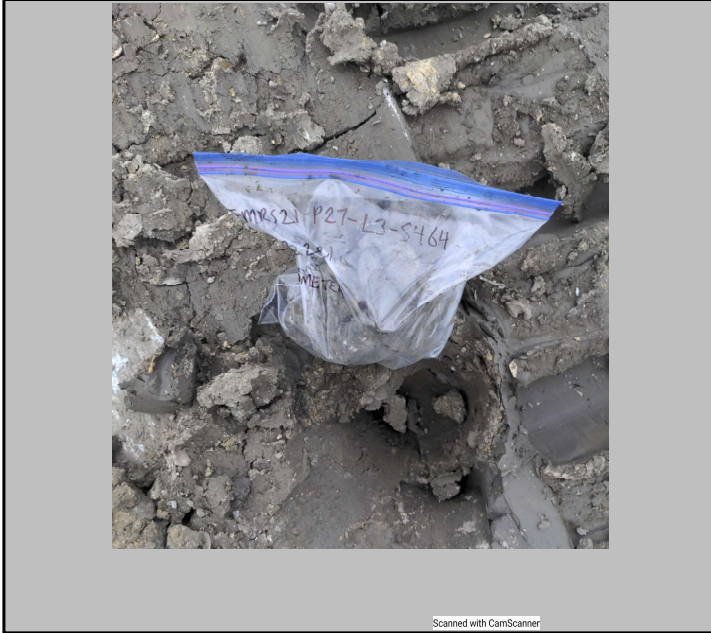
Photo #: 1

EMRS21-P27-L3-S464.

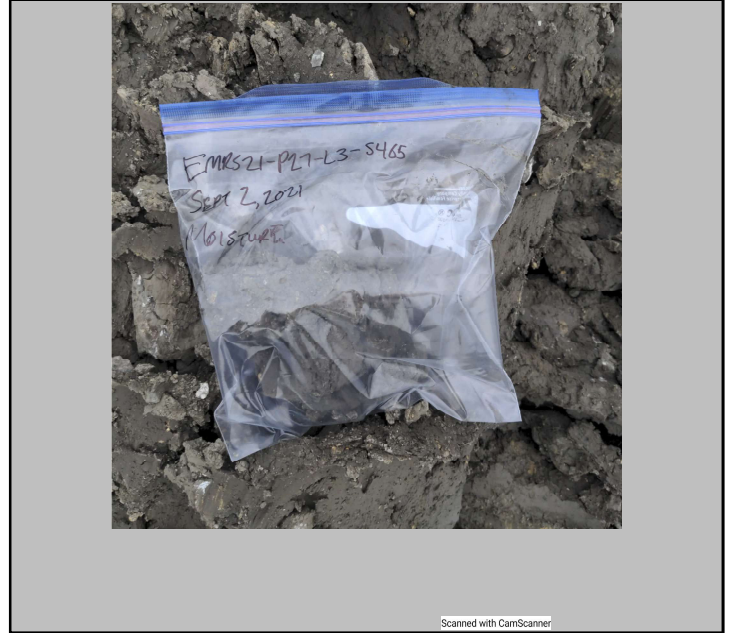
Photo #: 2

EMRS21-P27-L3-S465.

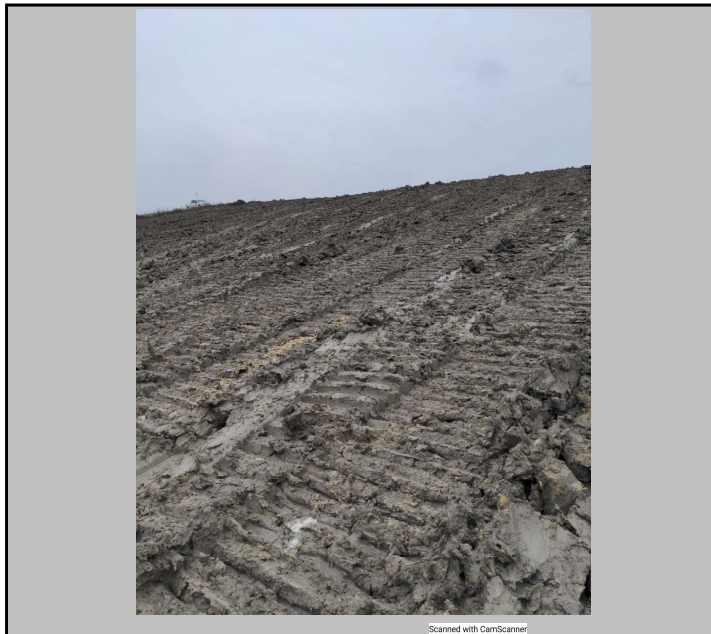
Photo #: 3

Panel 27 NCL Lift 3.

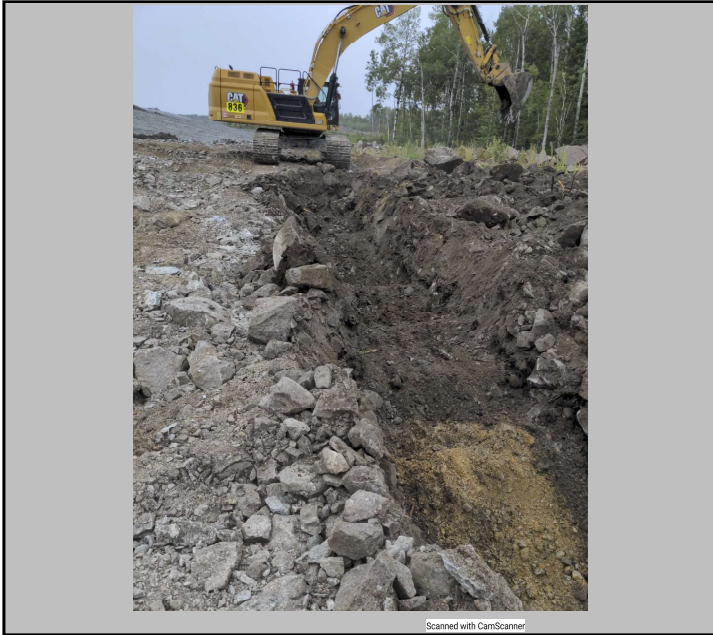
Photo #: 5

Pnle 28 Key Trench.

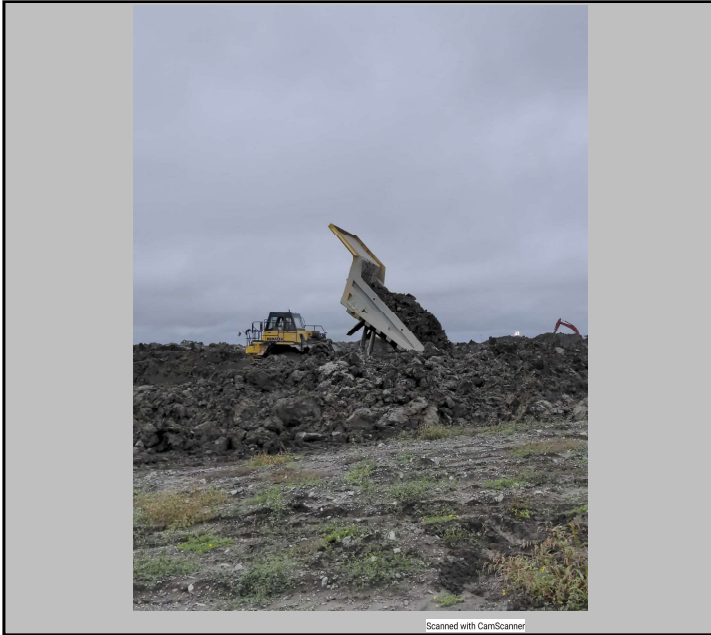
Photo #: 1

Material hauling for Panel 27 NCL Lift 4.

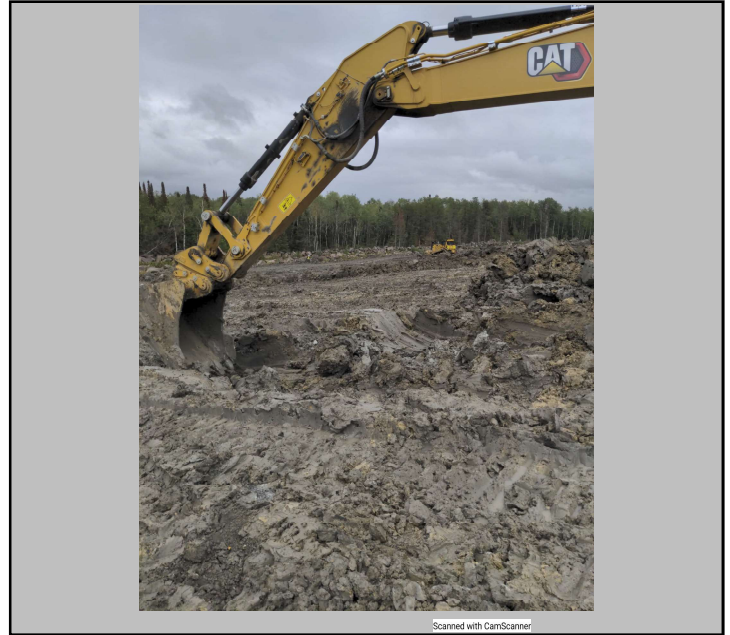
Photo #: 2

Excavating section of rock exposed through lift 1.

CCL material appeared to be dark brown and grey with spots of light brown. Humps of base rock found exposed at the top of Lift 1 being removed as well as oversize boulders.

Additional locations with humps of rock showing through Lift 1 being removed when found.

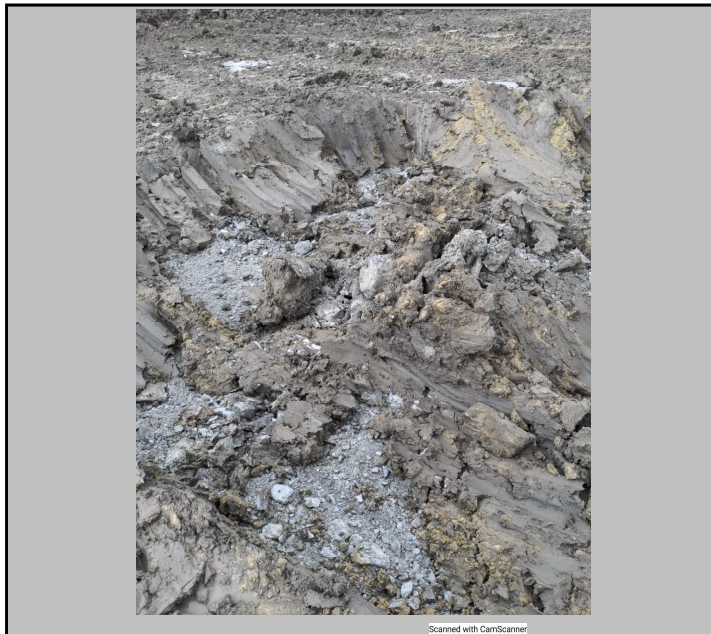
Photo #: 3

0.5m hump of rock.

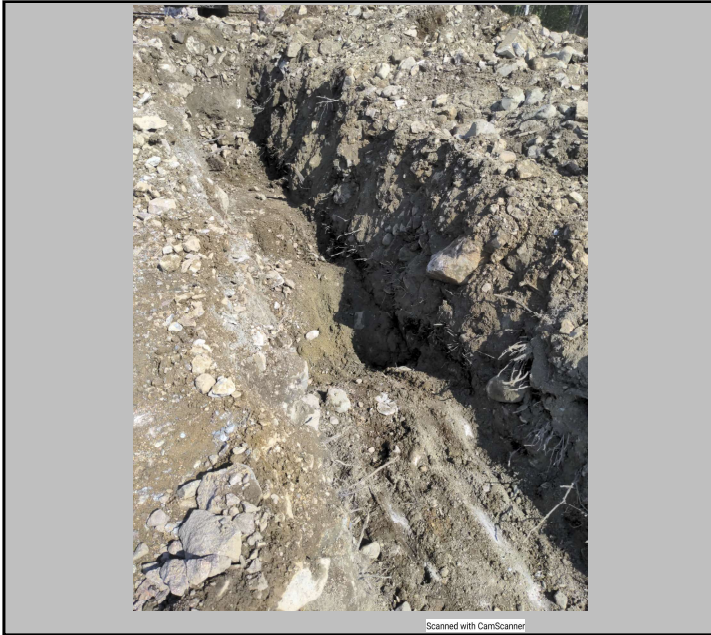
Photo #: 1

Panel 28 Key Trench extension.

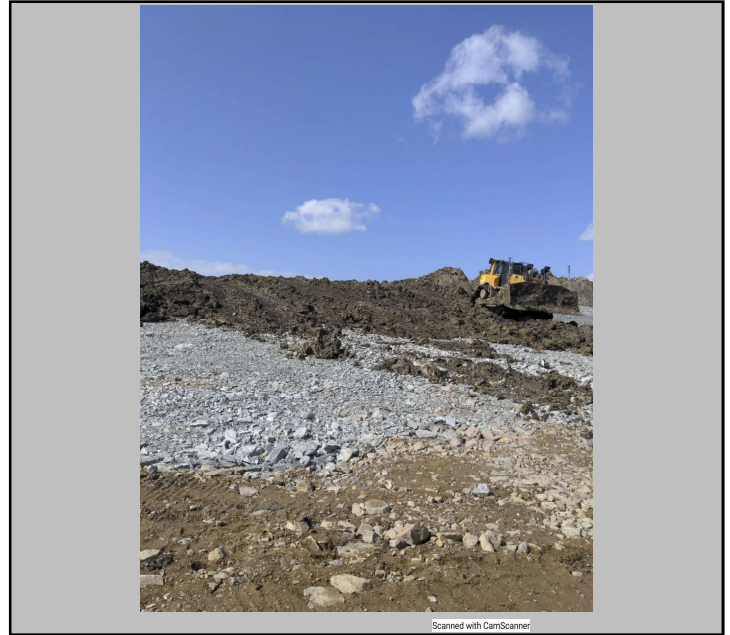
Photo #: 2

Panel 28 CCL Lift 1 placement.

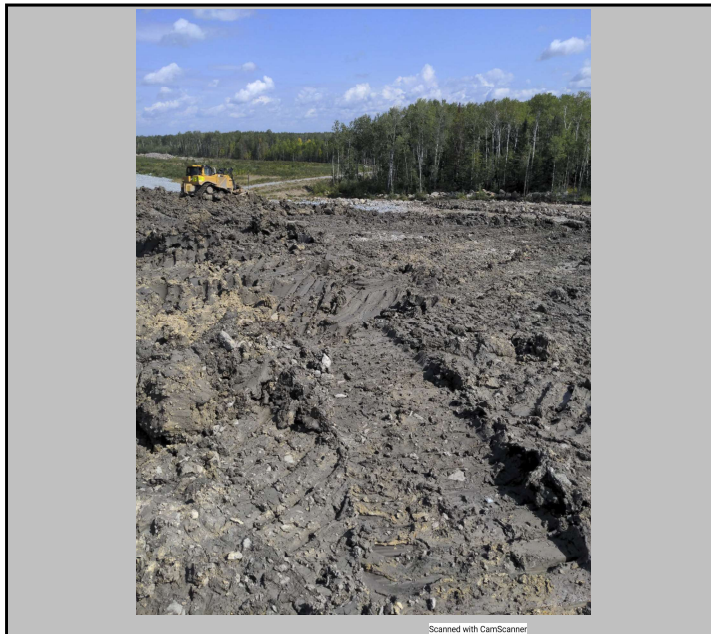
Photo #: 3

Panel 28 CCL Lift 1 placement.

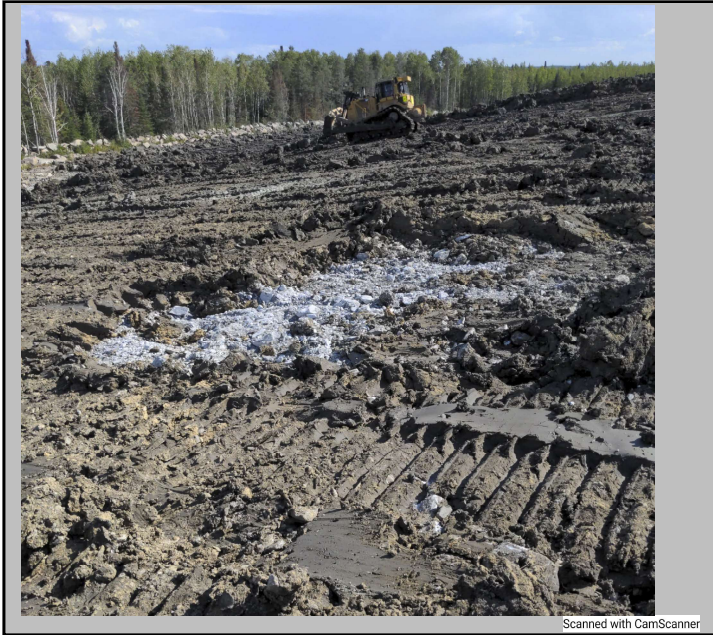
Photo #: 5

Panel 28 CCL Lift 1 rock hump removal.

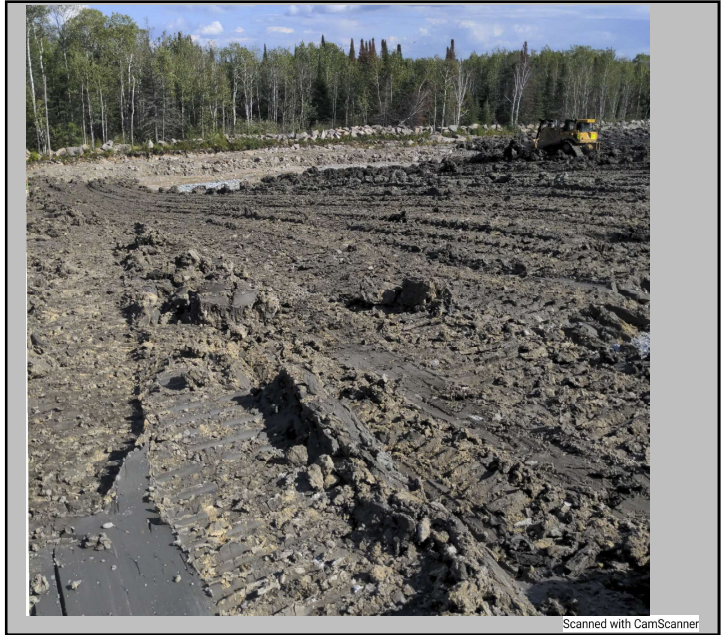
Photo #: 6

Panel 28 CCL Lift 1 placement.

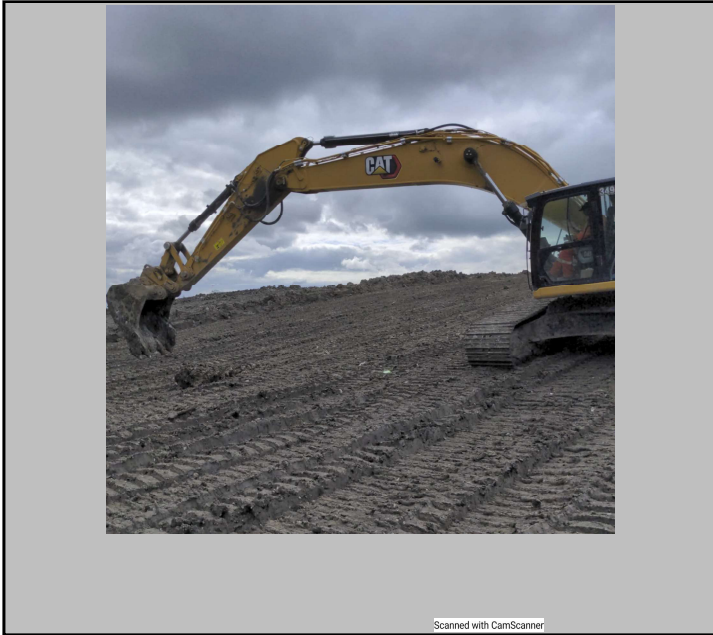
Photo #: 1

CCL material appeared to be dark brown and grey with spots of light brown. Abundance of oversize rocks being removed from Lift 1. Sections with an abundance of smaller rocks removed and replaced with suitable material with no rocks.

Oversize rock removal.

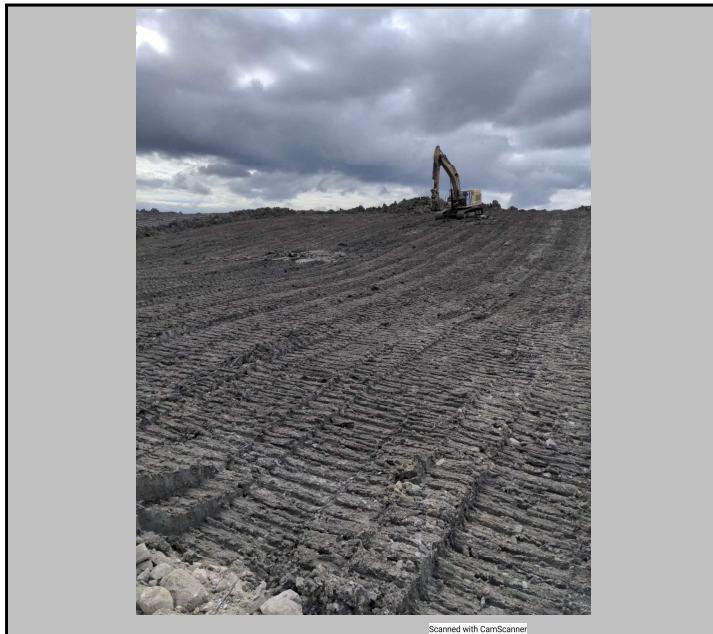
Photo #: 3

Panel 28 CCL Lift 1.

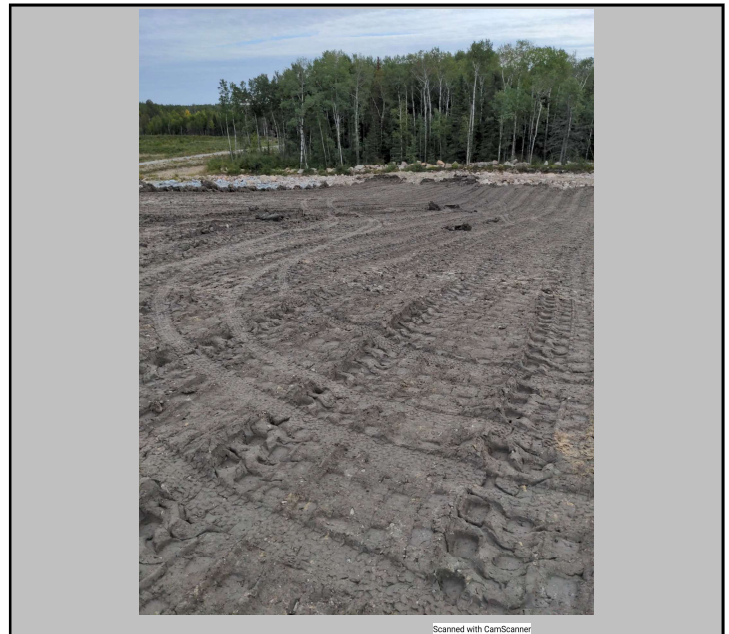
Photo #: 8

Panel 28 CCL Lift 1 complete.

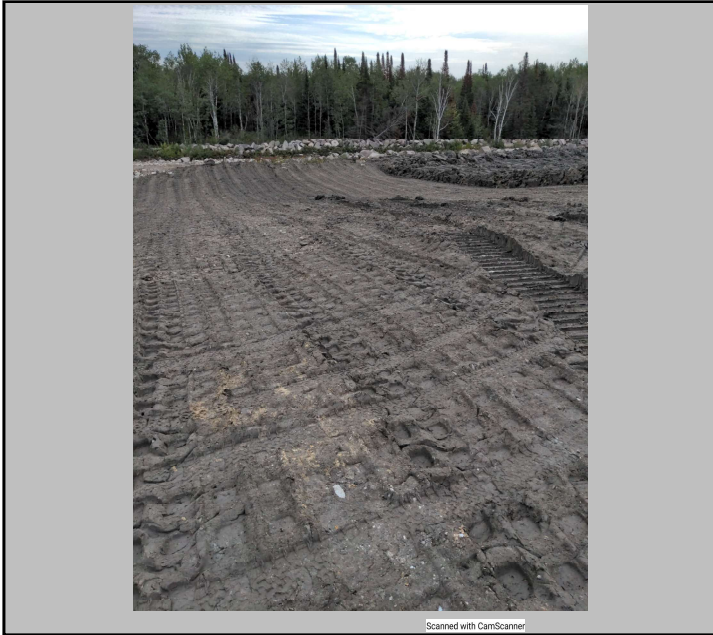
Photo #: 9

Panel 28 CCL Lift 1 complete.

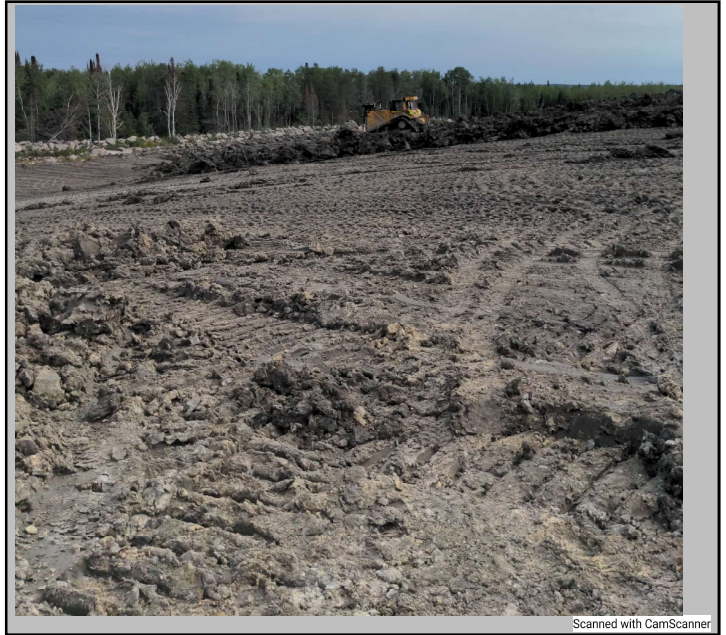
Photo #: 10

Panel 28 CCL Lift 2 placement.

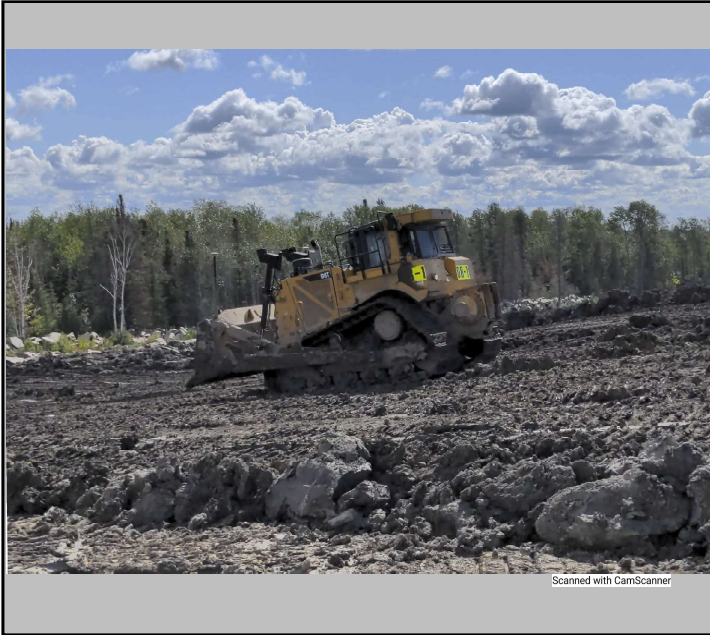
Photo #: 1

Panel 28 CCL Lift 2 grading.

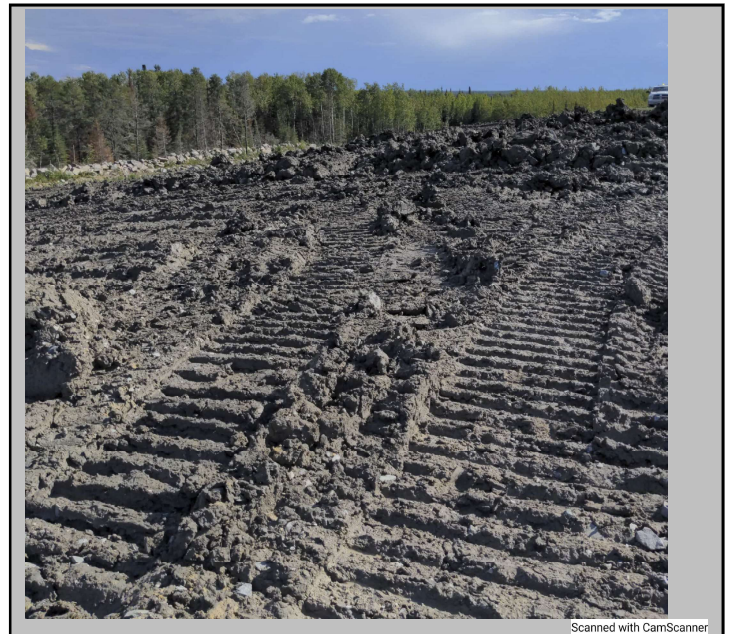
Photo #: 4

Panel 27 NCL Lift 4 placement.

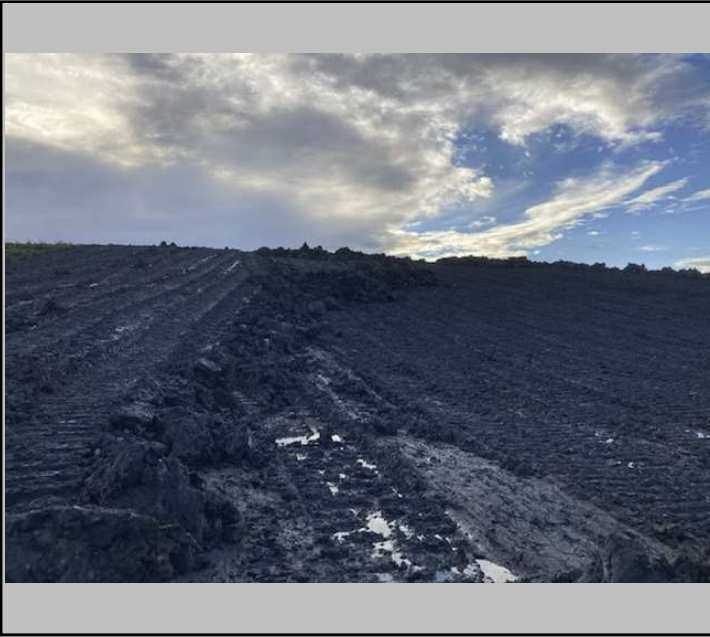
Photo #: 1

Panel 27 NCL Lift 4 progress.

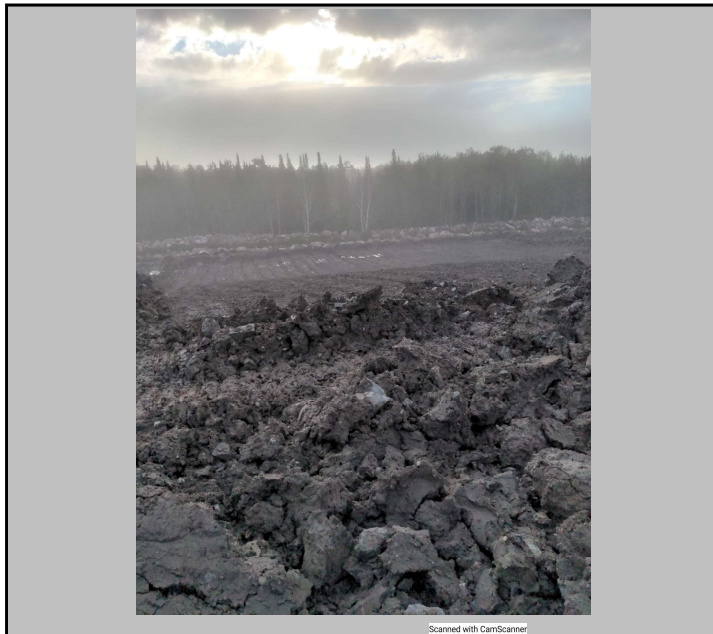
Photo #: 3

Panel 27 NCL Lift 3 and 4.

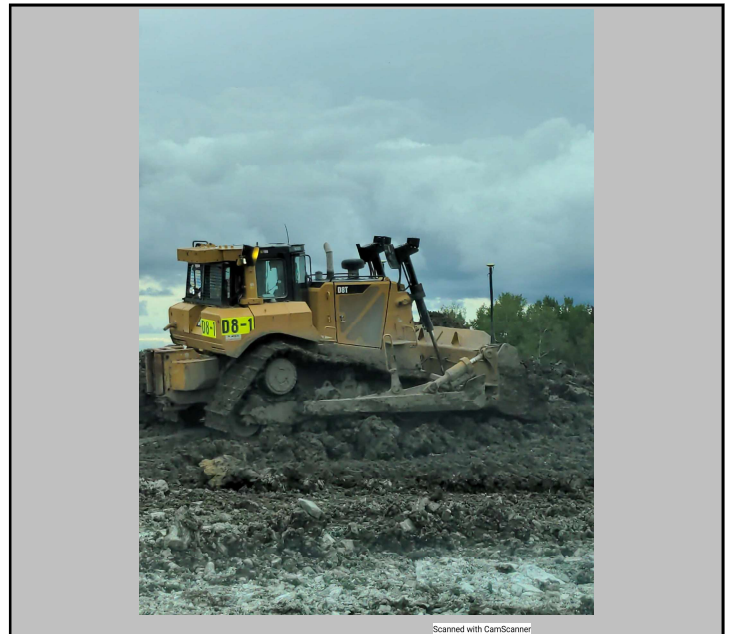
Photo #: 4

Bulking material for both panel 27 and 28.

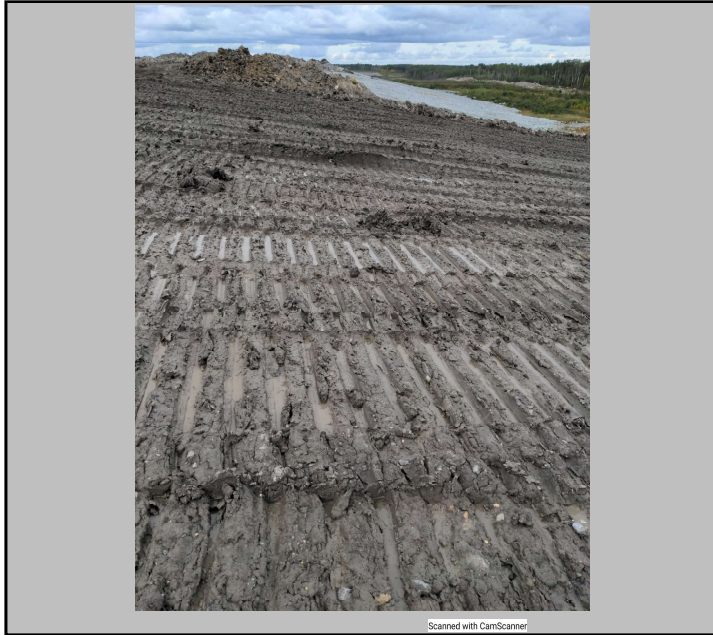
Photo #: 5

Panel 28 Lift 2 standing water.

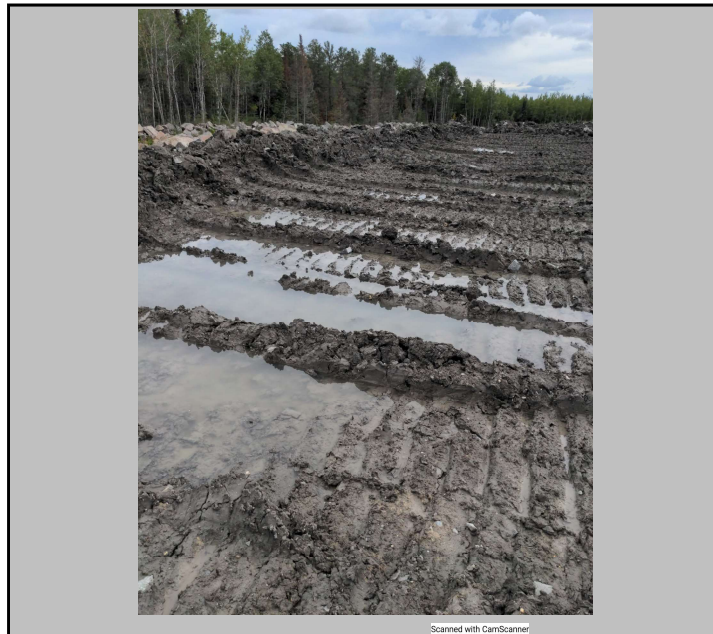
Photo #: 7

Panel 27 standing water at toe.

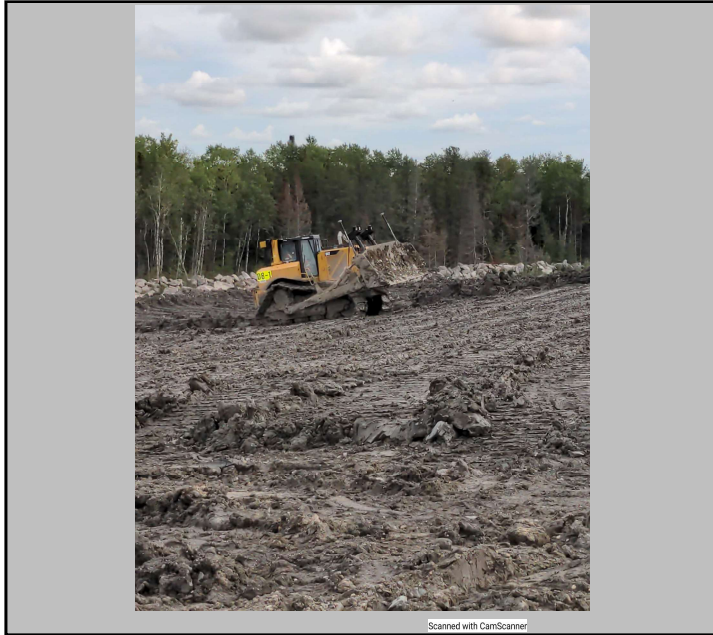
Photo #: 9

Track packing Panel 28 lift 2.

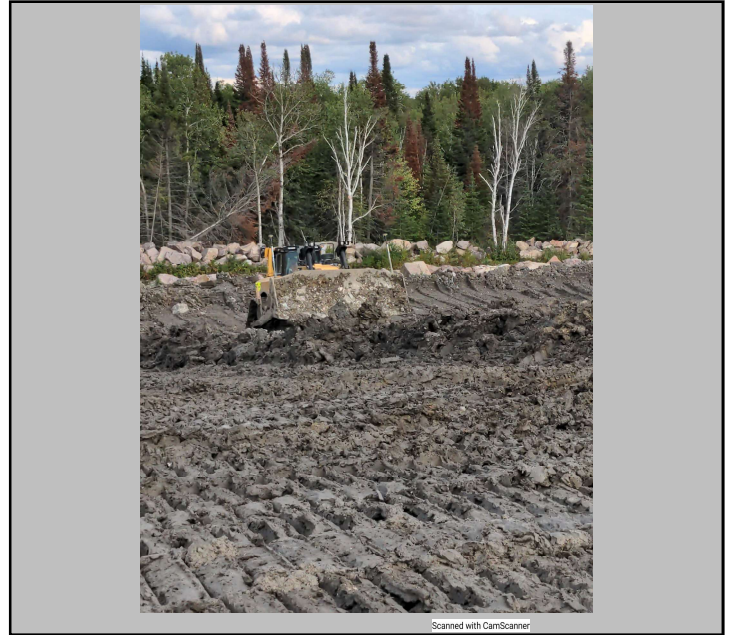
Photo #: 10

Track packing Panel 27 lift 3.

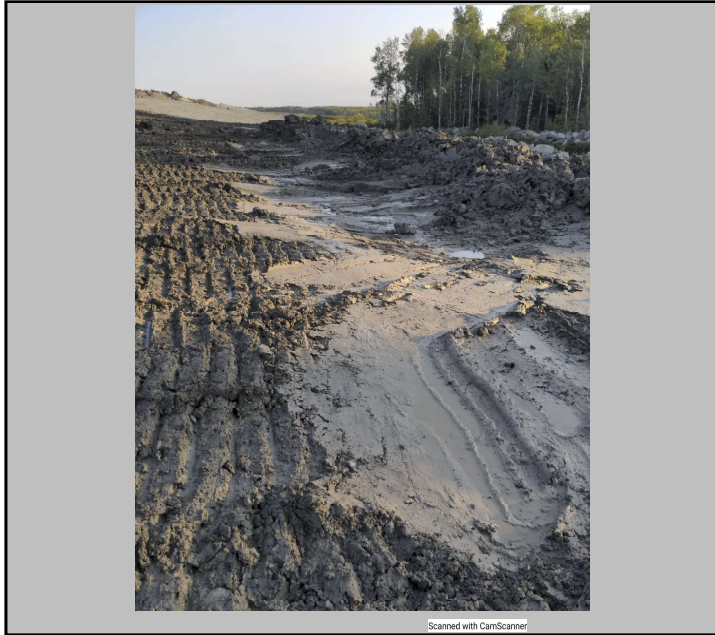
Photo #: 1

Removal of pooled water at toe.

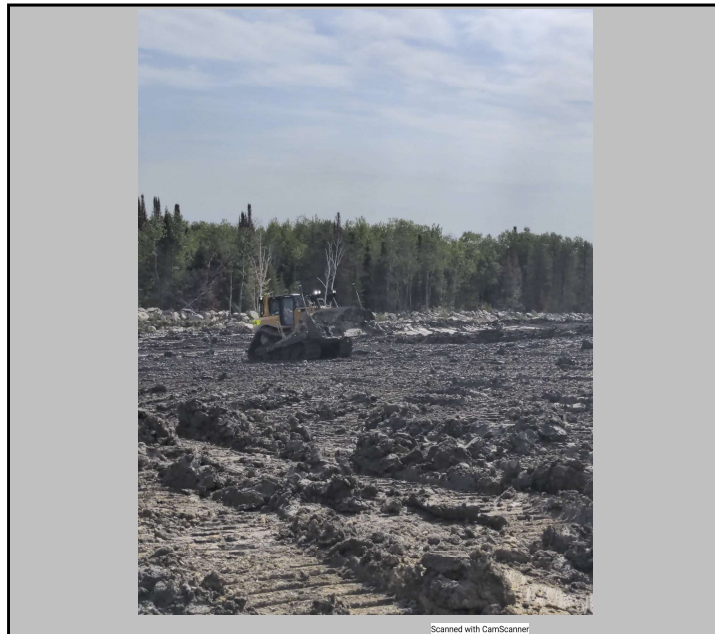
Photo #: 3

Track packing CCL Lift 2 again to remove standing water.

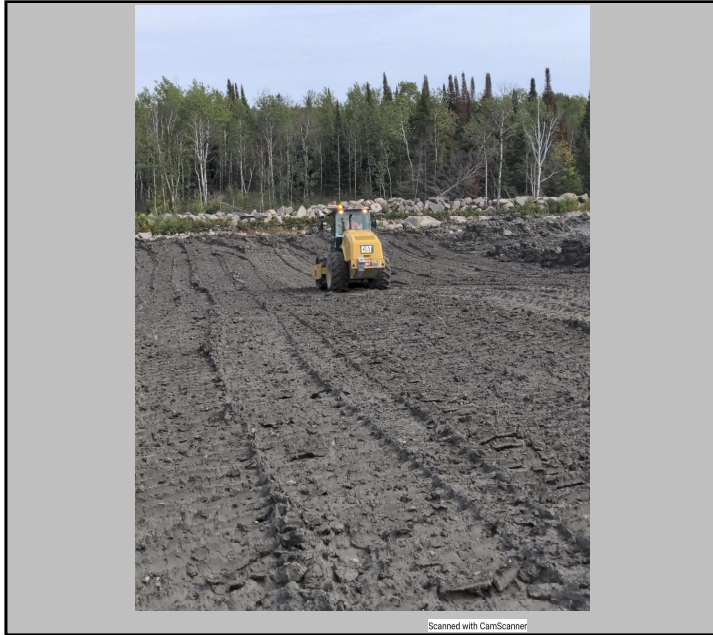
Photo #: 5

Began packing Panel 28 CCL Lift 2.

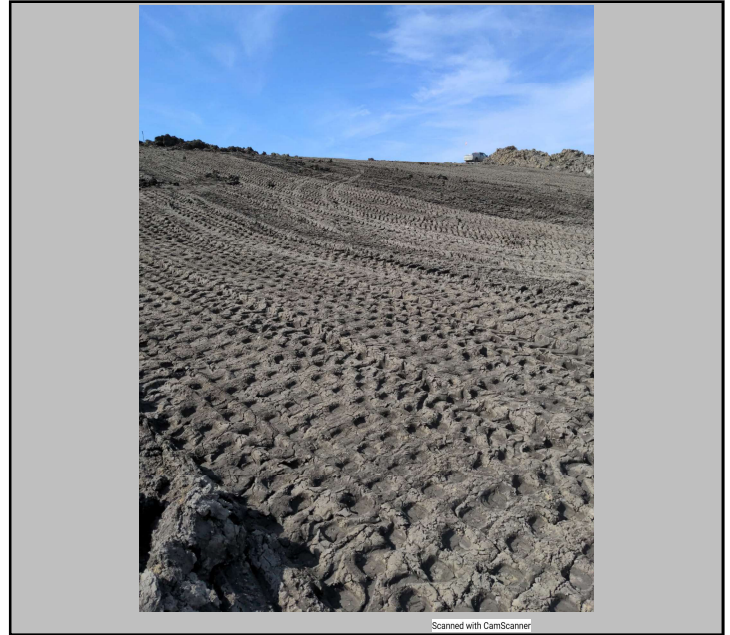
Photo #: 10

Panel 28 CCL Lift 2 complete.

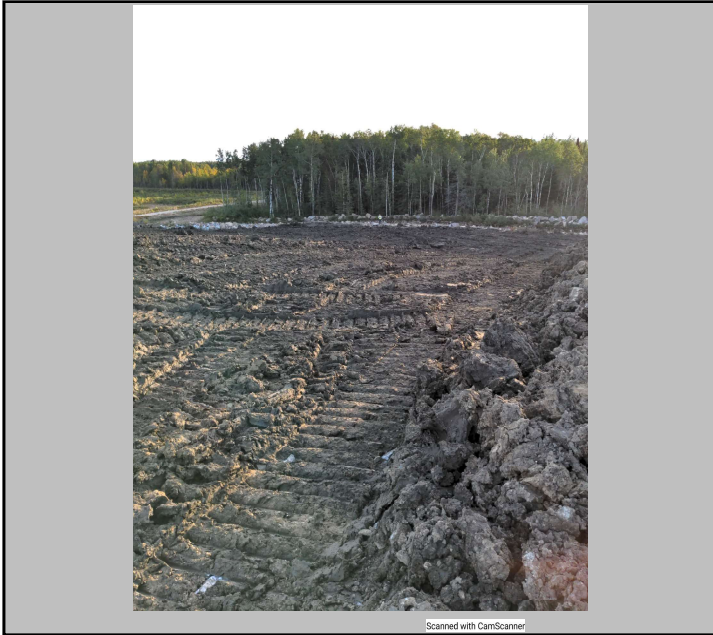
Photo #: 1

Panel 28 NCL Lift 3 covered lift 2.

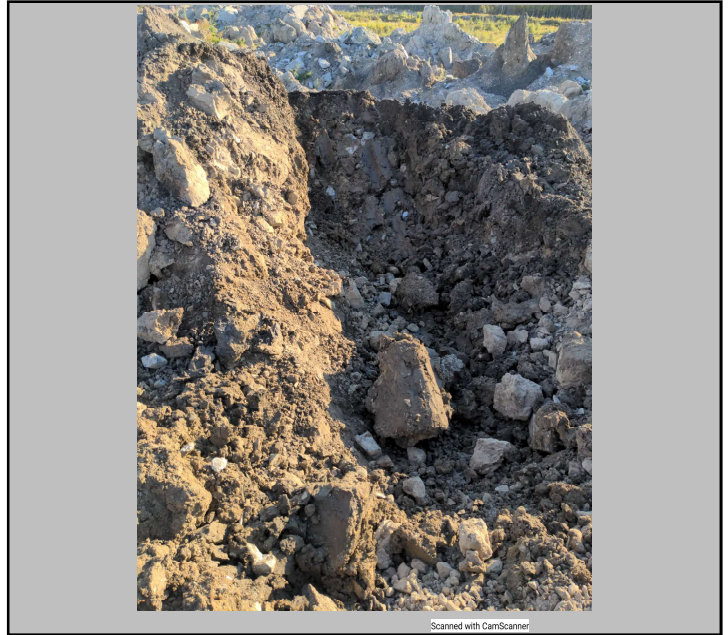
Photo #: 2

Waste material in stockpiles.

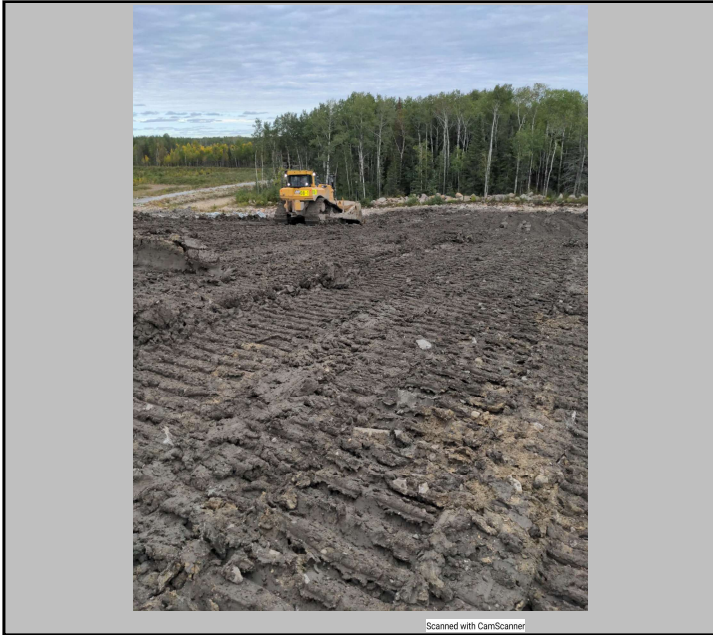
Photo #: 9

Panel 28 NCL Lift 3 near completion.

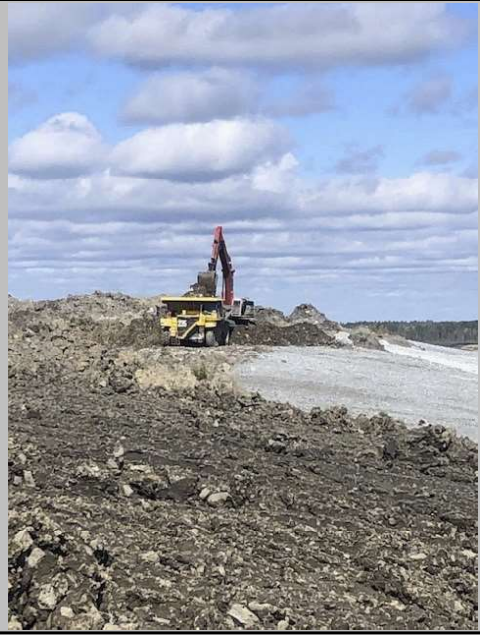
Photo #: 2

Excavator removing crest material

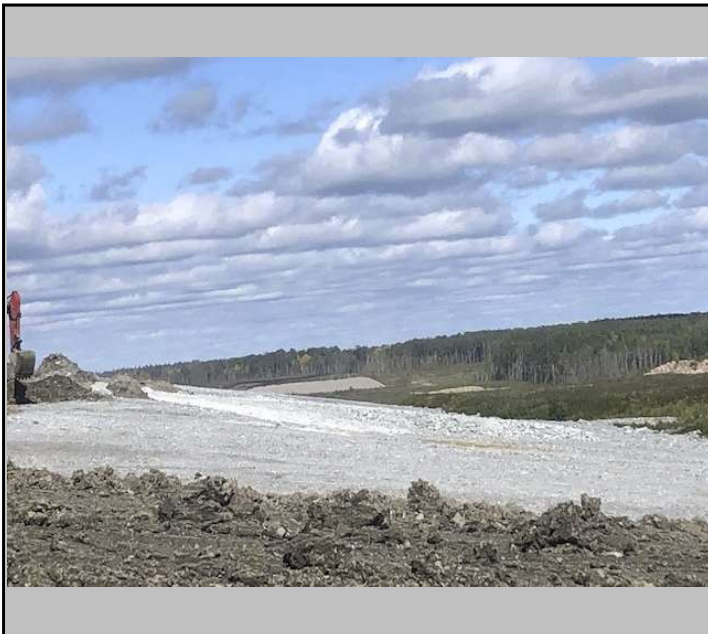
Photo #: 3

South East base slope

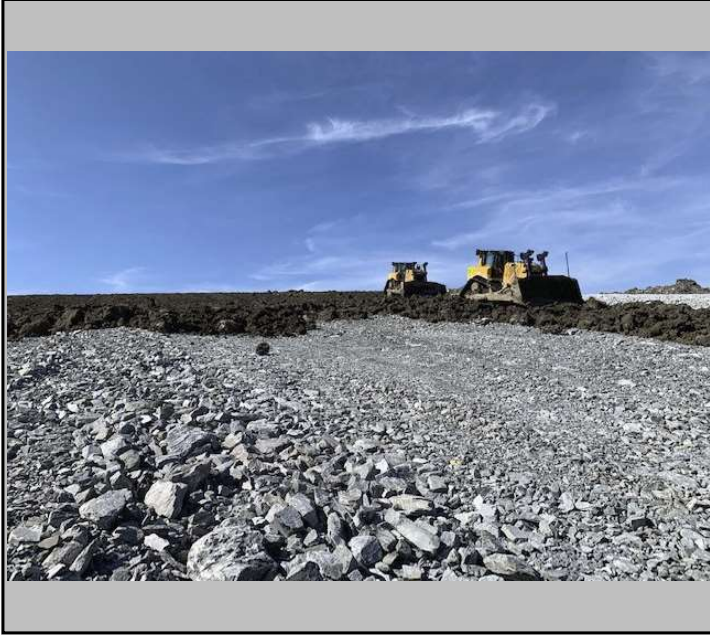
Photo #: 1

D8-1 and D8-2 pushing CCL Lift 1 on Panel 29.

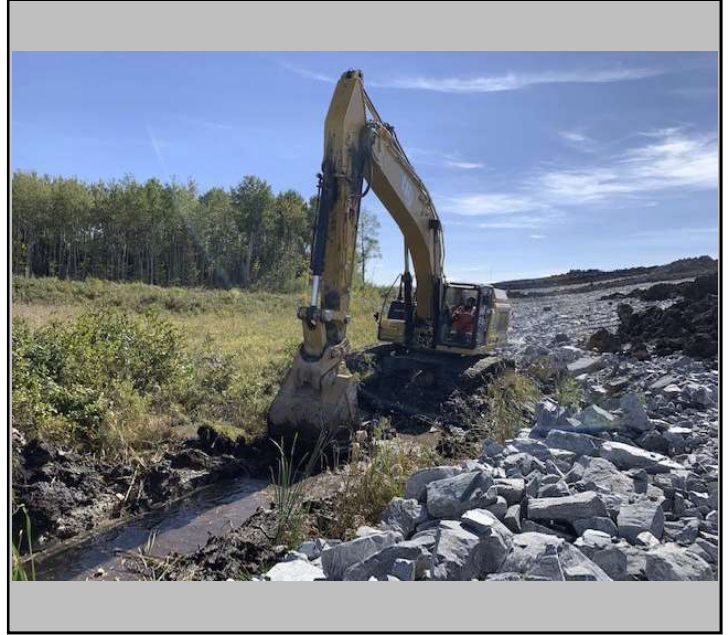
Photo #: 2

CAT 836 excavating key trench Panel 29.

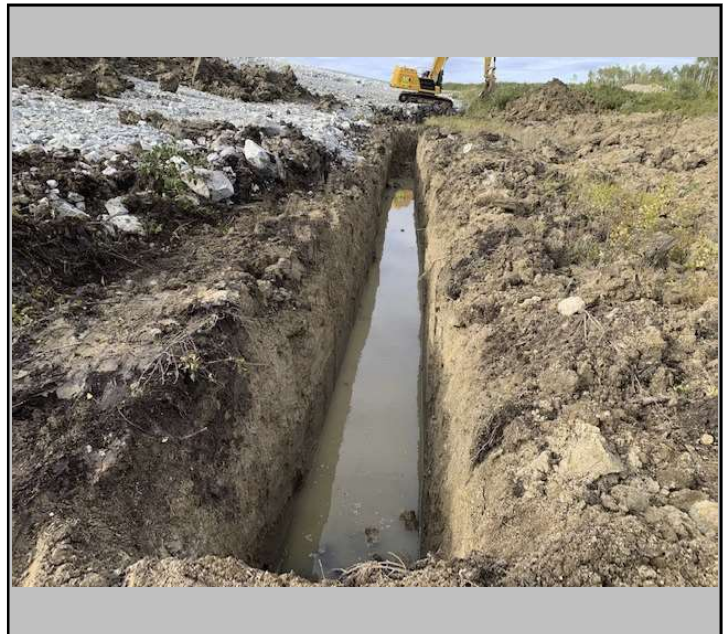
Photo #: 4

Panel 29 key trench STA 0+335 to 0+392.

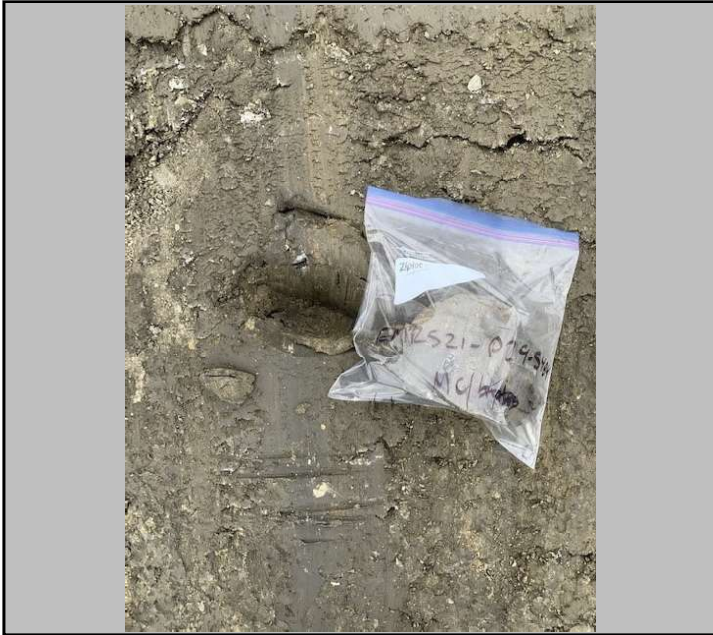
Photo #: 1

EMRS21-P29-L1-S484.

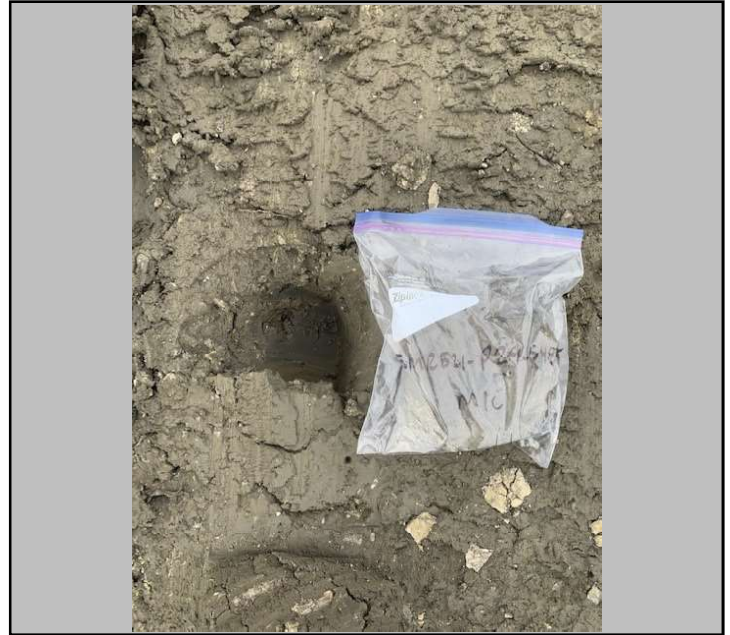
Photo #: 2

EMRS21-P29-L1-S485.

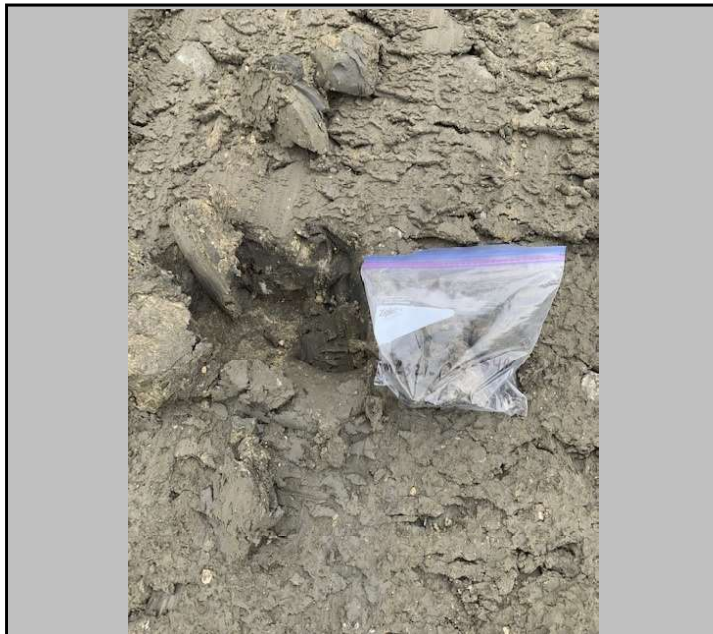
Photo #: 3

EMRS21-P29-L1-S486.

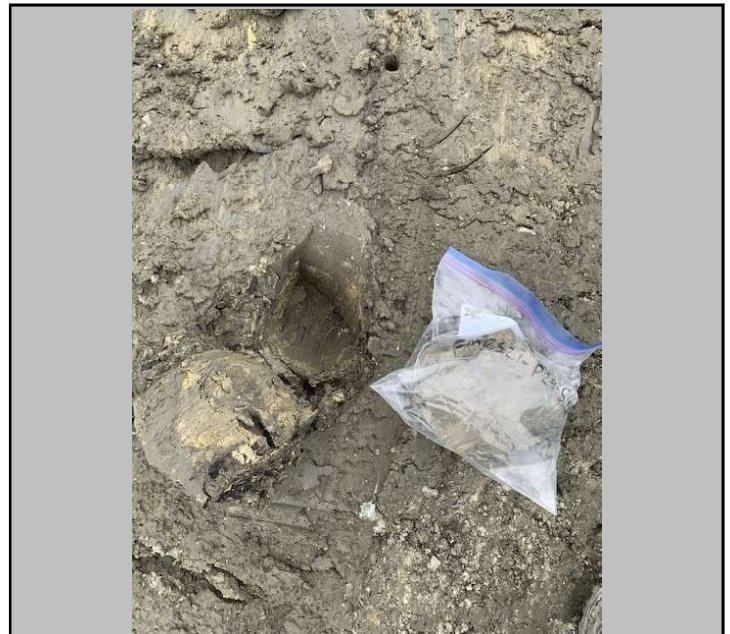
Photo #: 4

EMRS21-P29-L1-S487.

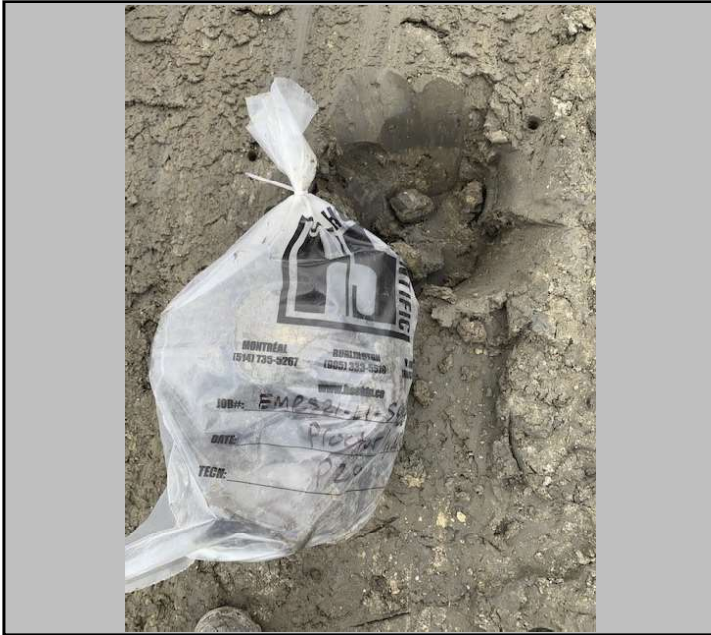
Photo #: 5

.EMRS21-P29-L1-S488.

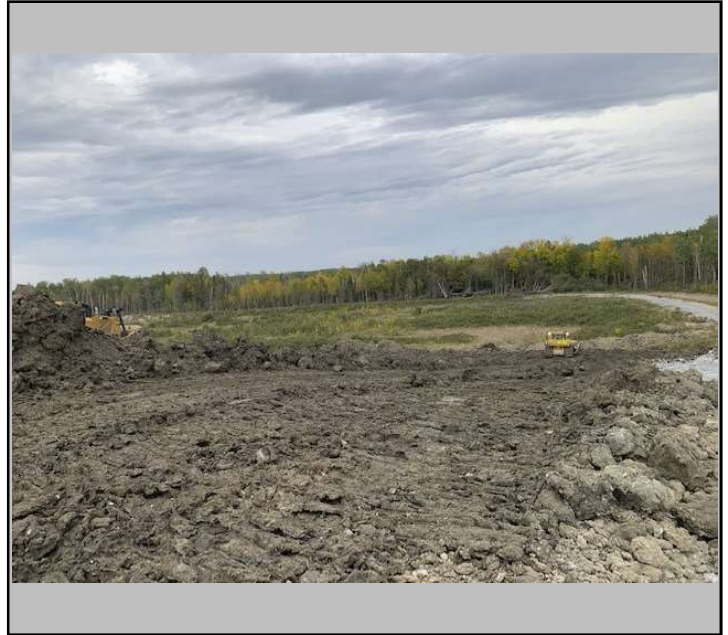
Photo #: 6

D8-1 and D8-2 pushing CCL Lift 2 on Panel 29.

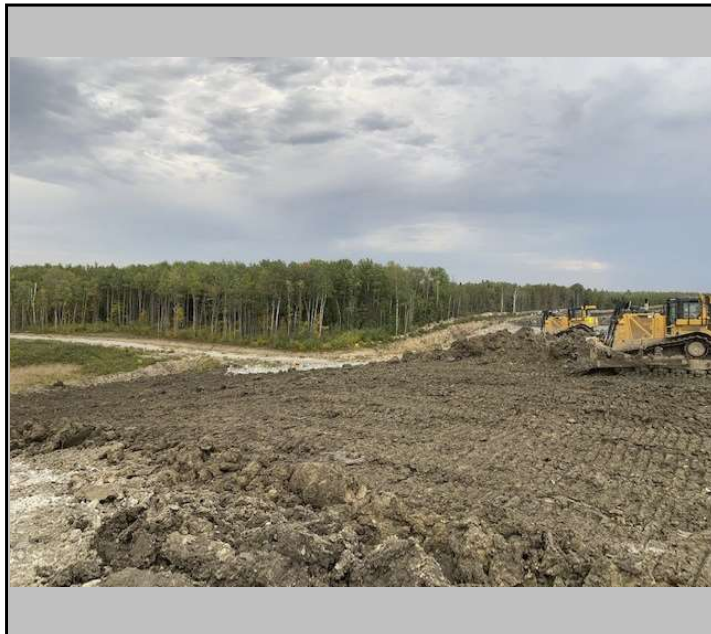
Photo #: 7

D8-1 and D8-2 pushing CCL Lift 2 on Panel 29.
