<b>Date:</b>	August 14, 2021	<b>Owner/Client:</b>	New Gold Inc.
<b>Day:</b>	Saturday	<b>OKC Project #:</b>	1003-19
<b>Prepared by:</b>	Martin Moore	<b>Project Location:</b>	Rainy River - Ontario

<b>Date:</b>	August 15, 2021	<b>Owner/Client:</b>	New Gold Inc.
<b>Day:</b>	Sunday	<b>OKC Project #:</b>	1003-19
<b>Prepared by:</b>	Martin Moore	<b>Project Location:</b>	Rainy River - Ontario

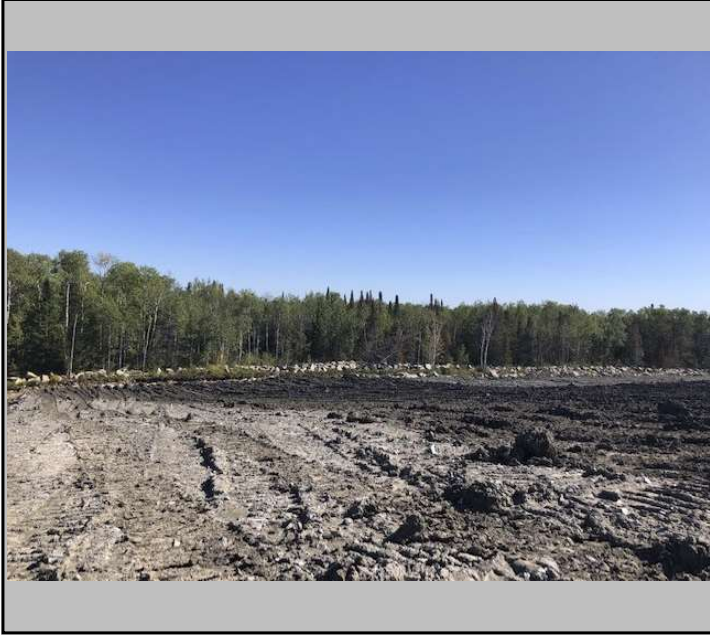
Photo #: 1

Panel 28 NCL L4

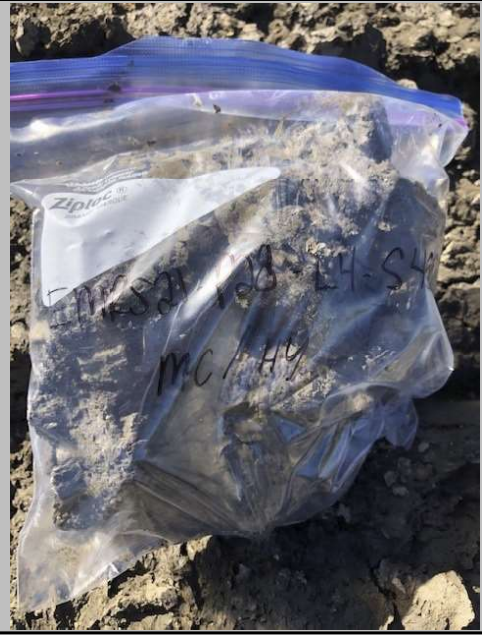
Photo #: 2

EMRS21-P28-L4-S489
